Exhibit 2.

Pictures of Outside Plant  
in Sprint's  
Central Telephone of Texas

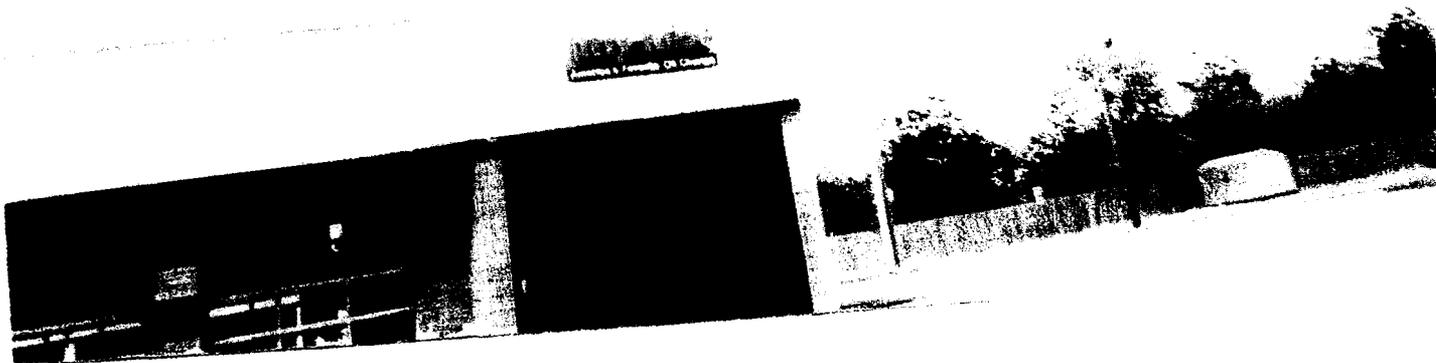
Due to cut backs by Sprint, a lot of closures around town have oil cloths on them as this one does. They can not be rehabed for lack of personnel.

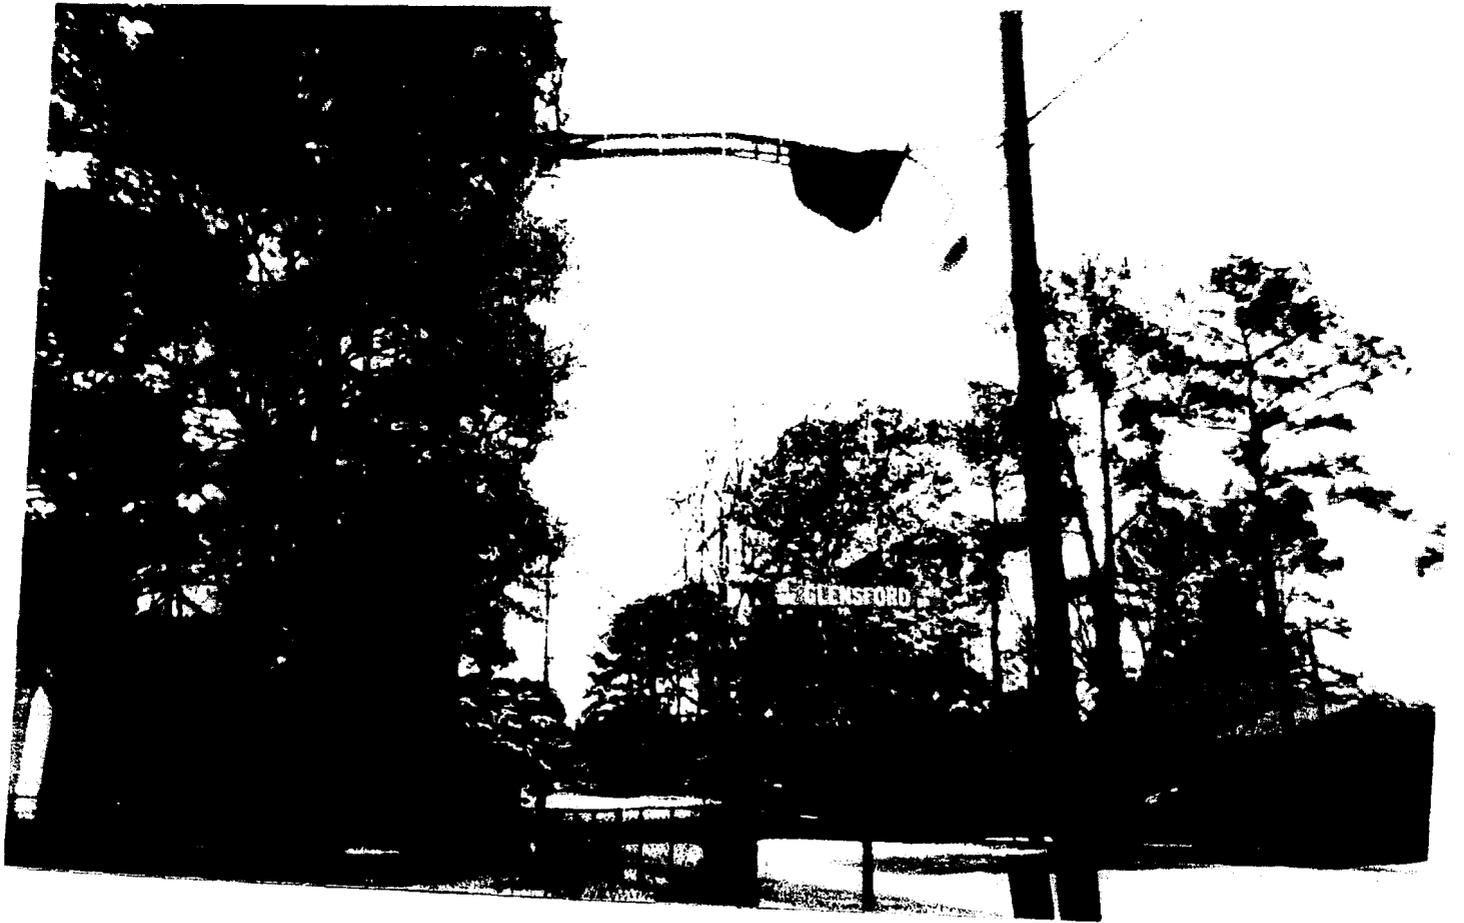
Another "temporary fix" in a nice North Carolina neighborhood.

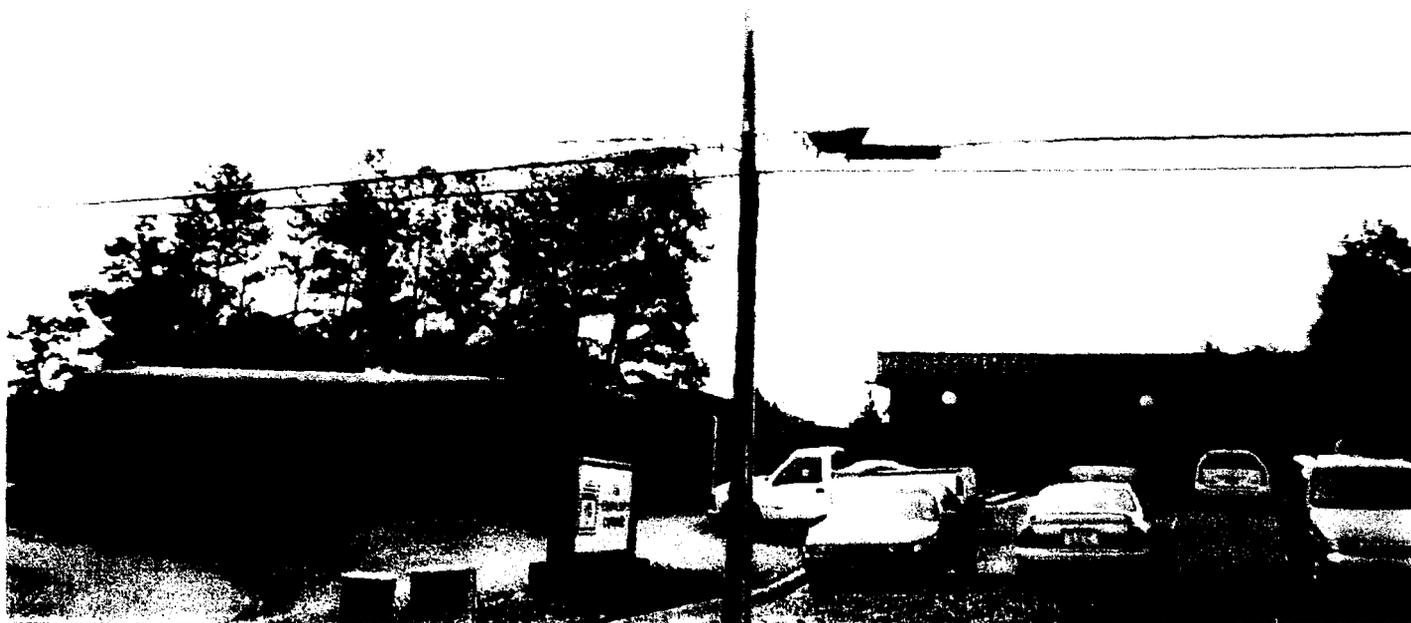
Plastic "oil-cloth" covers a deteriorated splice on a major thoroughfare in front of businesses.

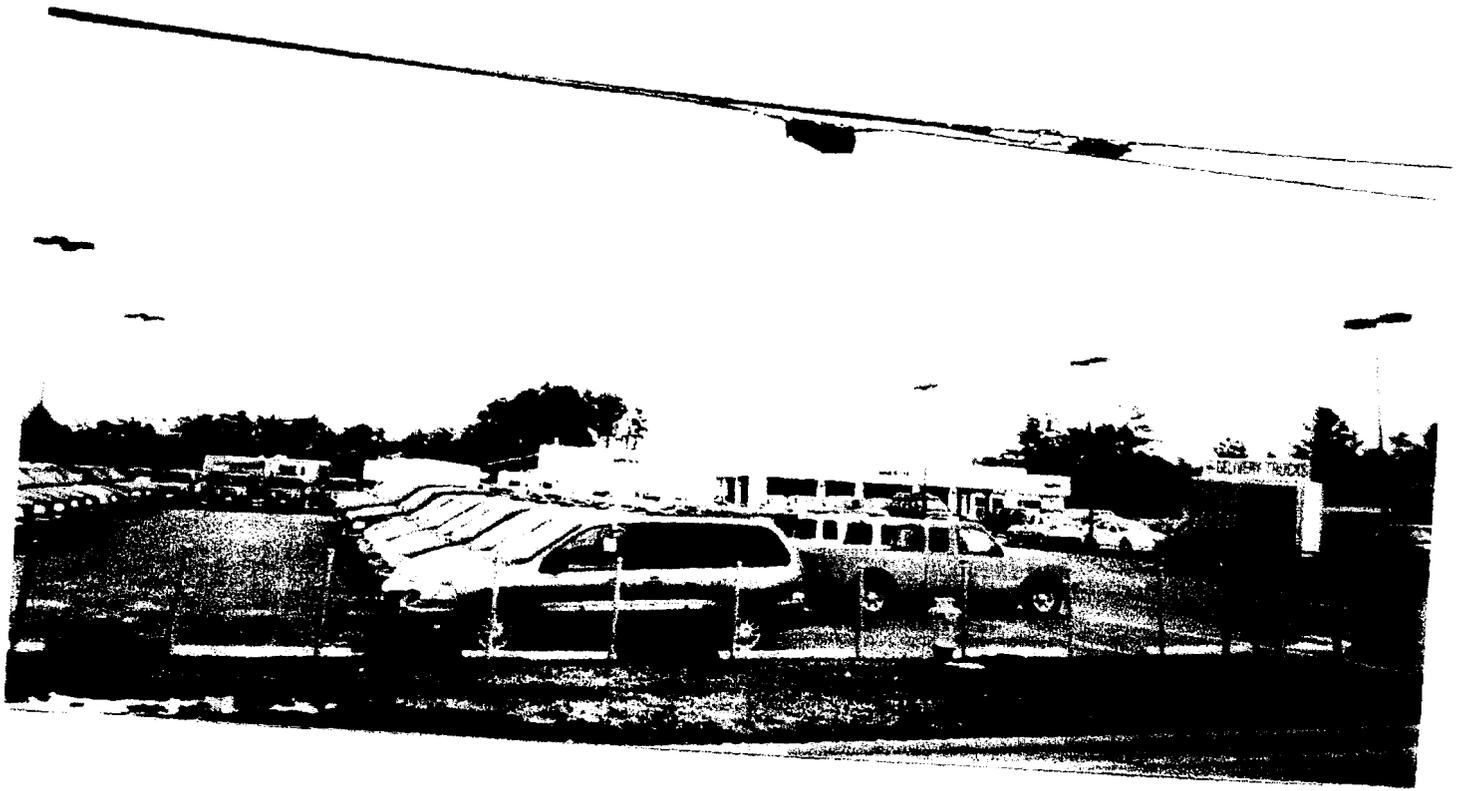
Another temporary fix makes for an eyesore in front of a Ford distributor in Fayetteville, N.C.

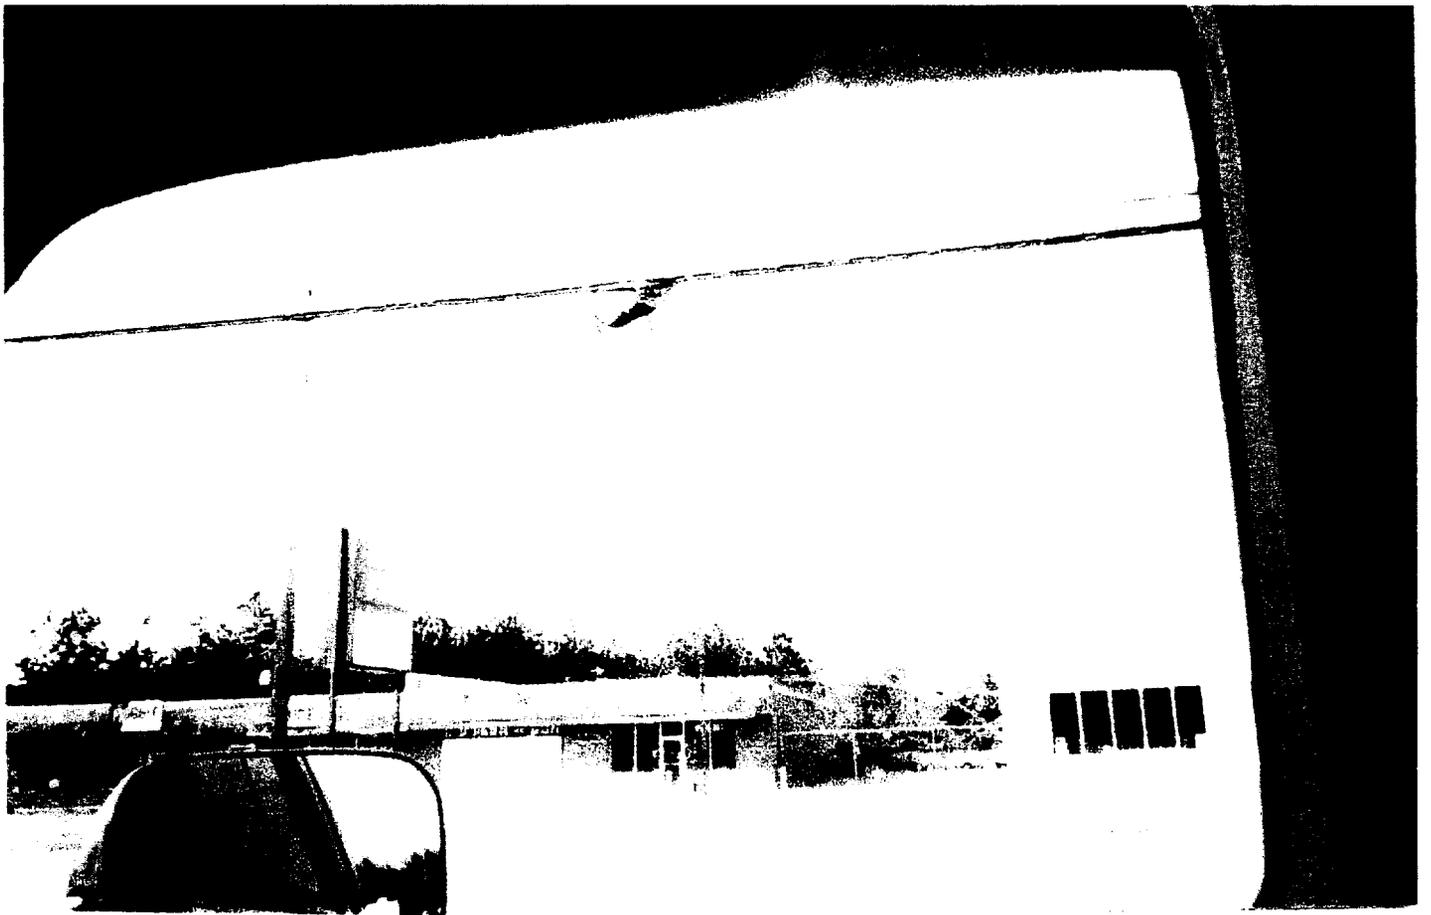
Temporary cover conceals deteriorated conditions at other business customers' locations.

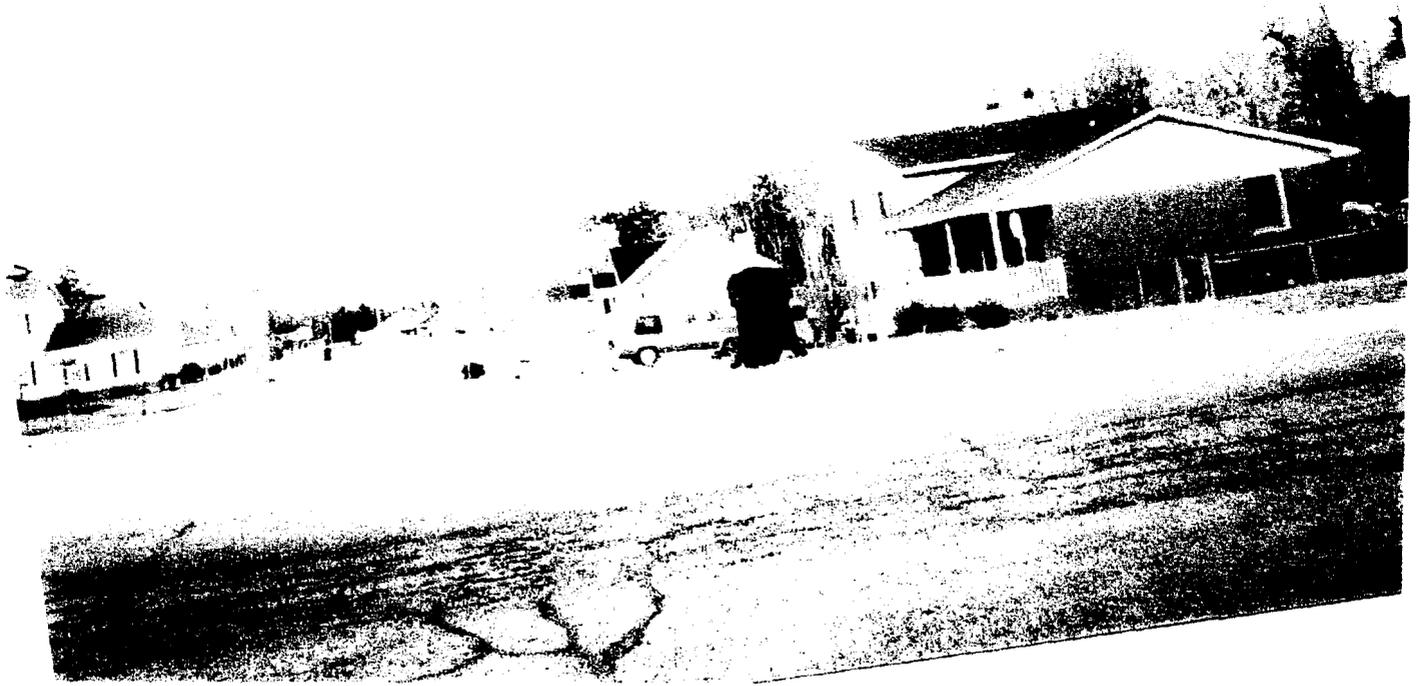
The high, black monument in this photo is really a temporary plastic covering of a large buried pedestal on this street-corner.

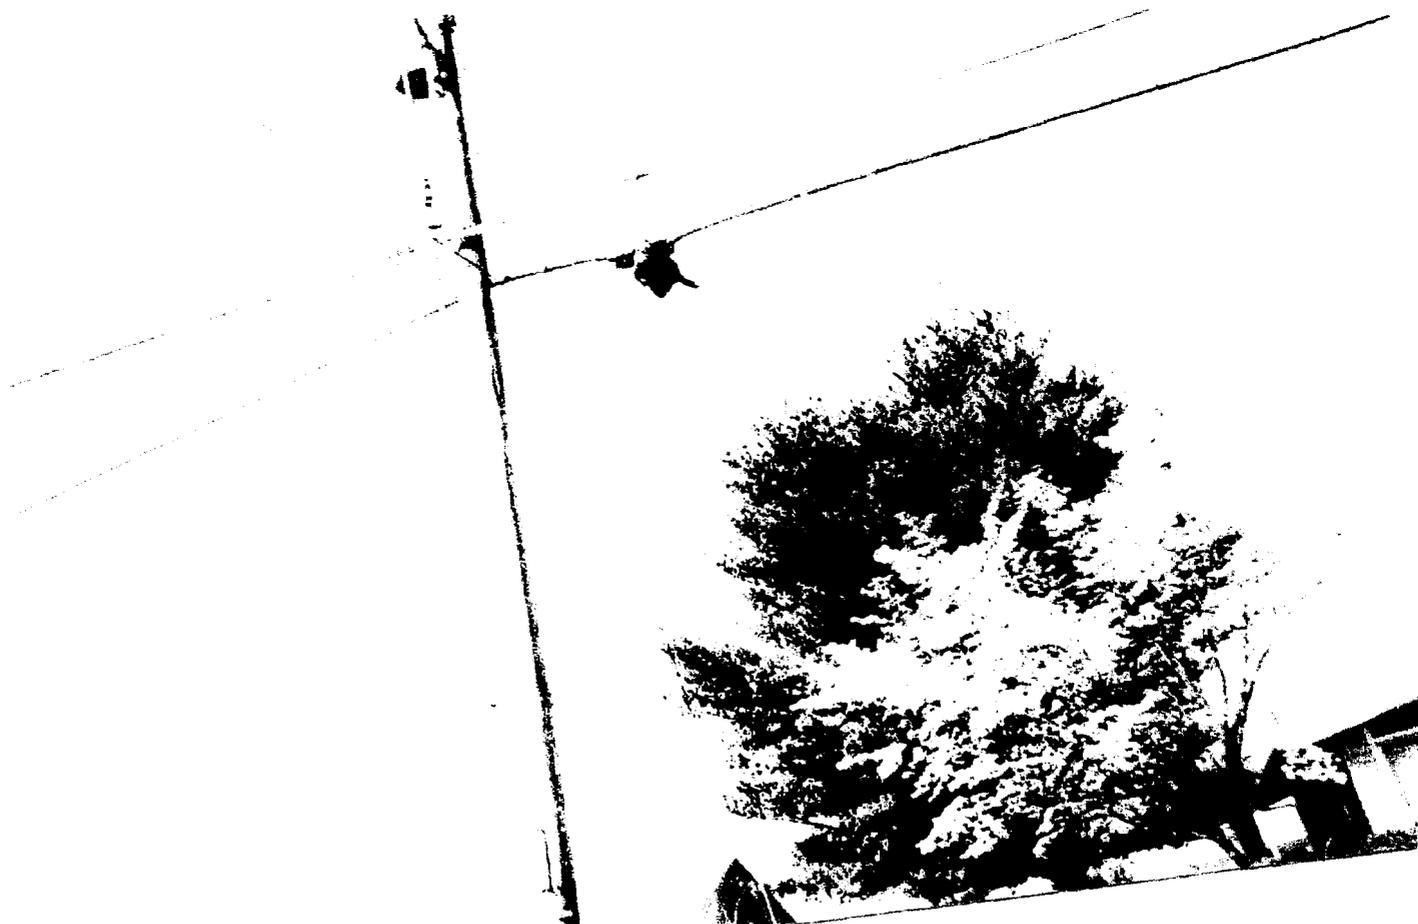
This temporary plastic cover has been in place so long that it has become deteriorated -- leaving cable pairs exposed.

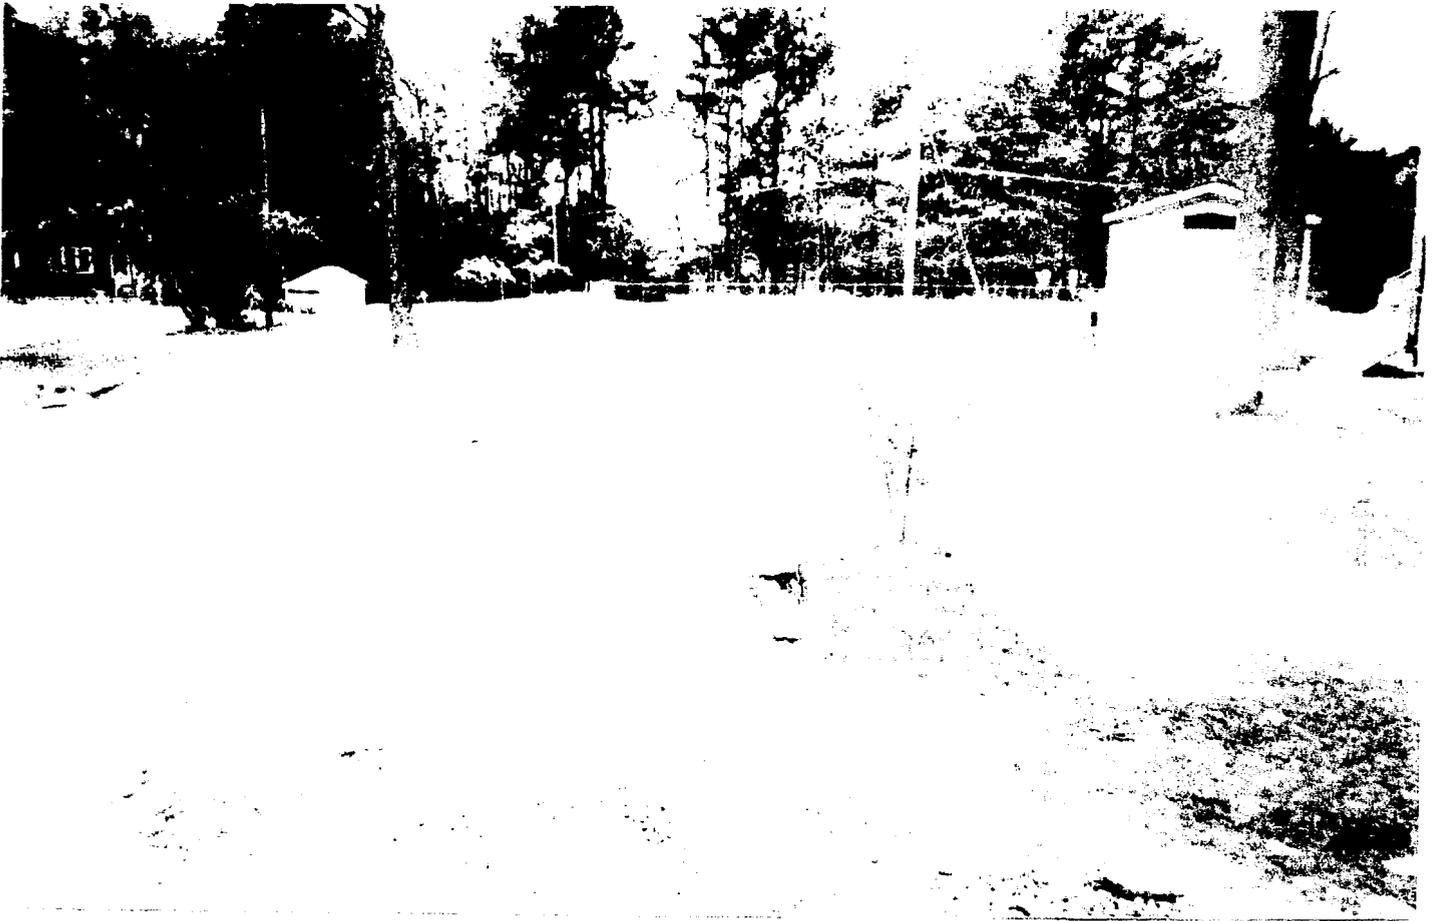
A request for replacement of this damaged pedestal has been ignored for months.

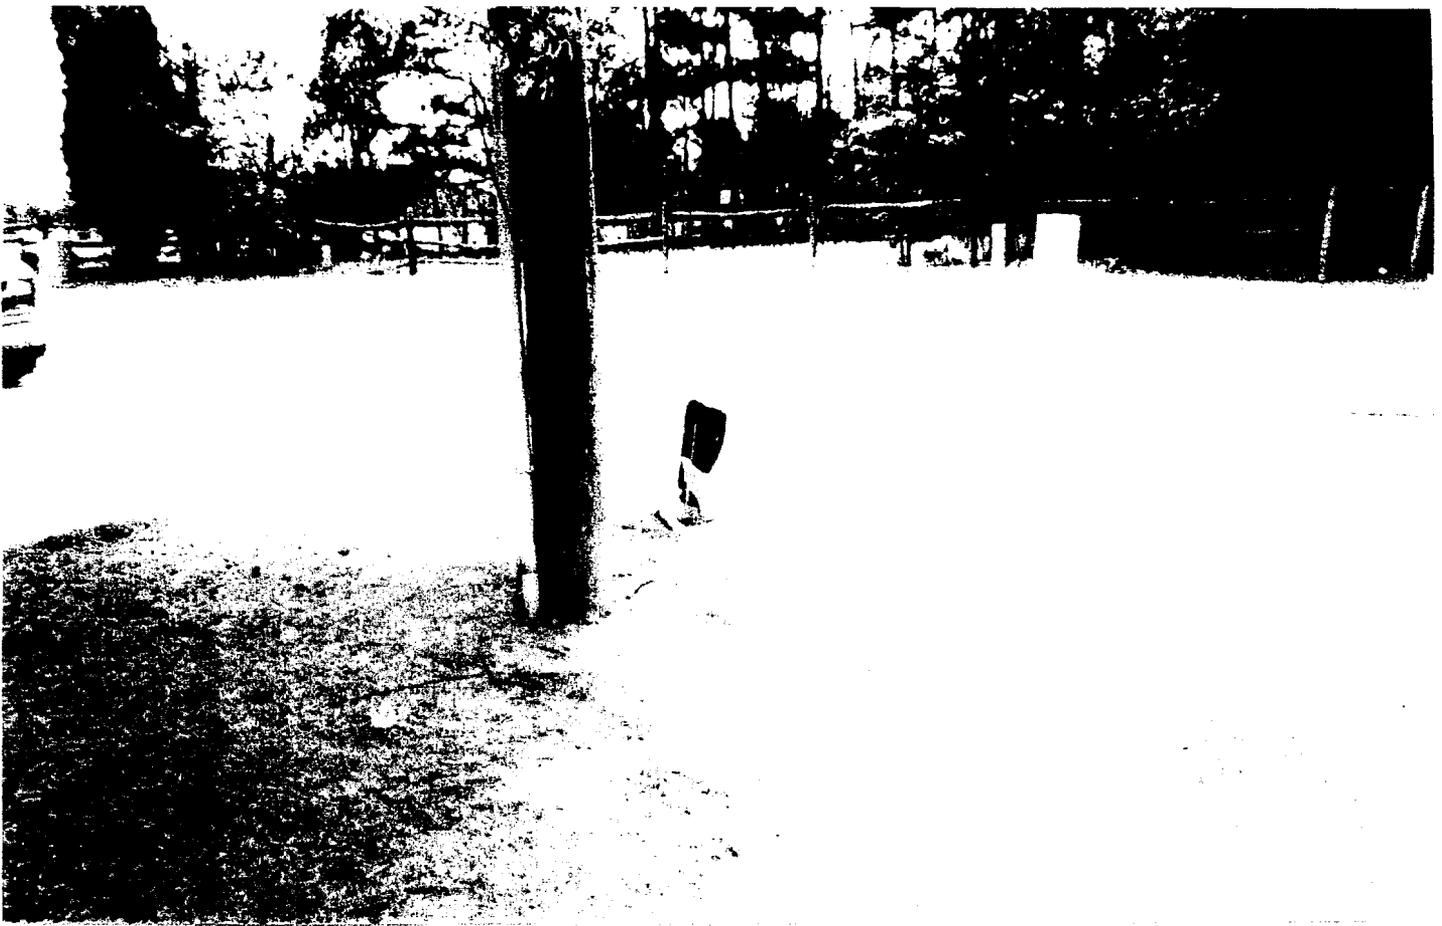
Another damaged pedestal in a residential area. Budget constraints prevent repair and replacement.

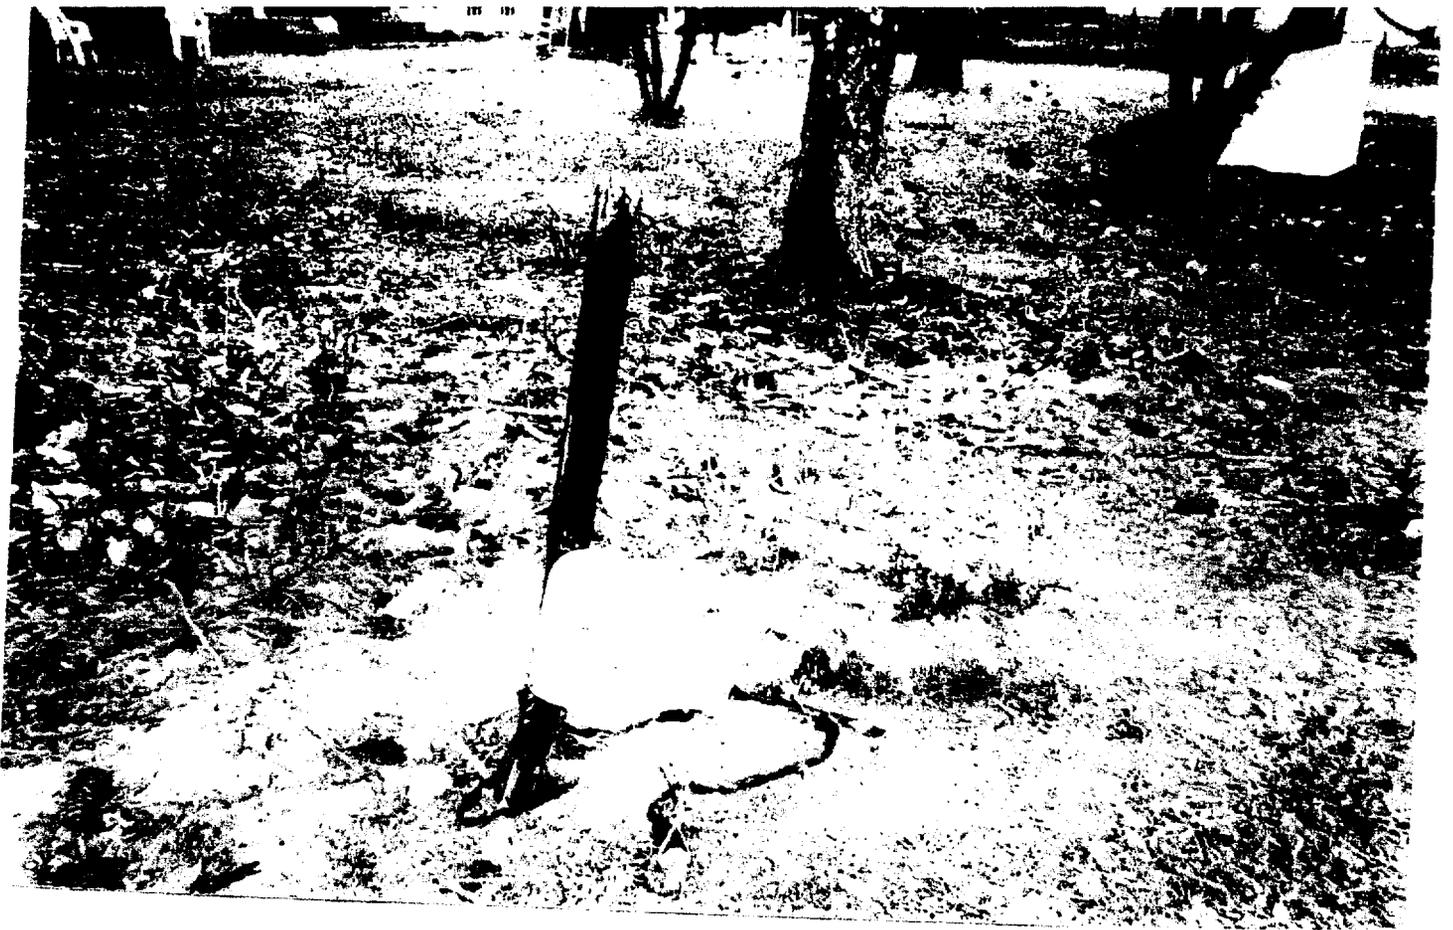
How would you like this modern, contemporary cost-saver in your front yard?

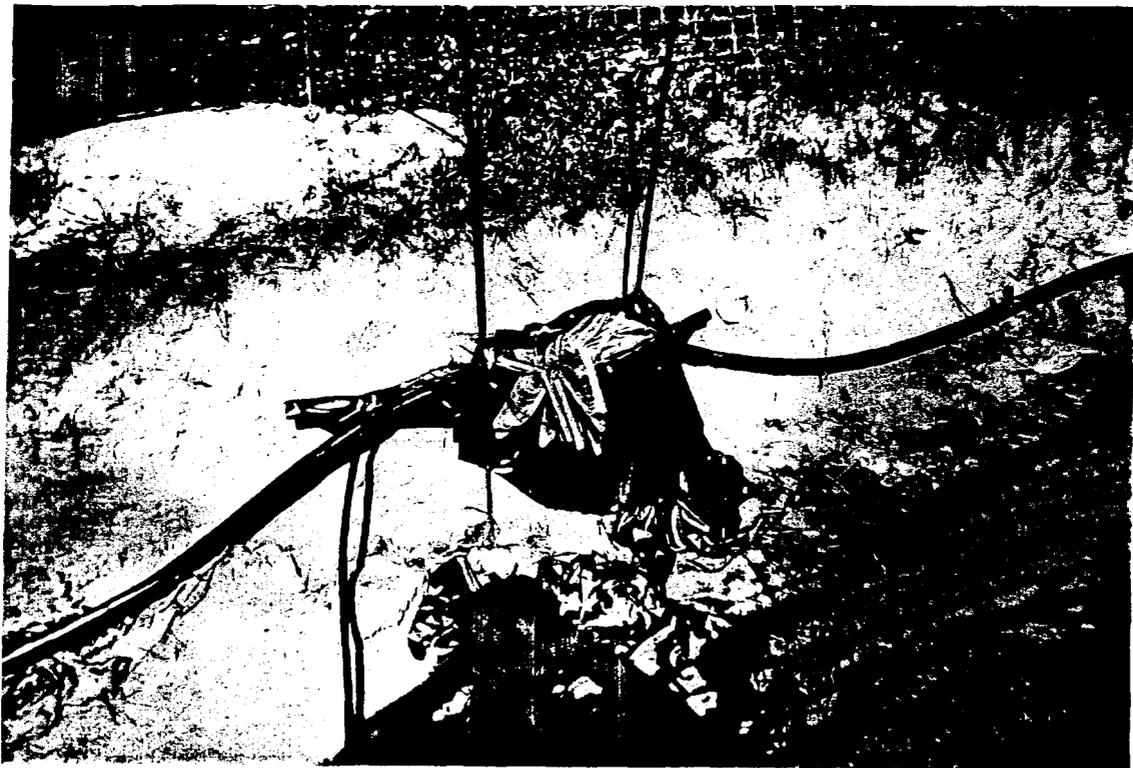
Down in the hole

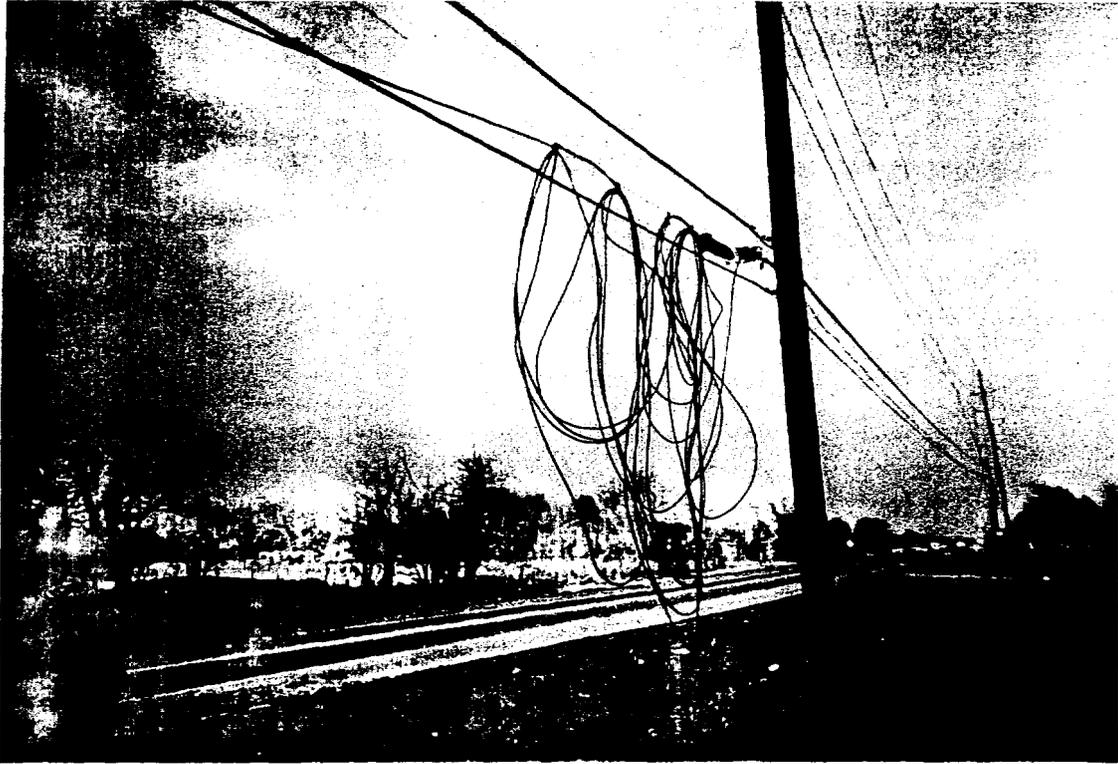
All traffic for one city goes on these!

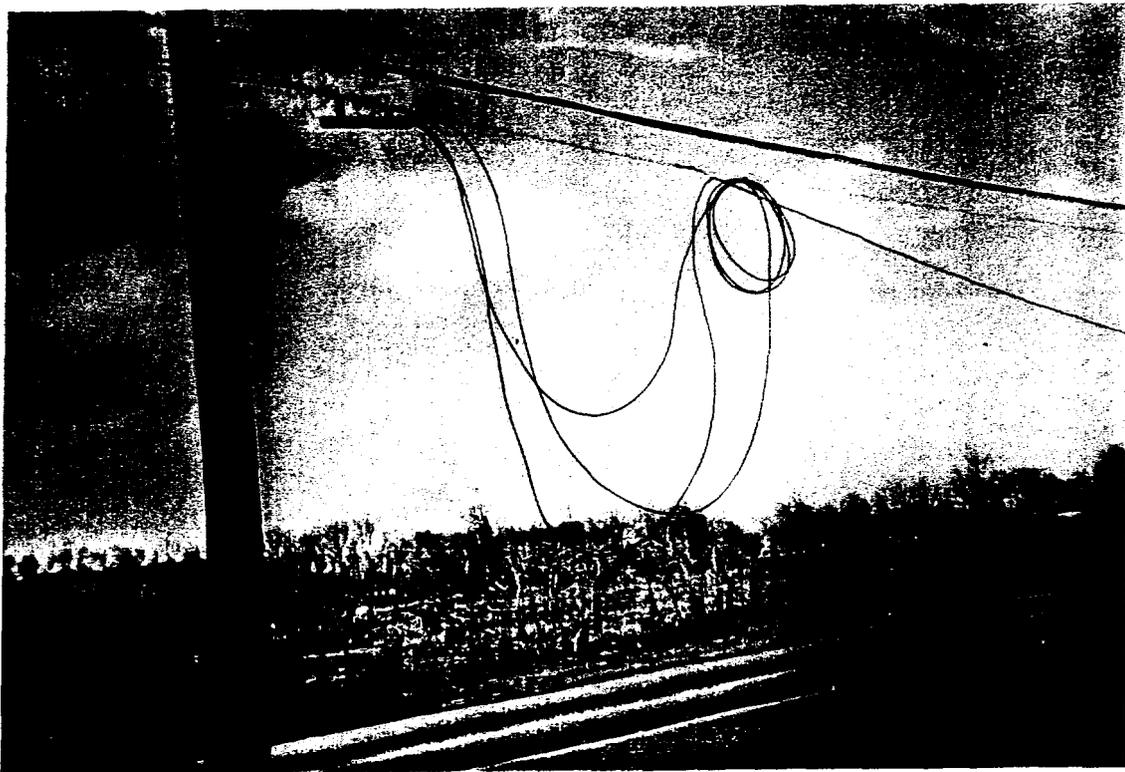
Other end "fiber optics" city to city  
200 pr pulled down

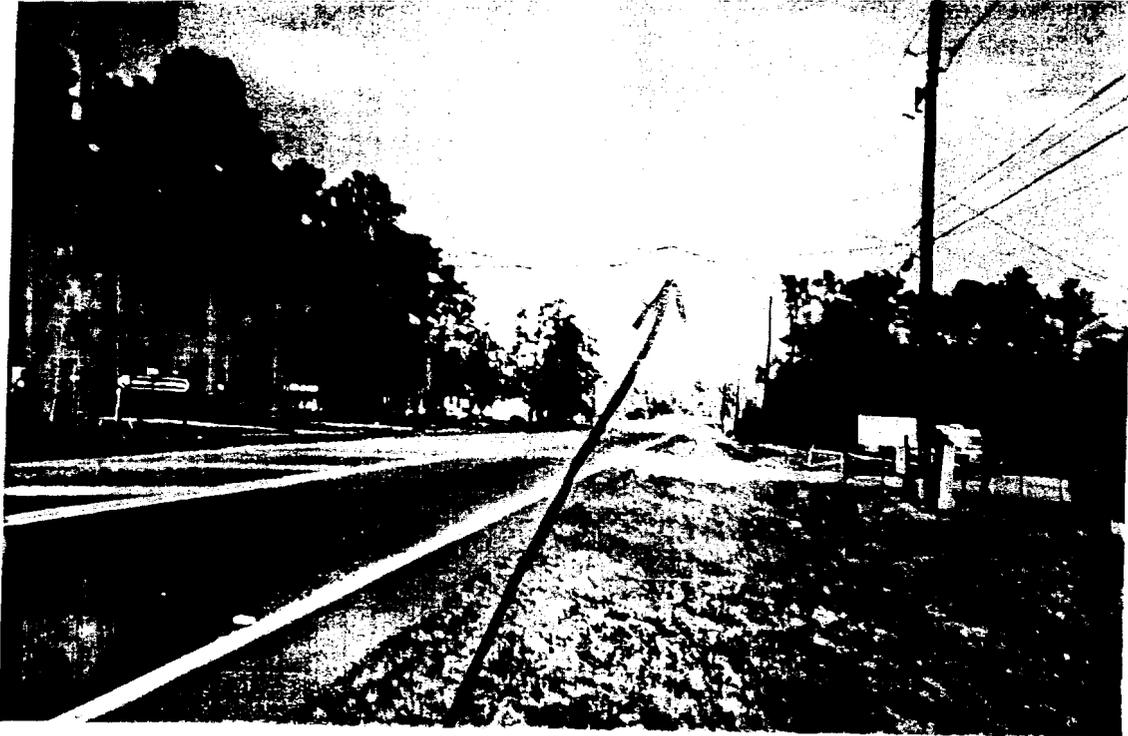
Temporarily tied to power lines over 2 years now!

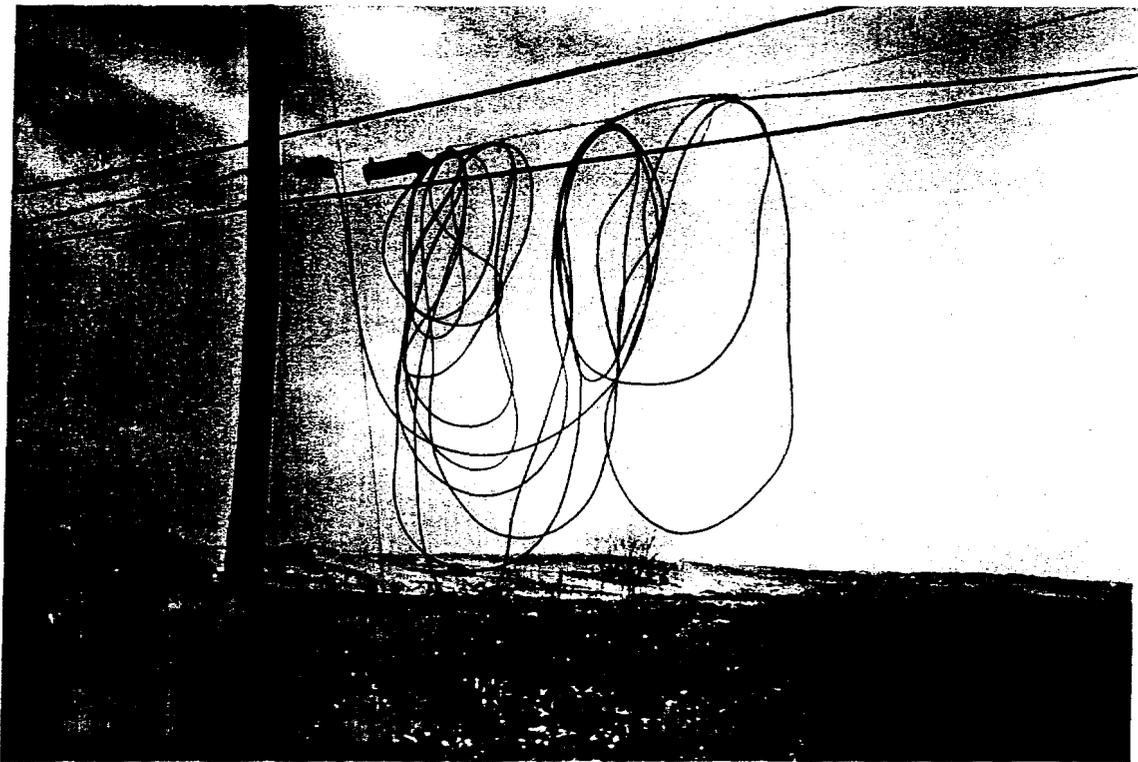
Fiber optics over a year

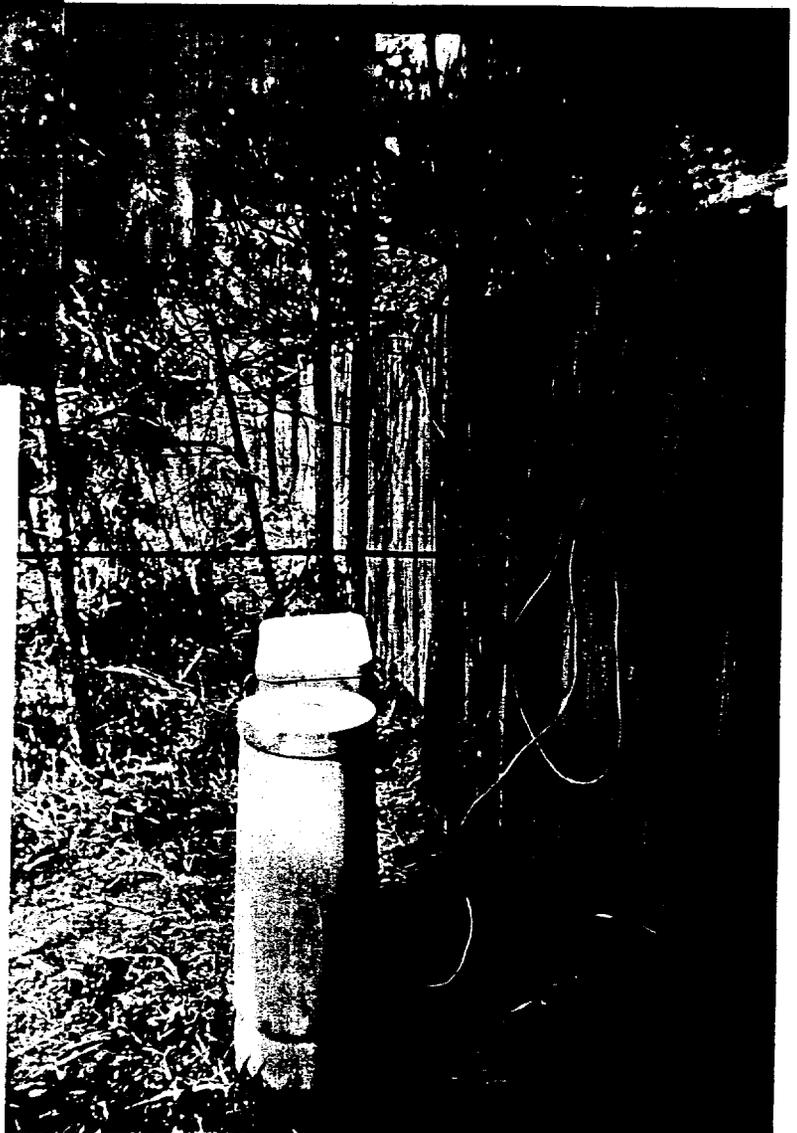
Broken pole--over 5  
years old. I've turned  
it in 3 times myself.  
2-300 pr cables

Bad section from one  
box to another. Pairs  
are working on "inside  
wire". At least 6  
months now  
tied to fence!

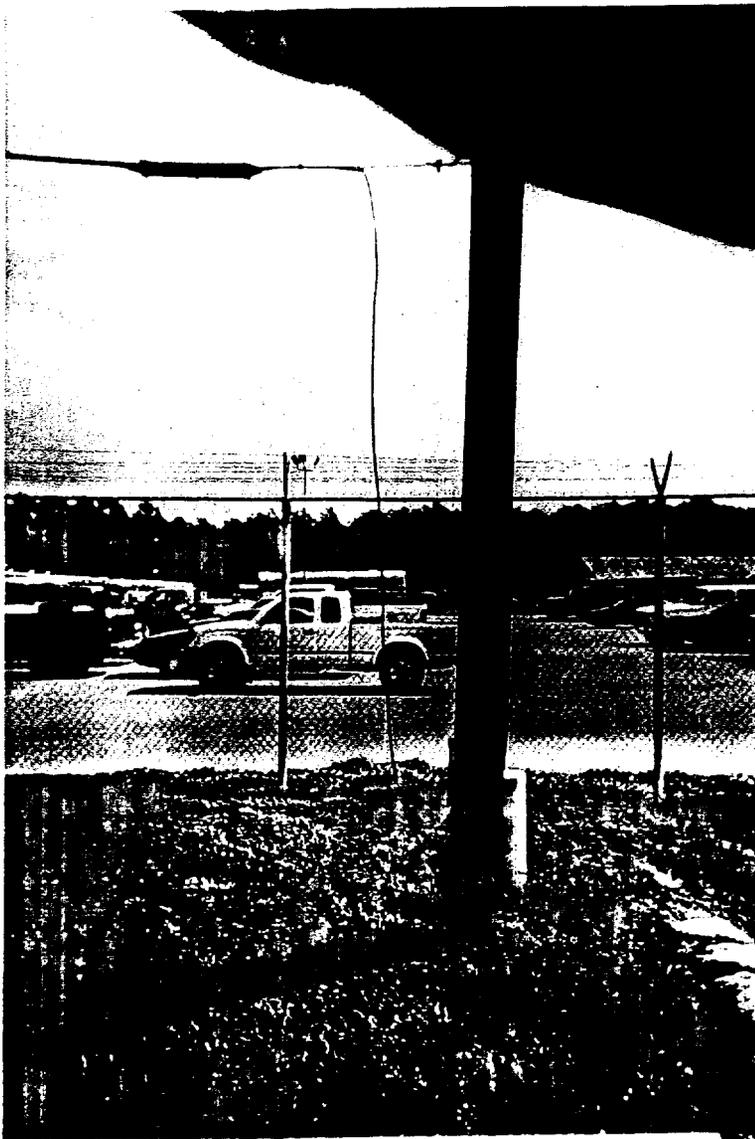
50 pr cable just waiting to get pulled down. Should be attached to pole

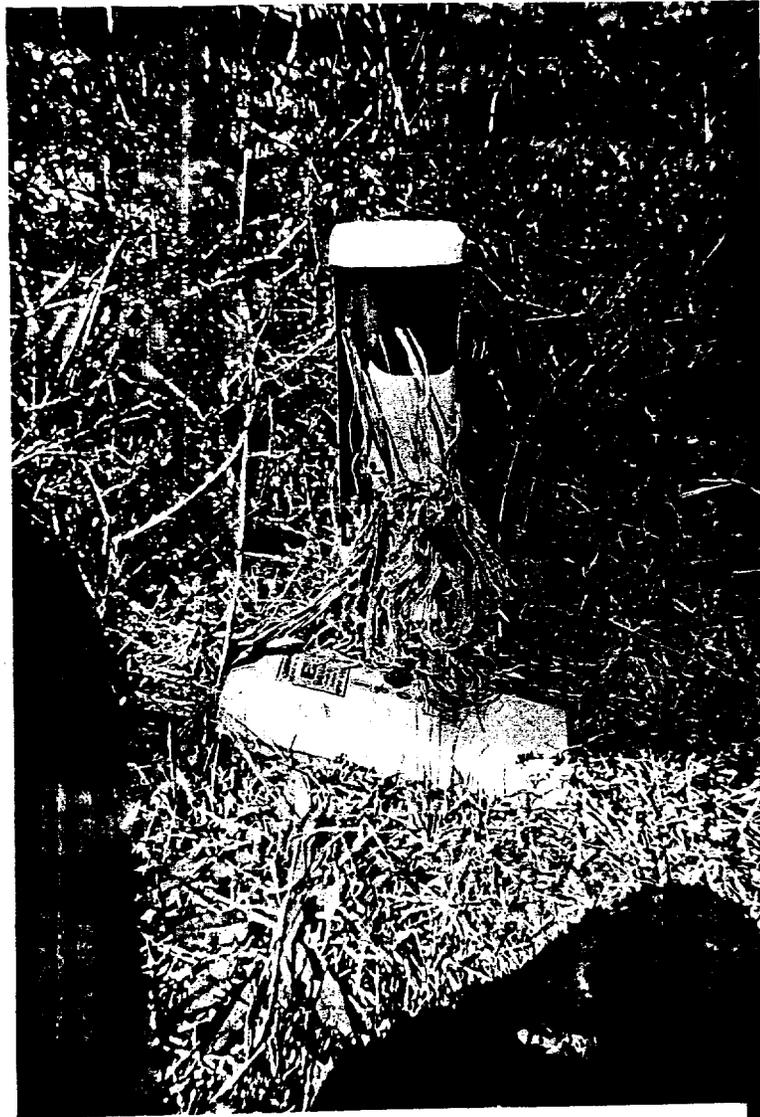
Peds left open. 300 pr  
left open for years,  
still lines working on  
this mess. Contractors  
have been on this on  
and off for over 4 years

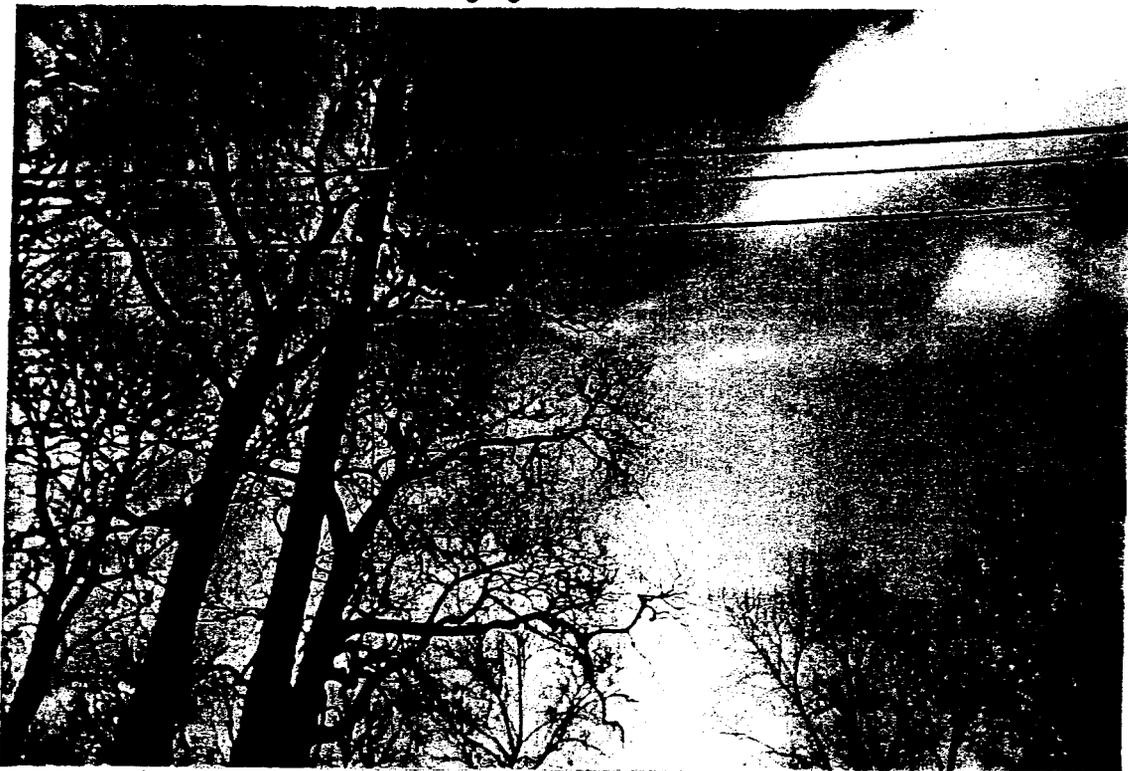
Holes in plastic

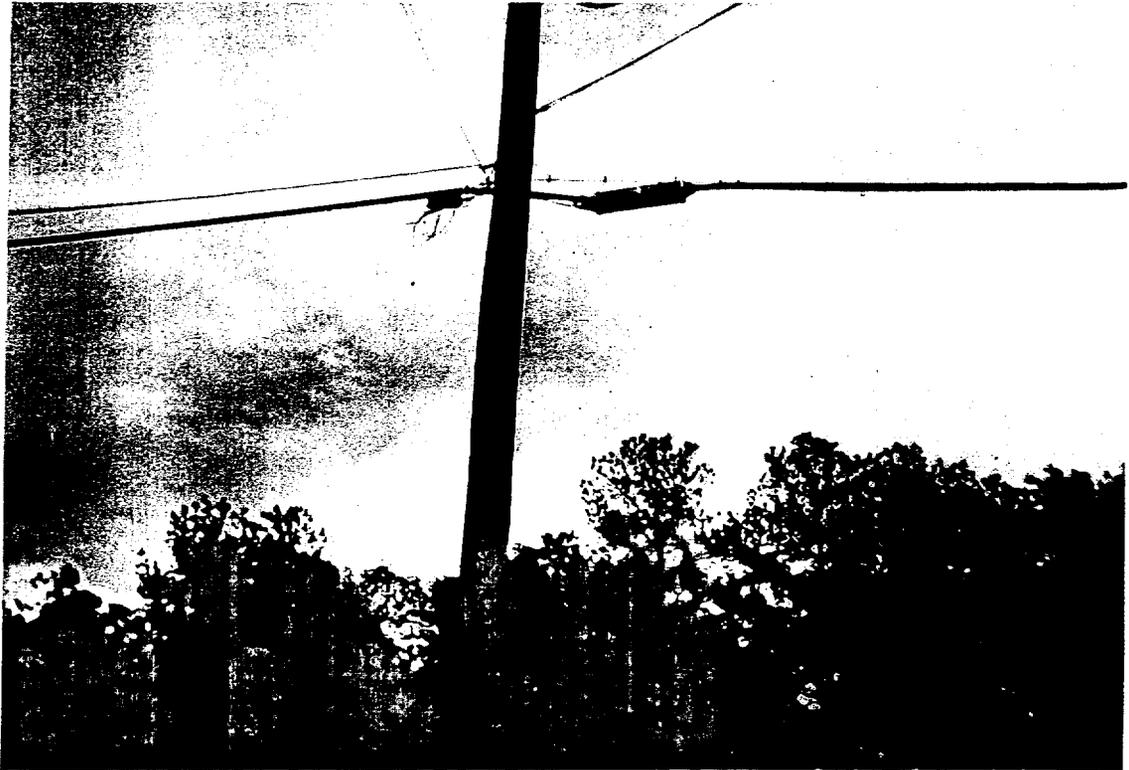
Aerial splice case broken-600 lines

Exposed to weather

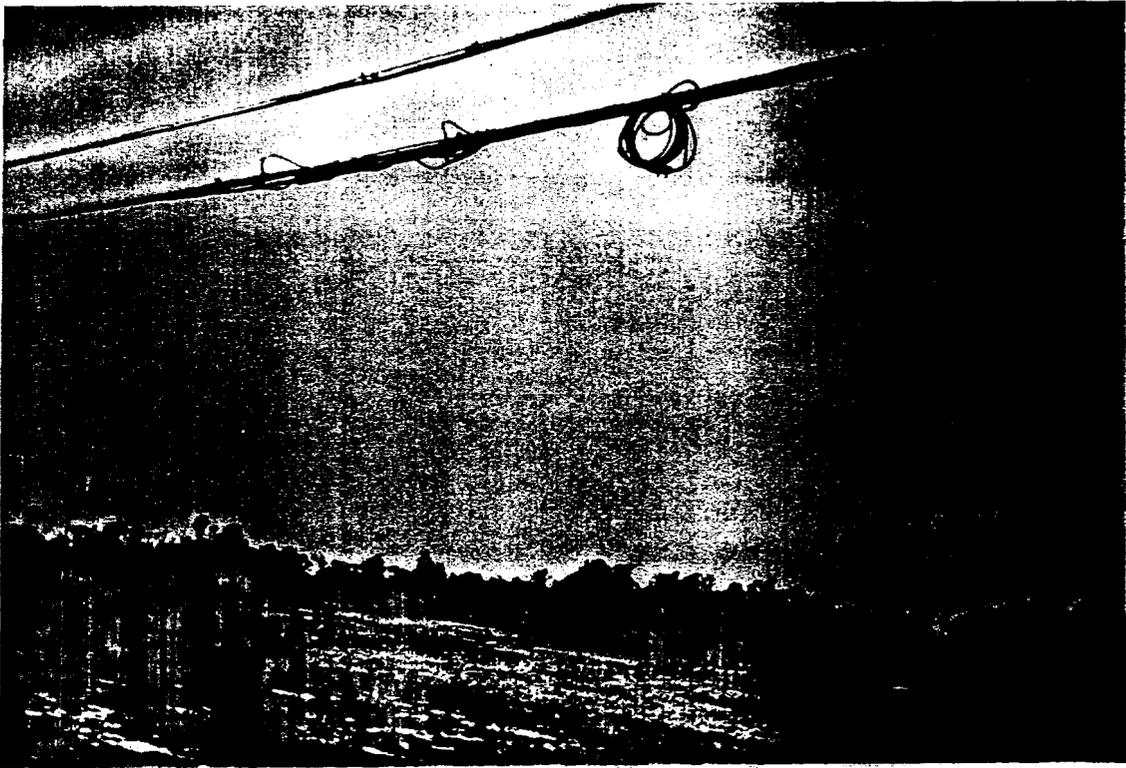
Aerial mess

It shouldn't look like this!

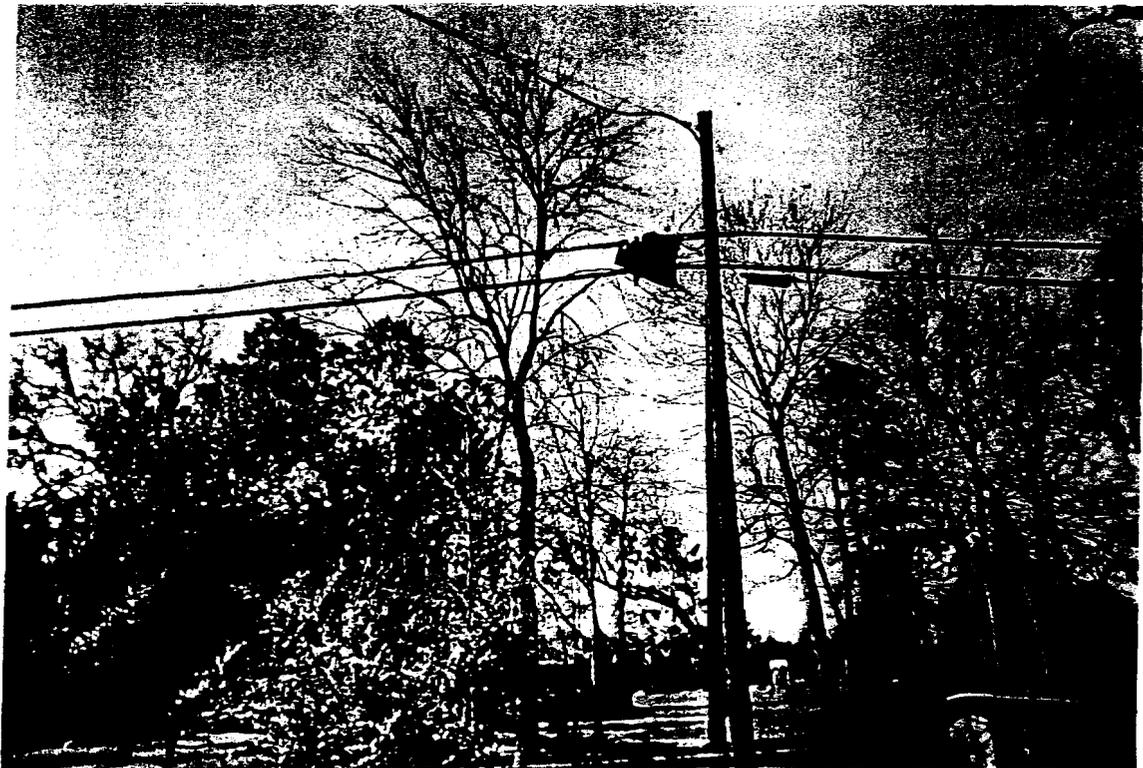
Another plastic covering 300 pr

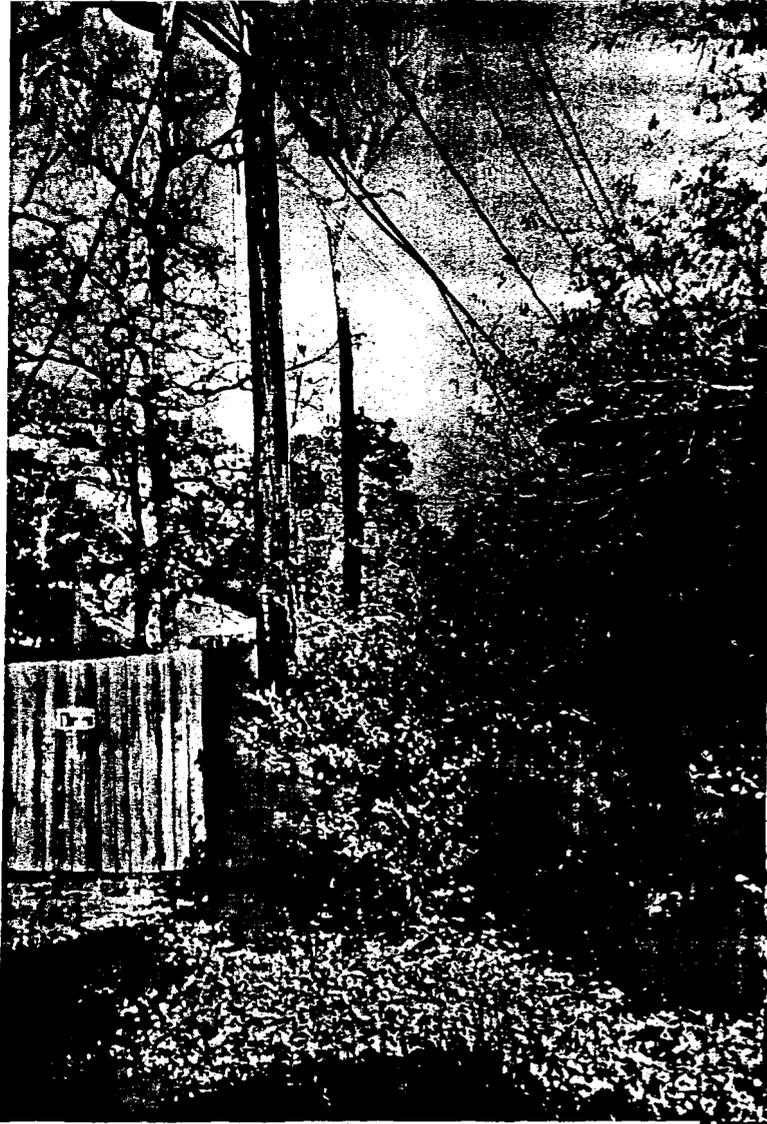
This cable is tied to another to get service. 800' of 100 pr laying in bushes and trees!!!!  
This is over 8 months now.....
