Exhibit 2.

Pictures of Outside Plant  
in Sprint's  
Central Telephone of Texas

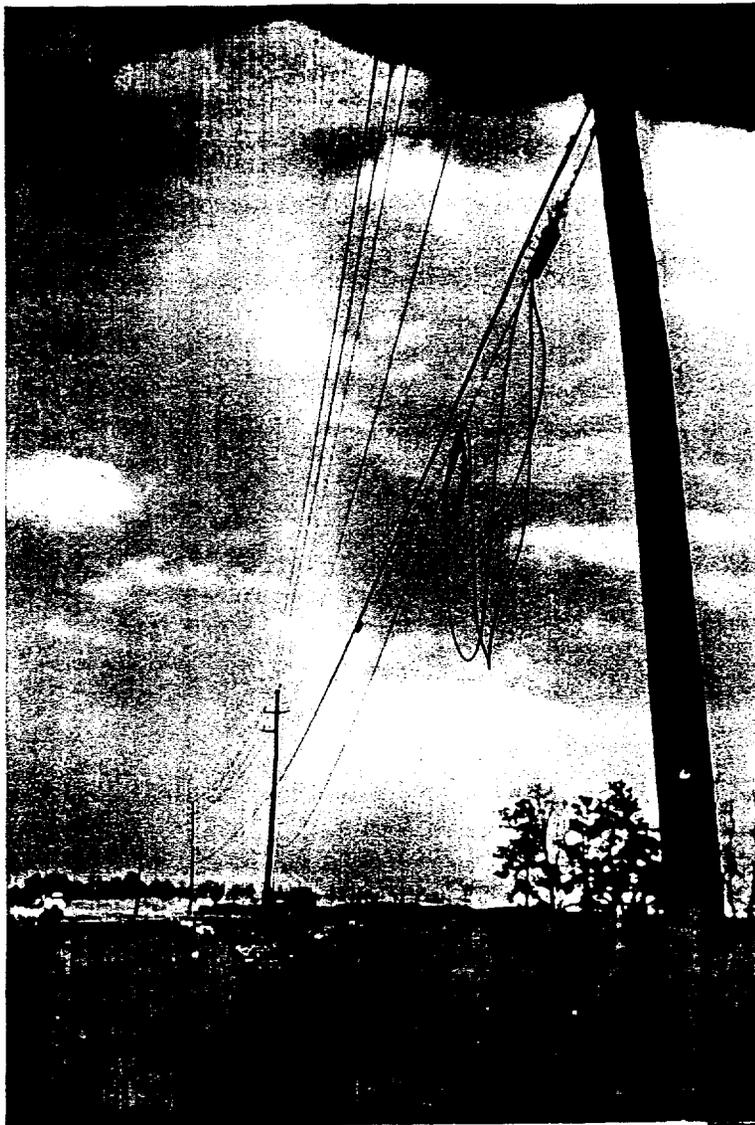
Fiber optic cable temporarily tied up so mowing machines won't cut into it! Over a year old!
