Example Picture #12
Pheasant Run
6100 N. Meridian, OKC
Terminal 6106B
05-20-03

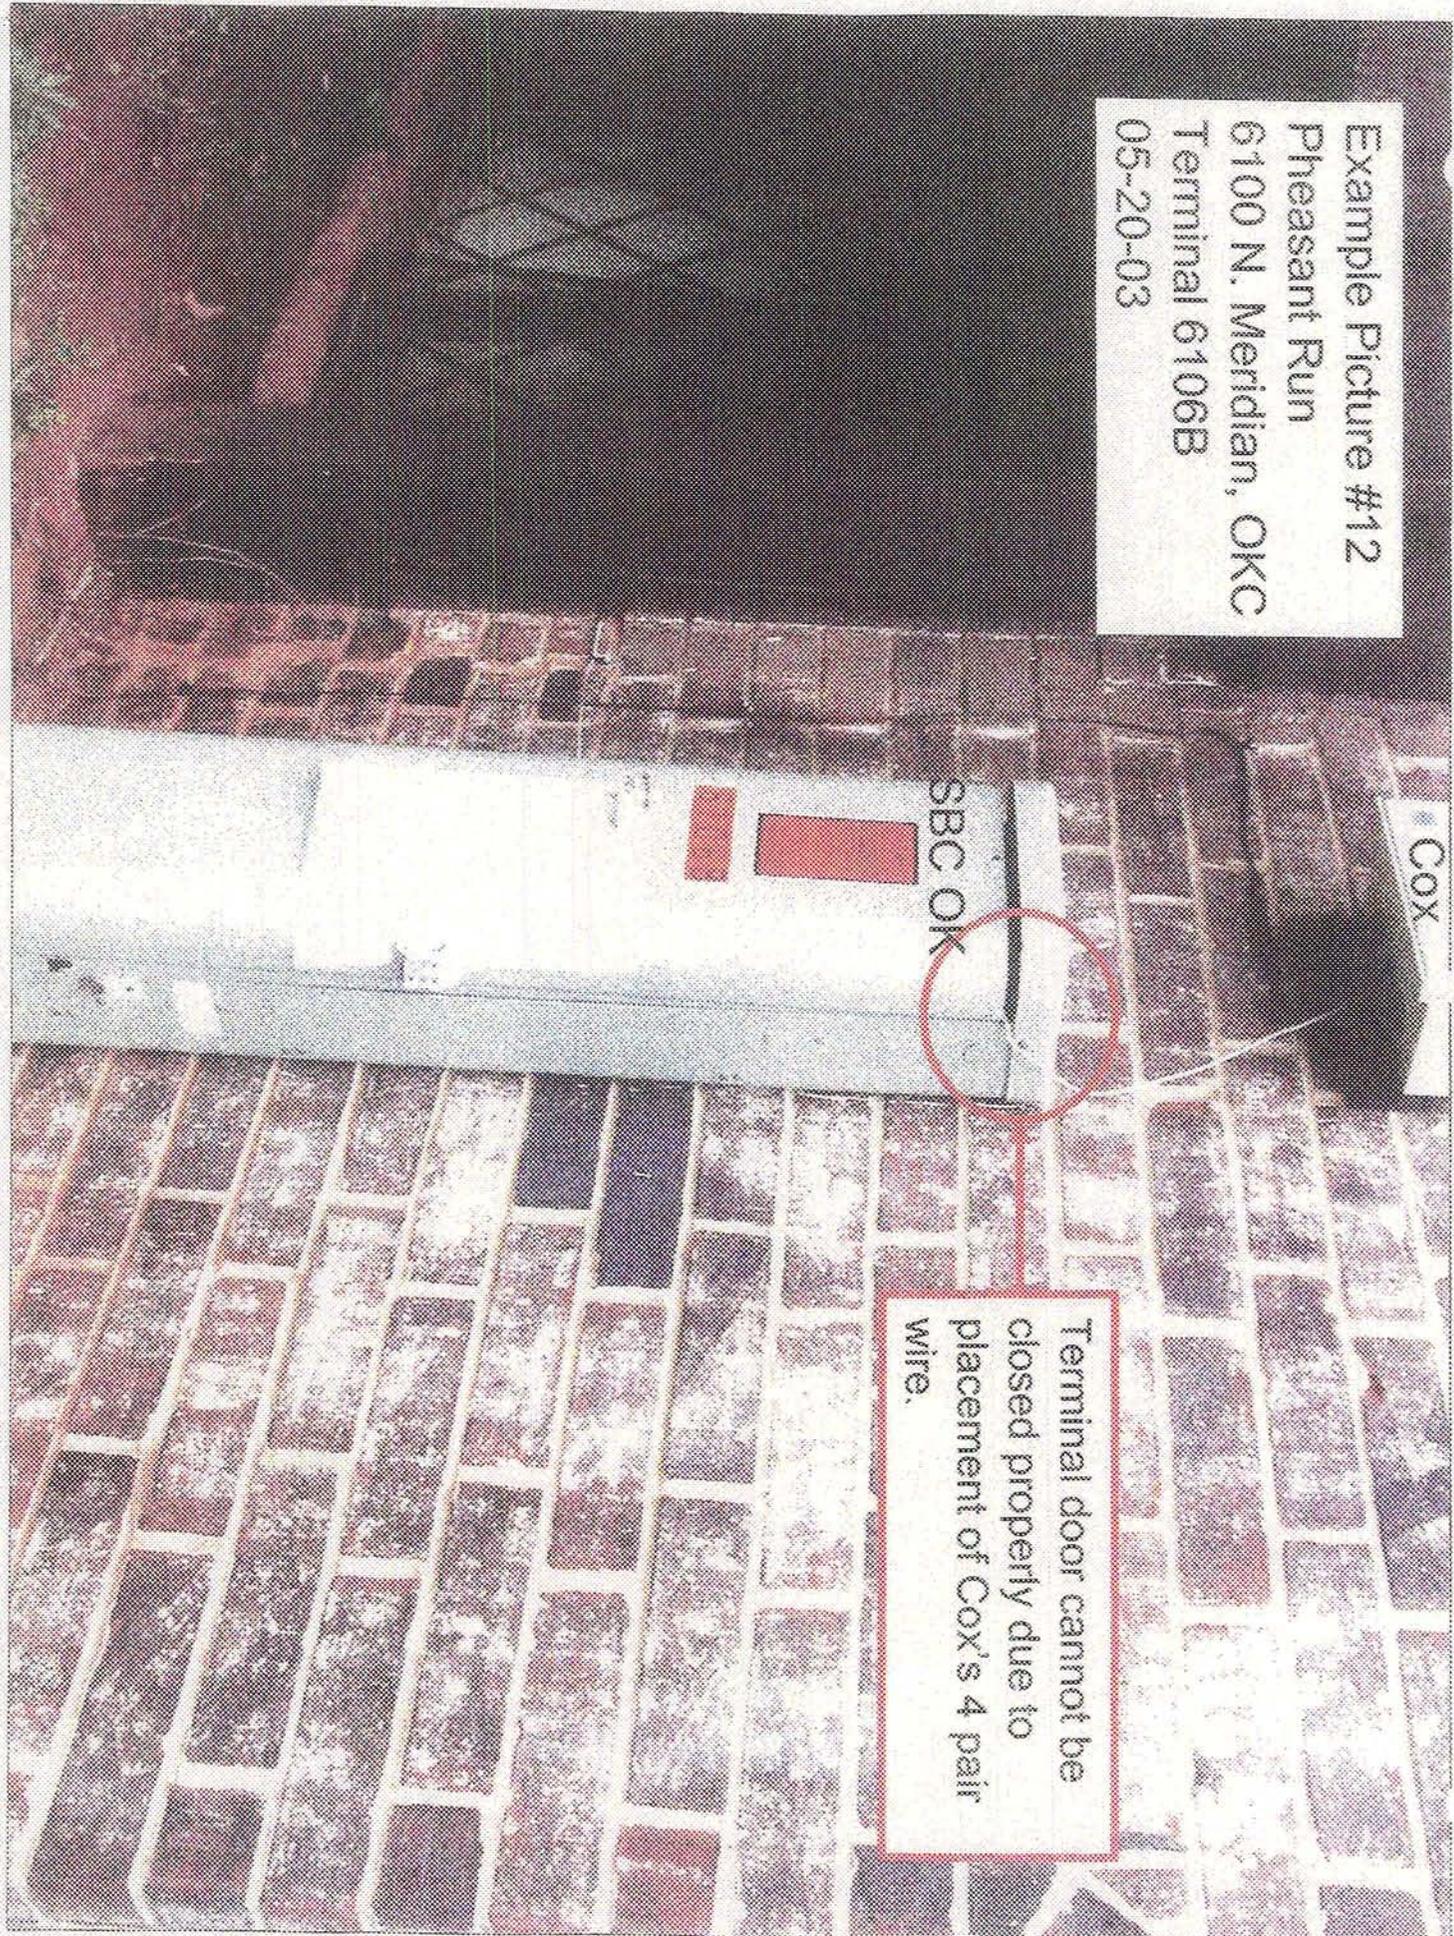
Terminal door cannot be closed properly due to placement of Cox's 4 pair wire.

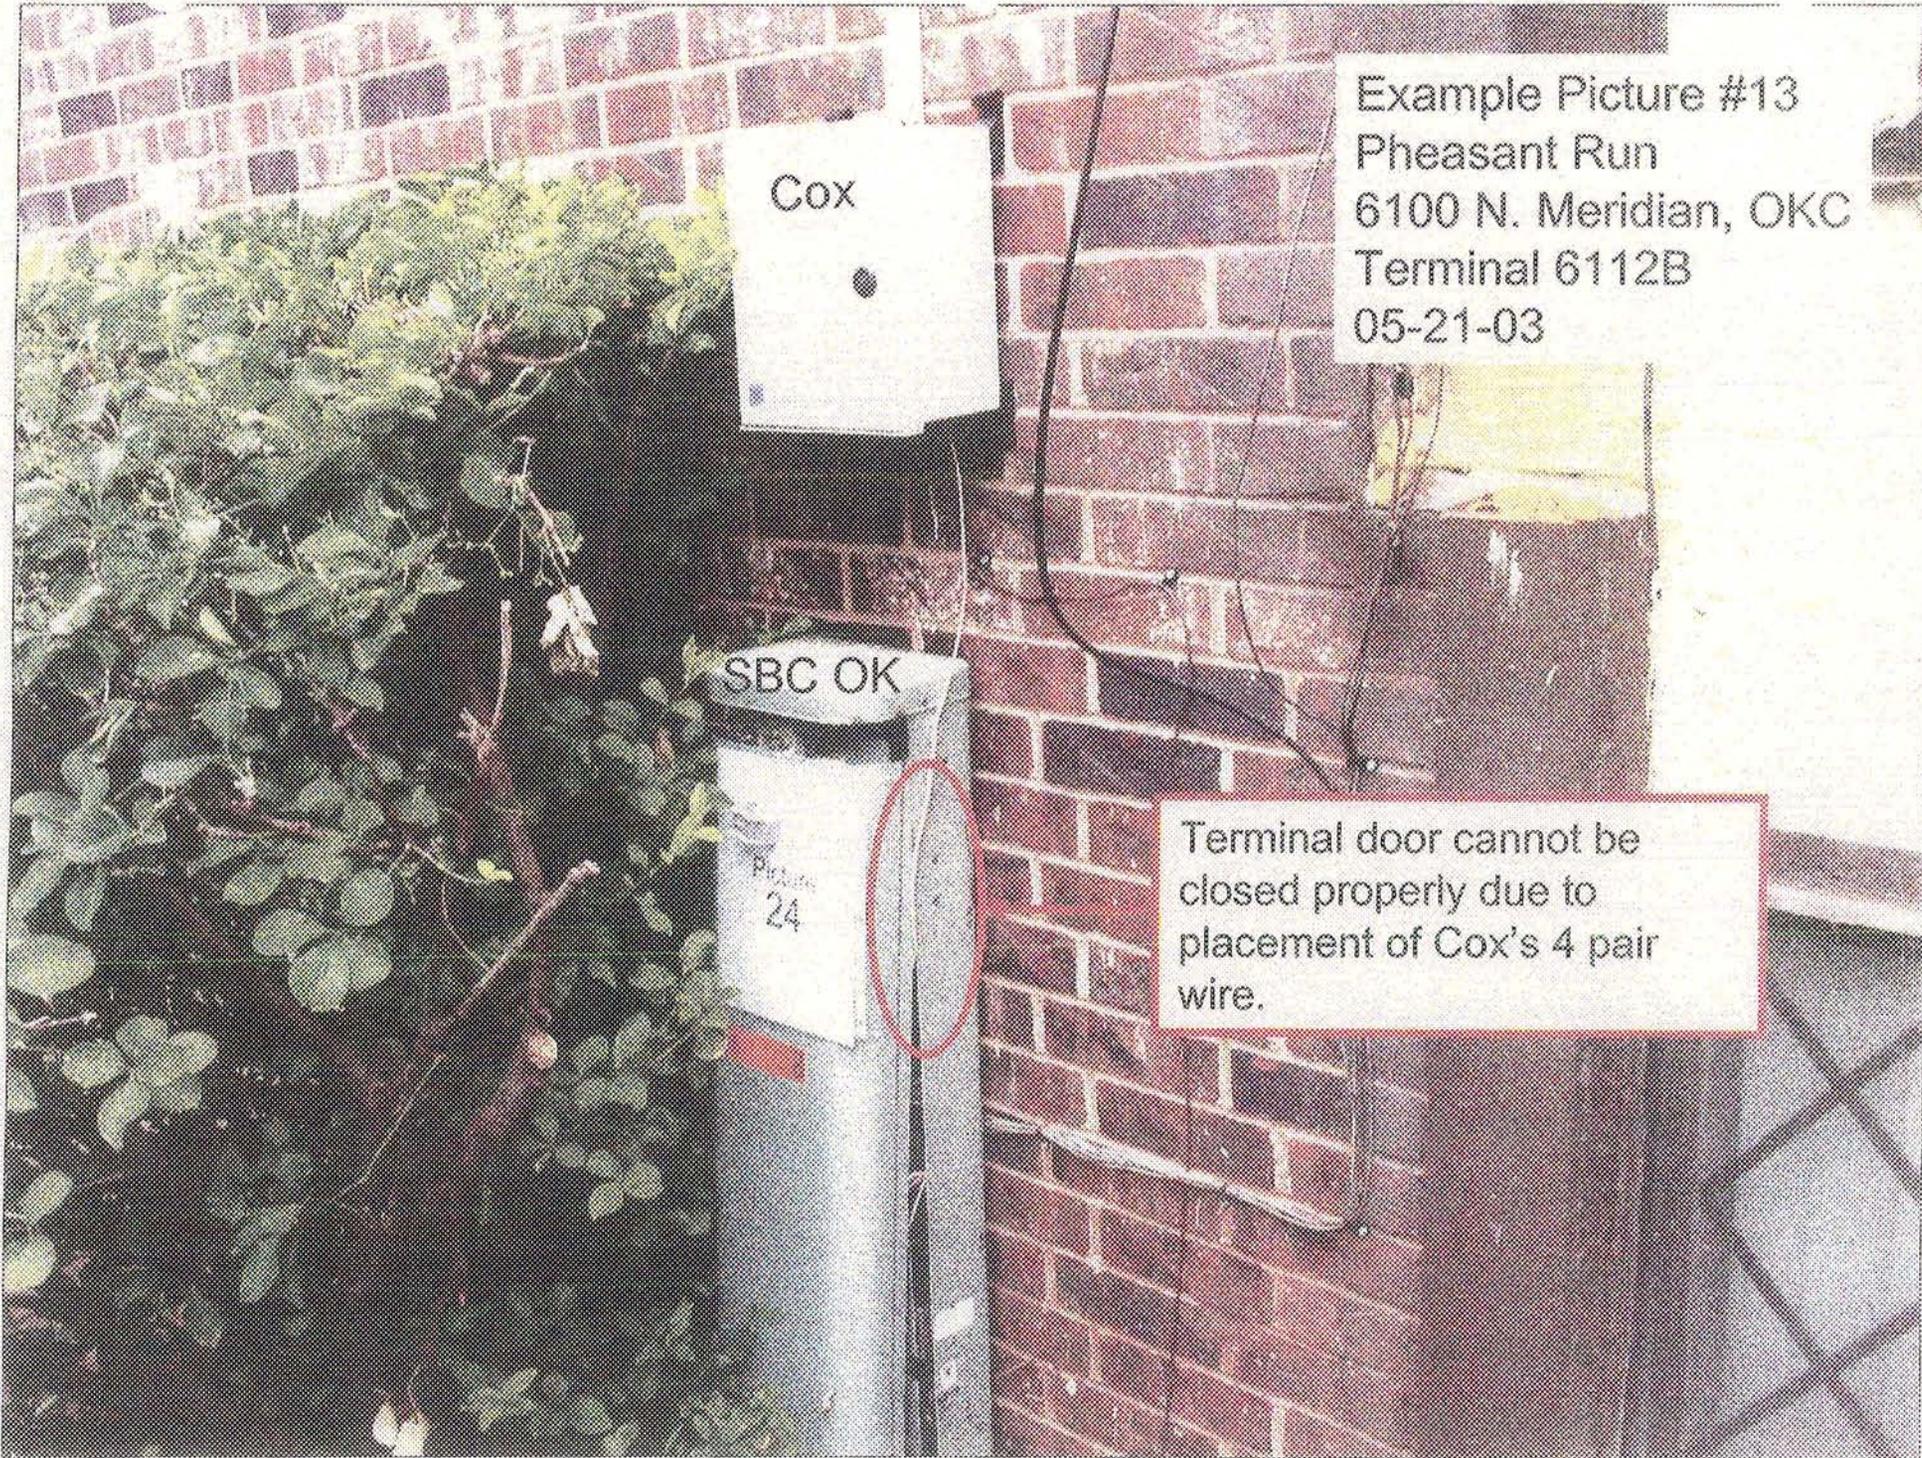
Example Picture #13
Pheasant Run
6100 N. Meridian, OKC
Terminal 6112B
05-21-03

Terminal door cannot be closed properly due to placement of Cox's 4 pair wire.

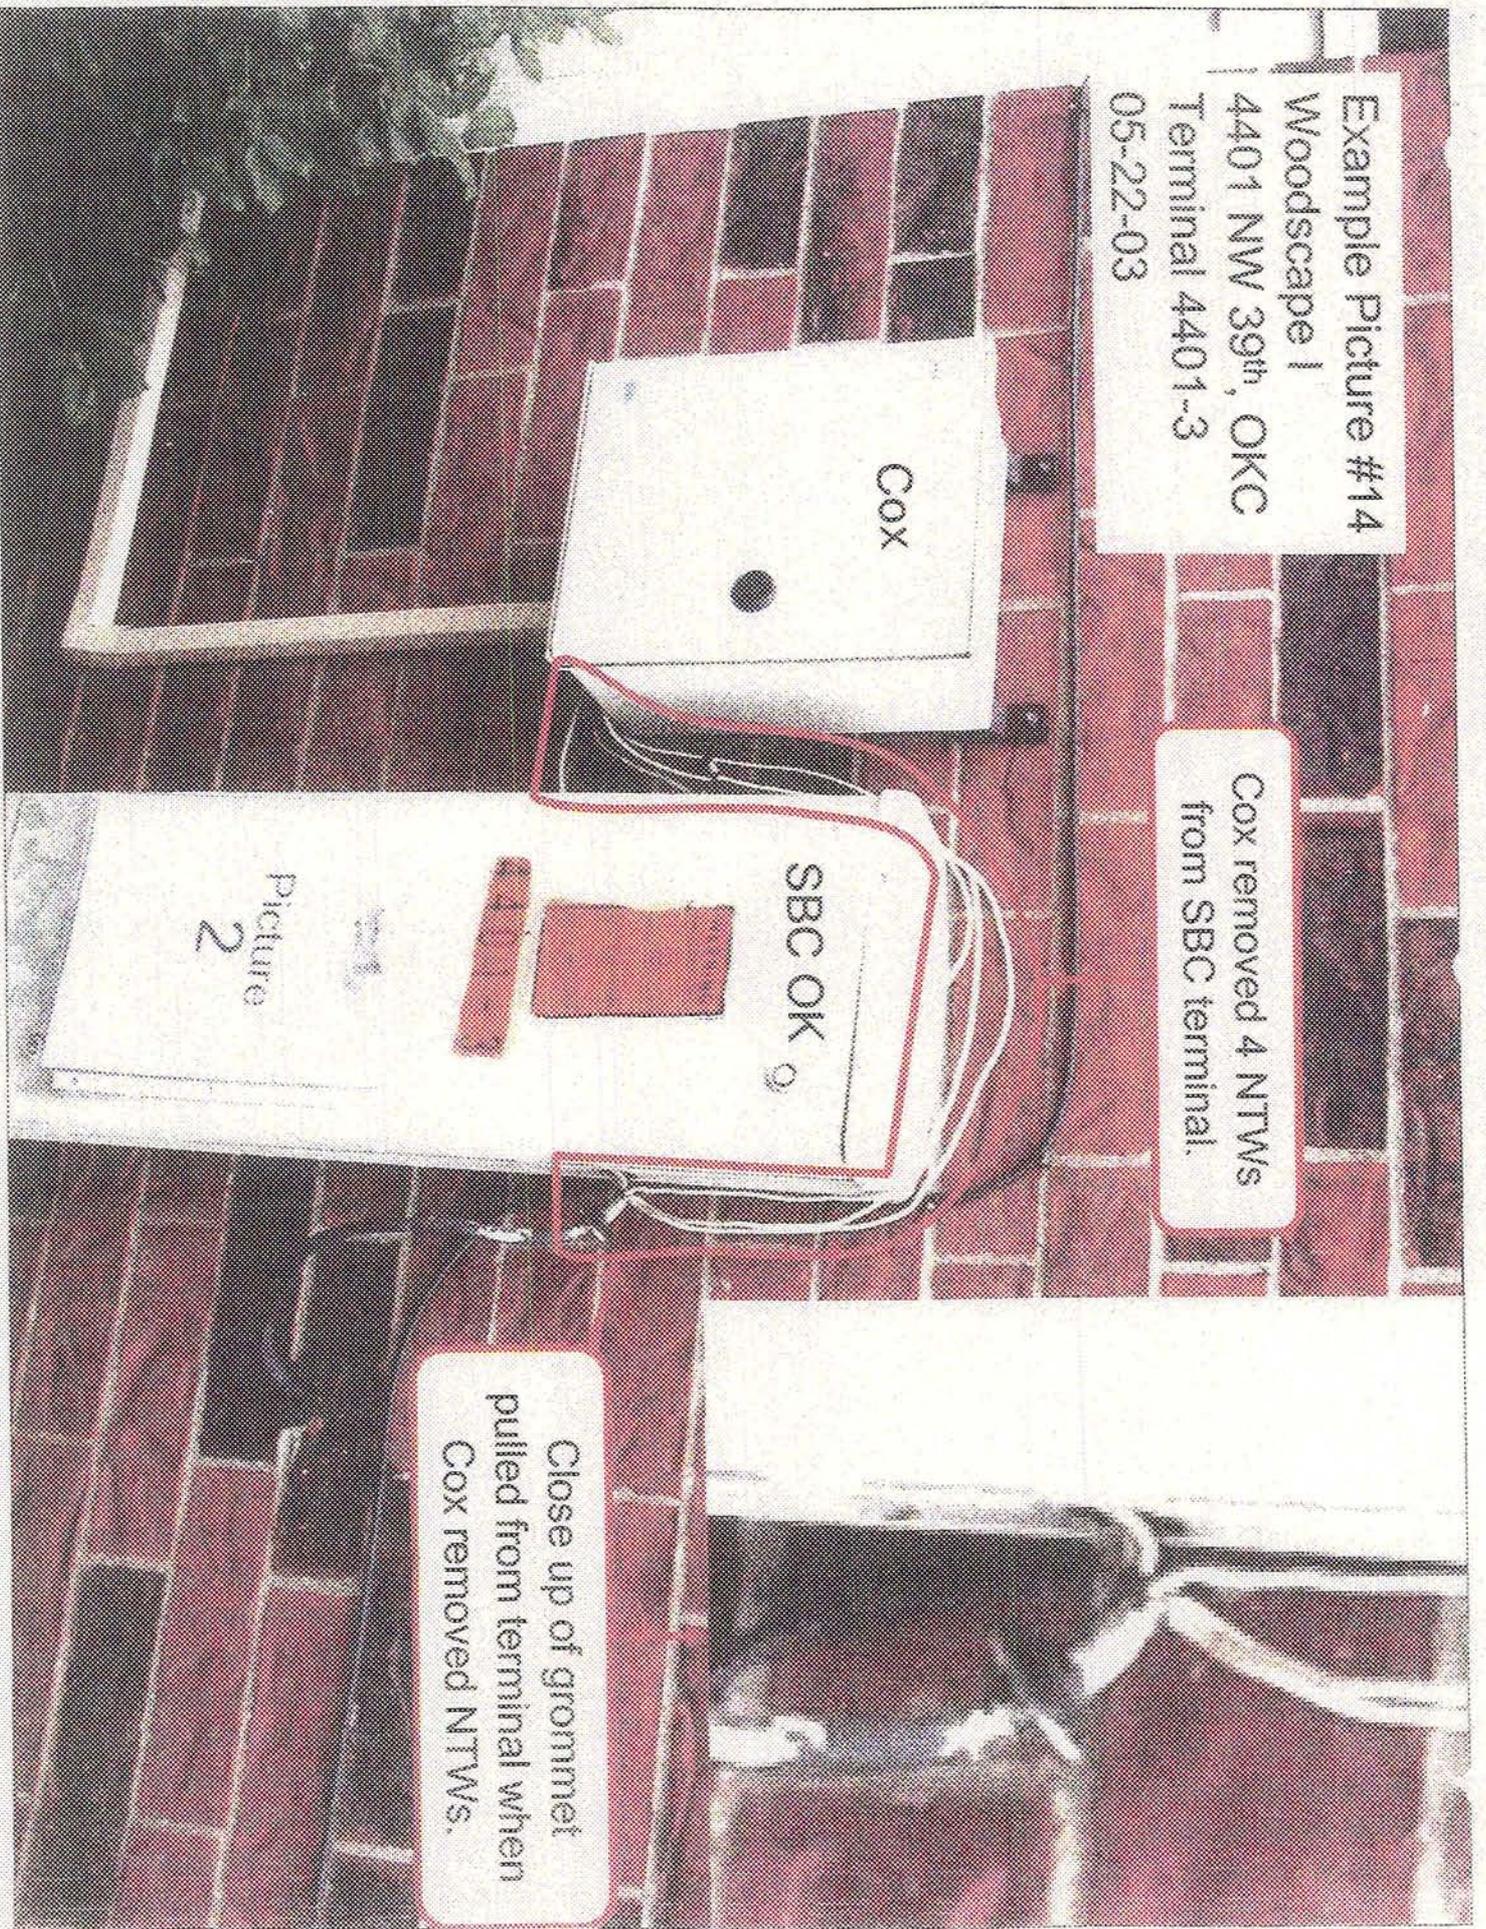
Example Picture #14
Woodscape I
4401 NW 39th, OKC
Terminal 4401-3
05-22-03

Cox removed 4 NTWs
from SBC terminal.

Close up of grommet
pulled from terminal when
Cox removed NTWs.

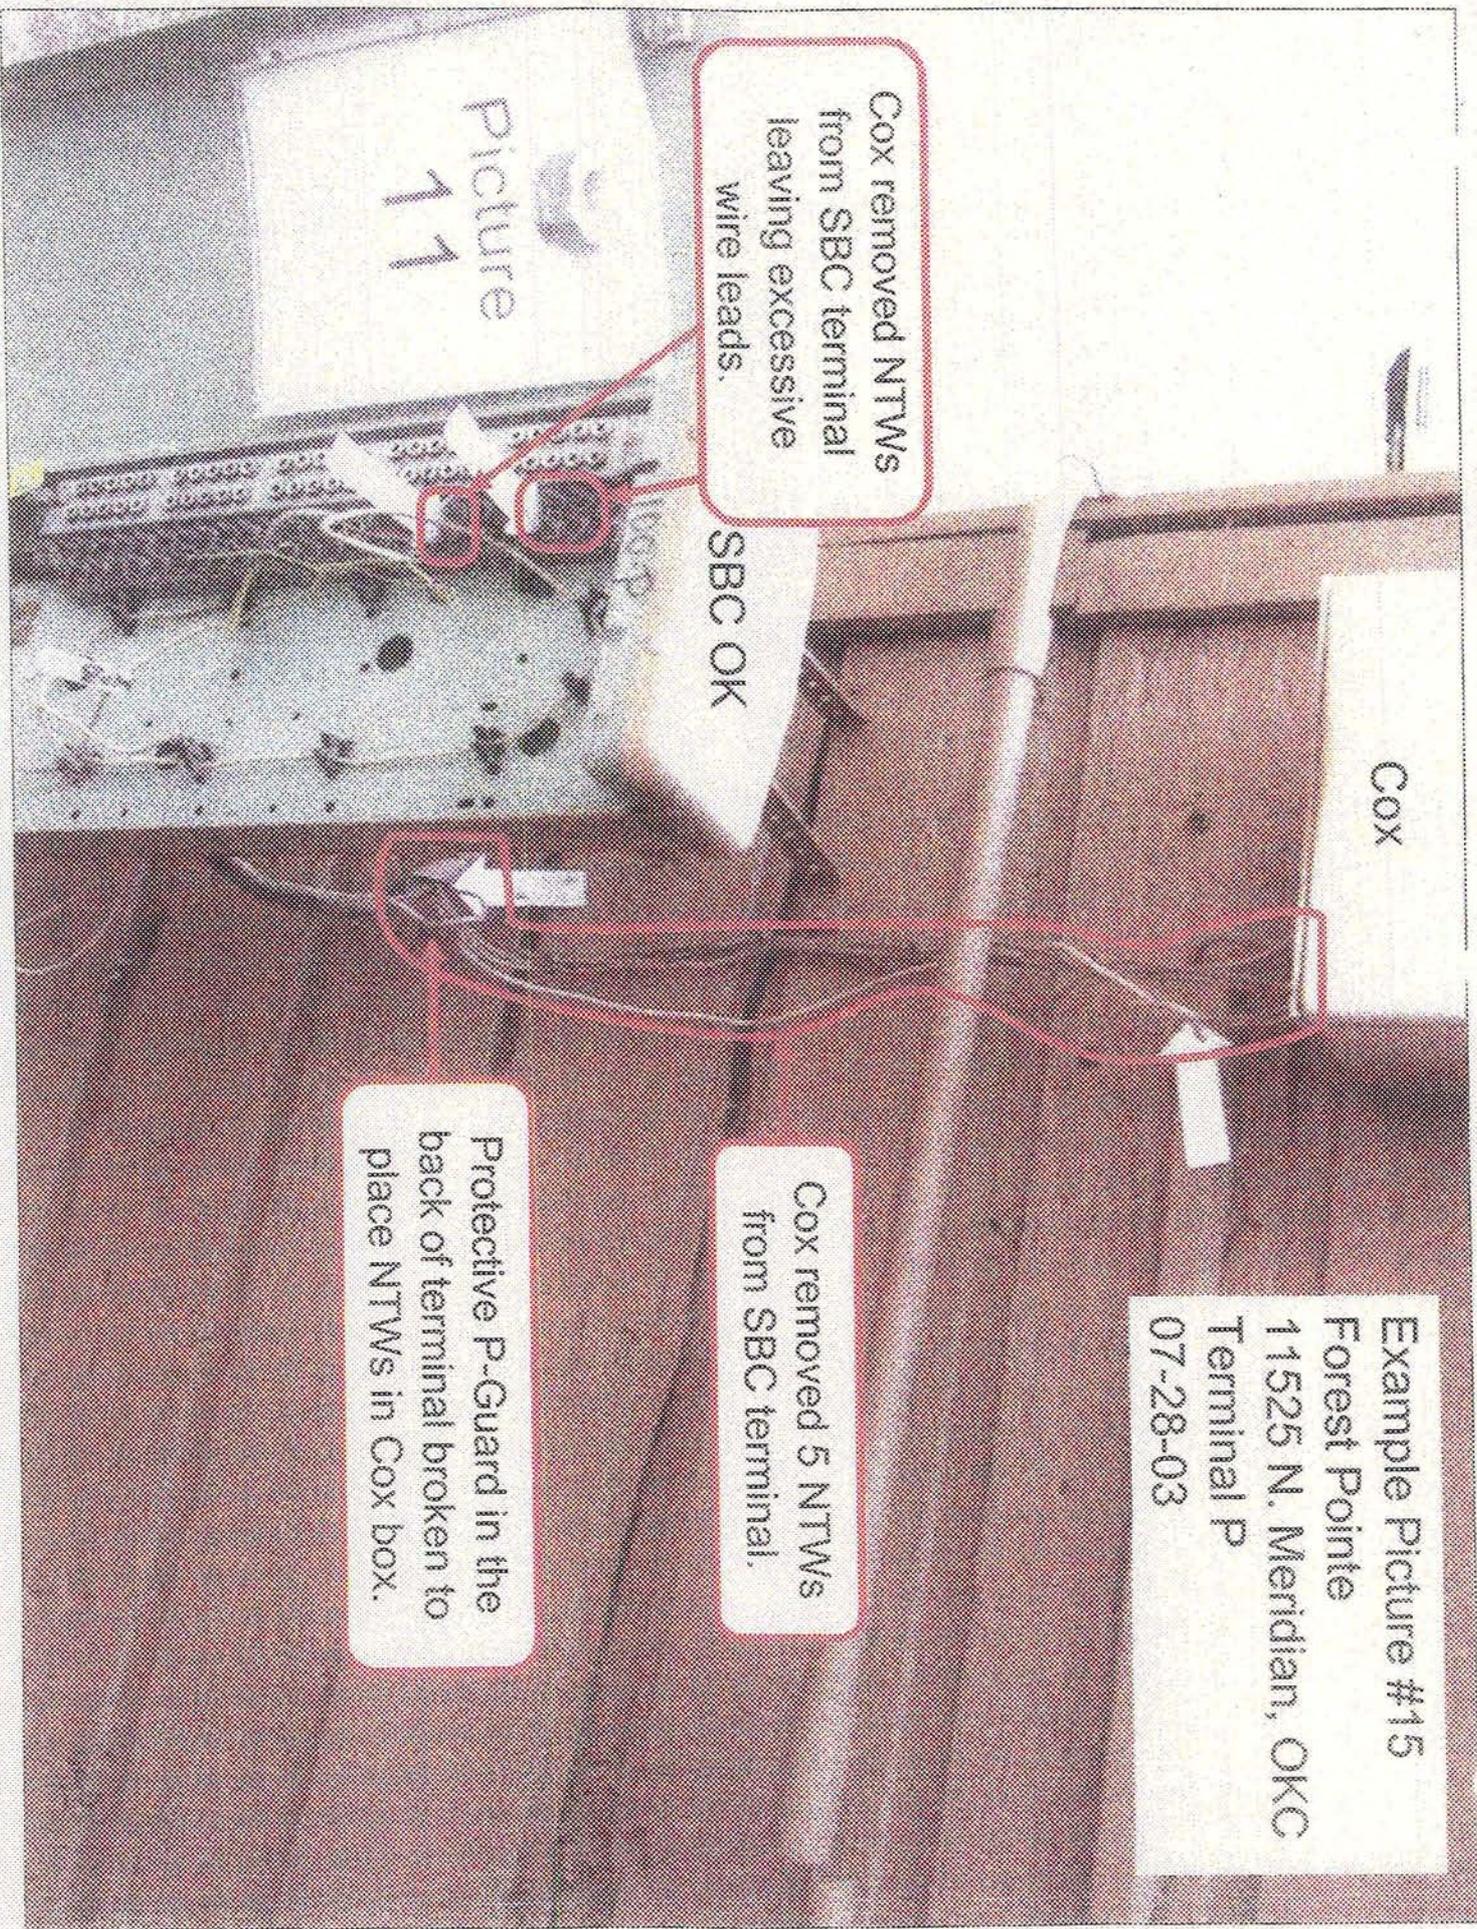
Example Picture #15
Forest Pointe
11525 N. Meridian, OKC
Terminal P
07-28-03

Cox removed NTWs
from SBC terminal
leaving excessive
wire leads.

Cox removed 5 NTWs
from SBC terminal.

Protective P-Guard in the
back of terminal broken to
place NTWs in Cox box.

Wasps entered SBC terminal through hole left by Cox and/or through terminal door not being closed properly. Wasp nest was found inside of terminal.

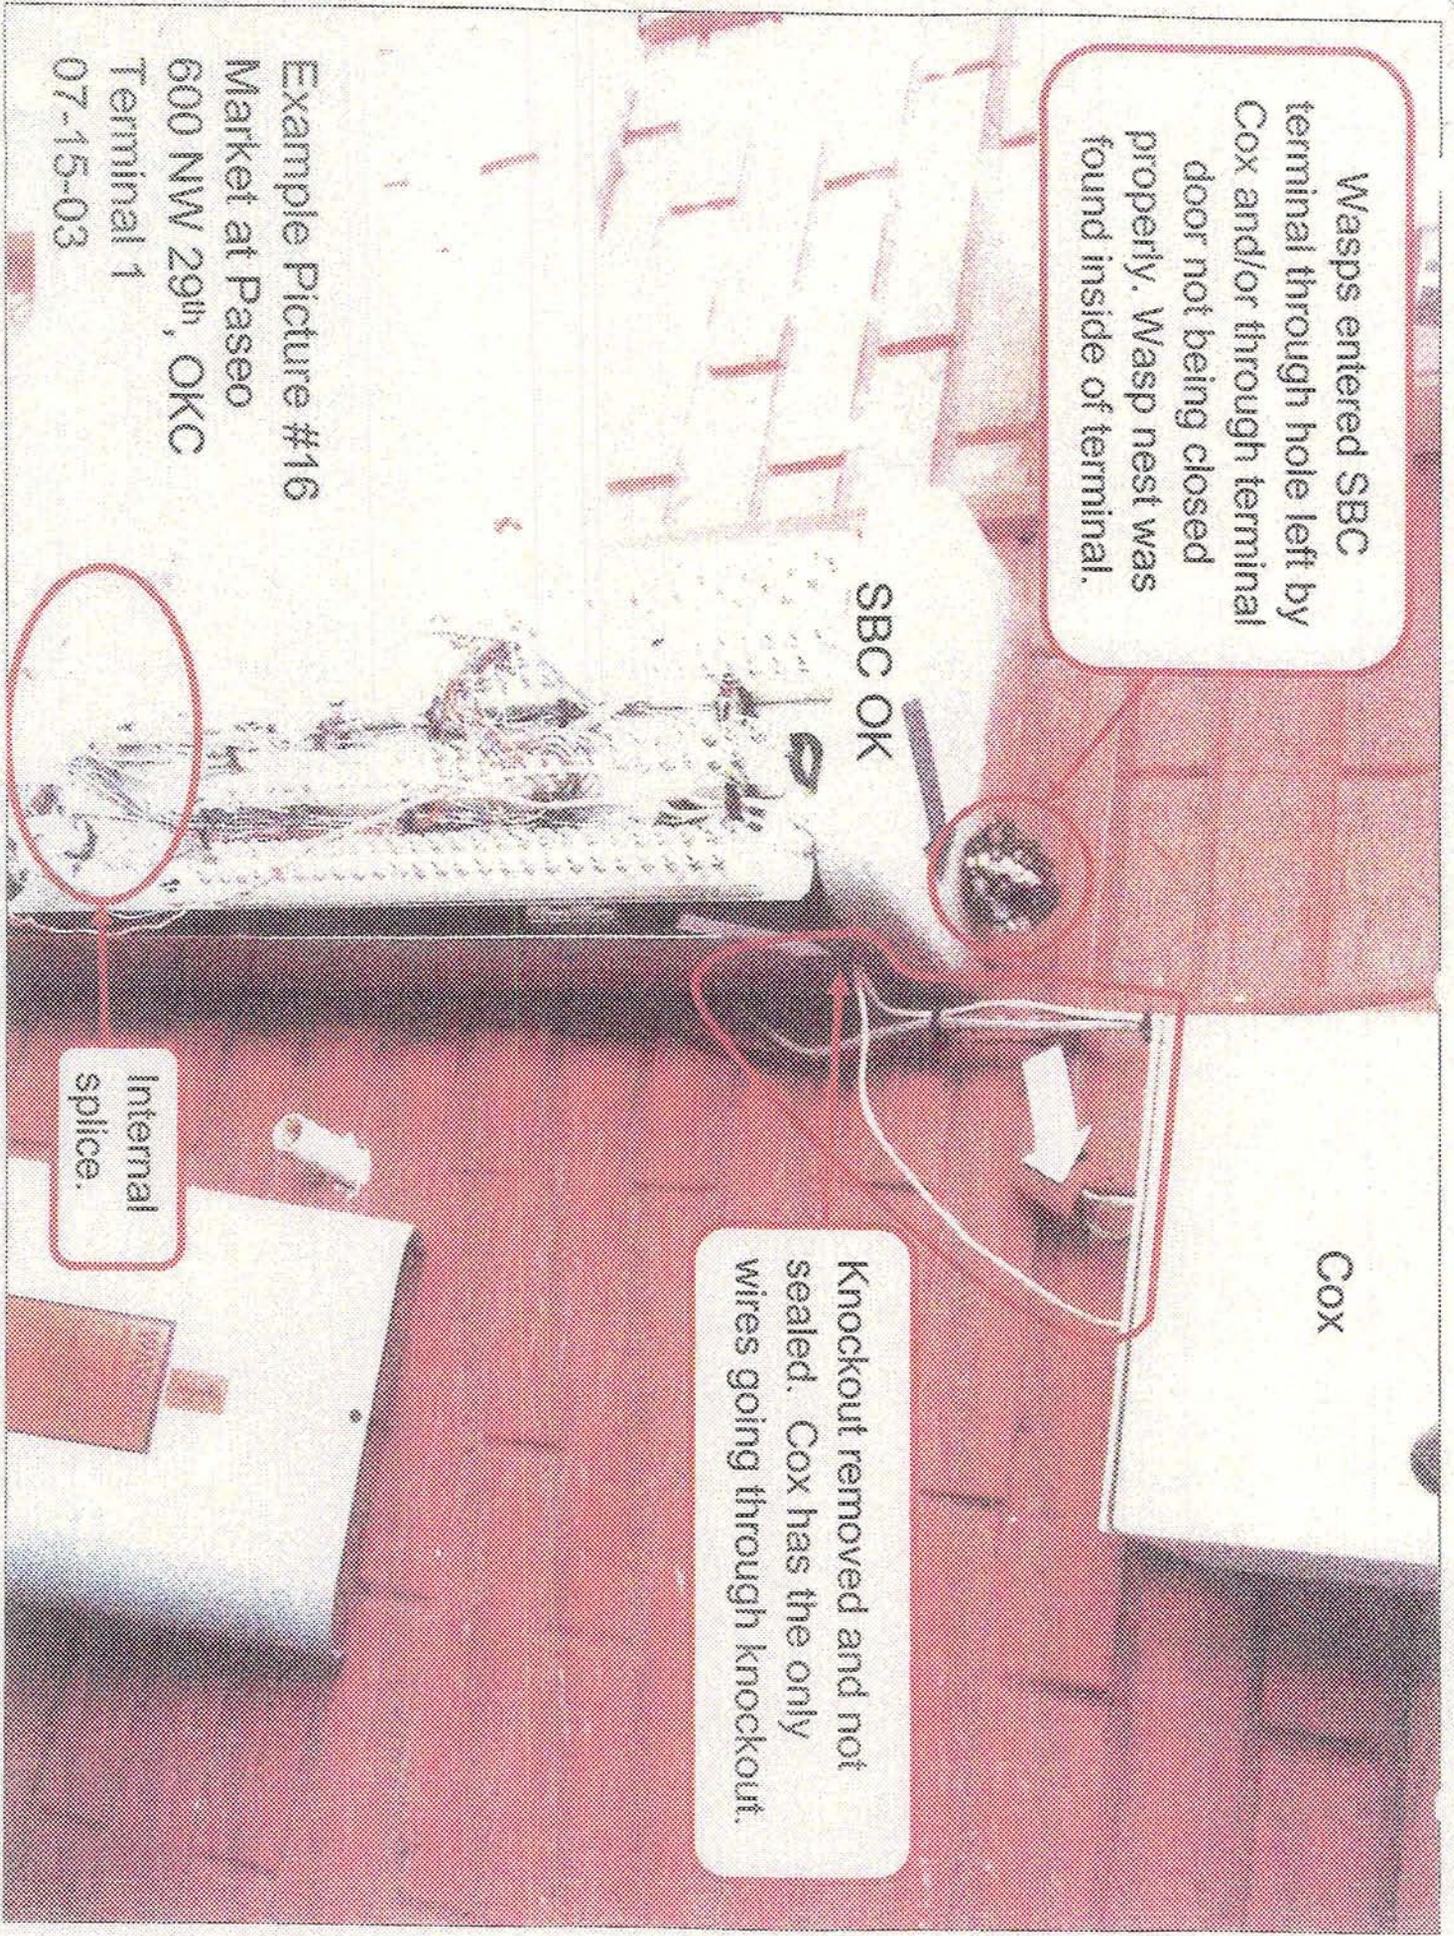
Example Picture #16
Market at Paseo
600 NW 29th, OKC
Terminal 1
07-15-03

Knockout removed and not sealed. Cox has the only wires going through knockout.

Internal splice.

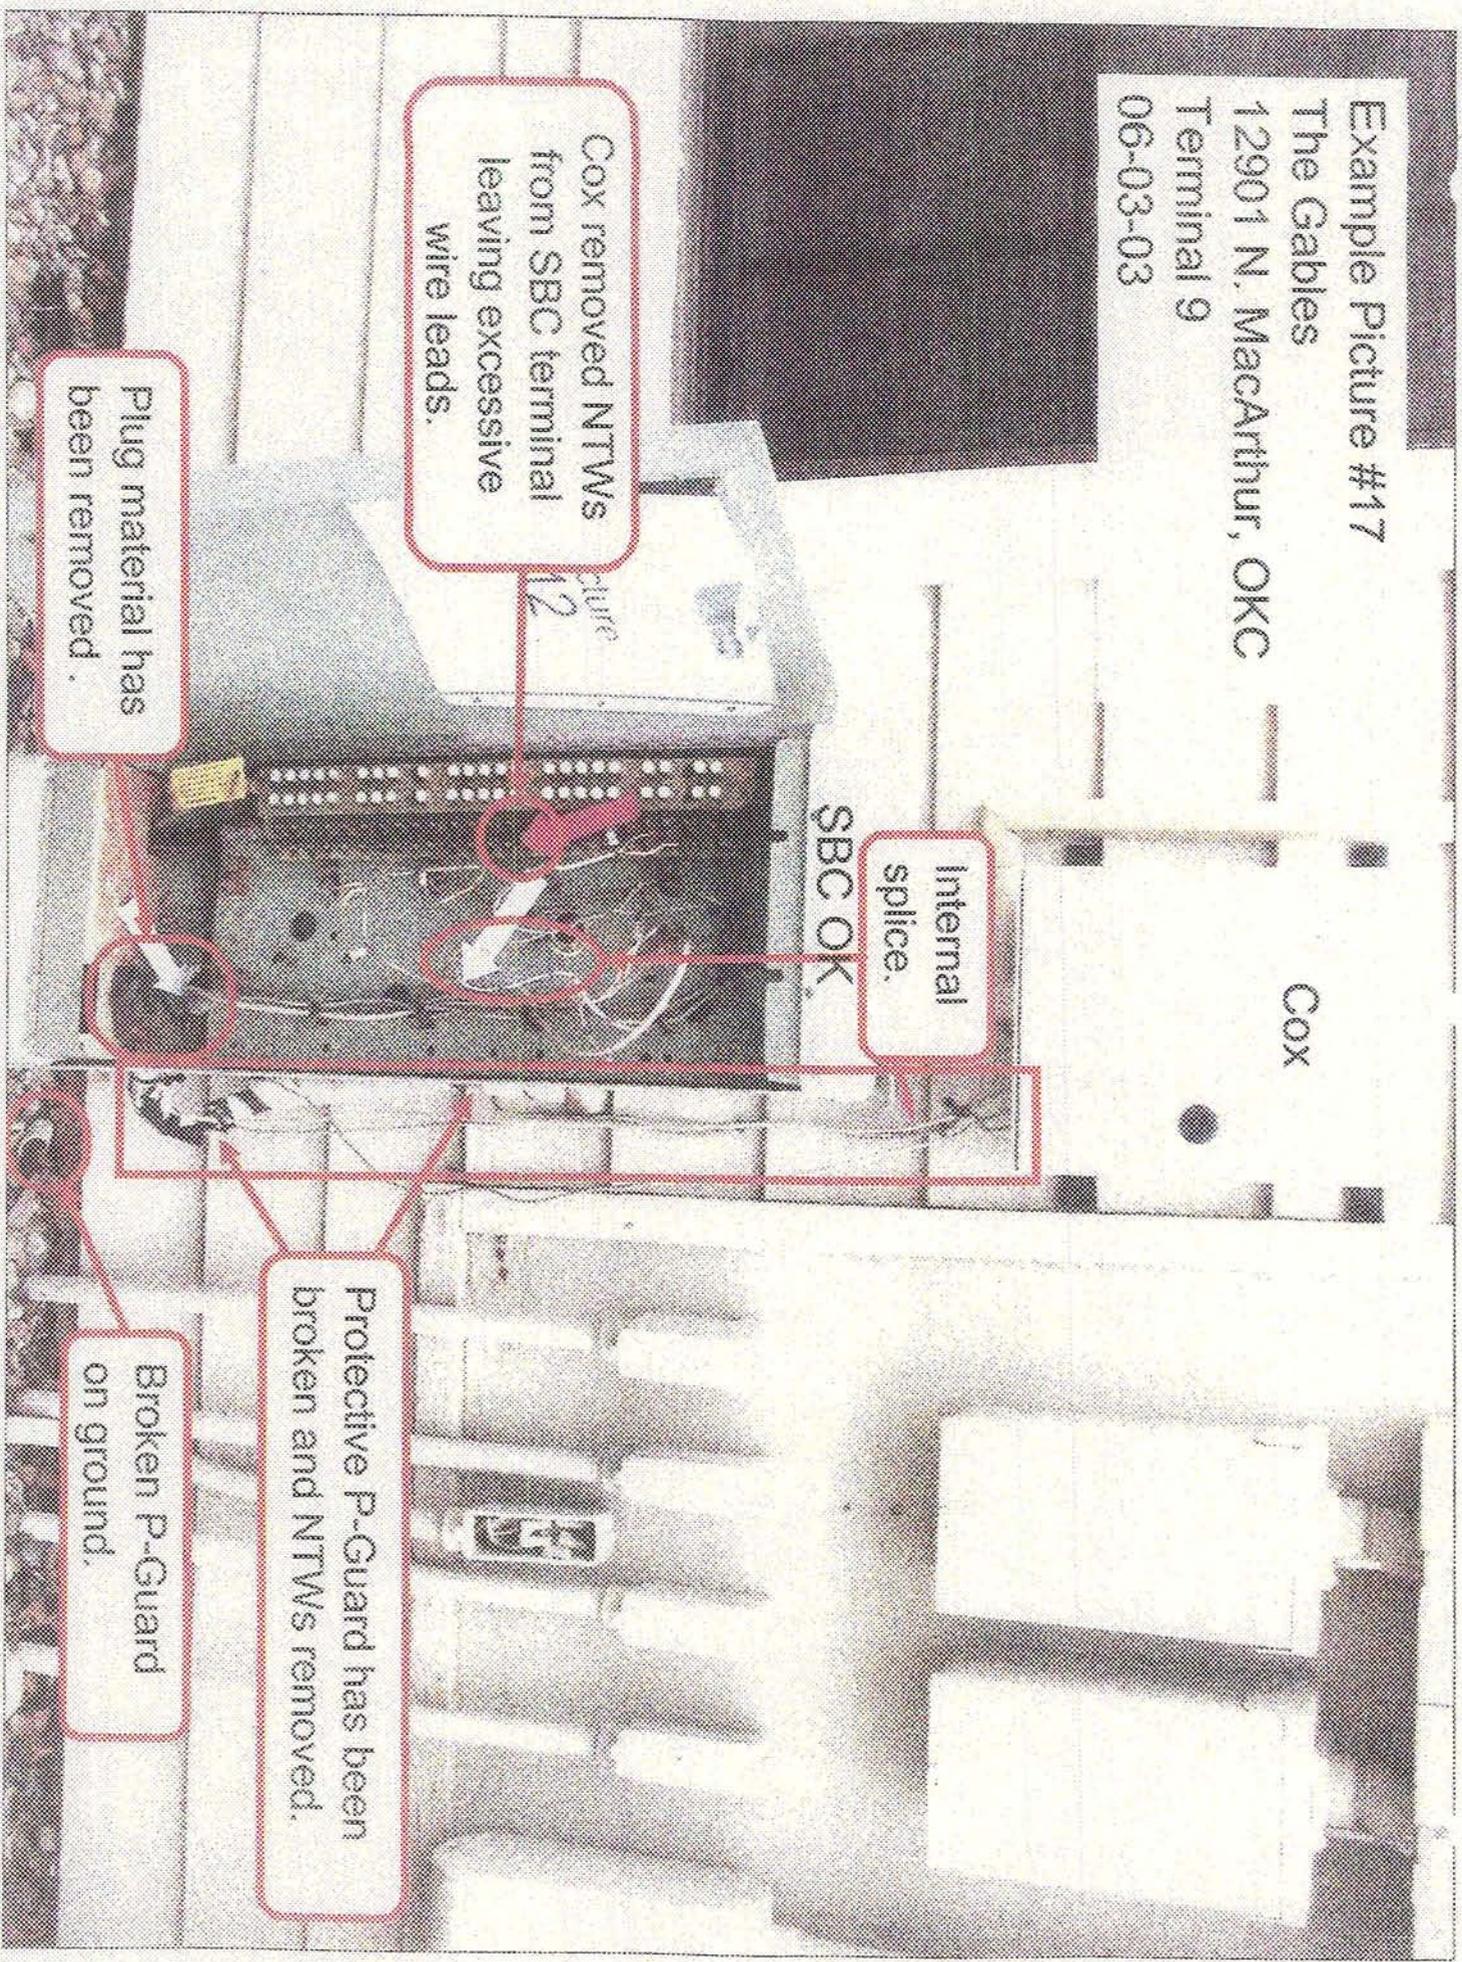
Example Picture #17
The Gables
12901 N. MacArthur, OKC
Terminal 9
06-03-03

Internal splice.

Cox removed NTWs from SBC terminal leaving excessive wire leads.

Plug material has been removed.

Protective P-Guard has been broken and NTWs removed.

Broken P-Guard on ground.
