Tree damage caused by mobile phone base stations

An observation guide

By Helmut Breunig

March 2017

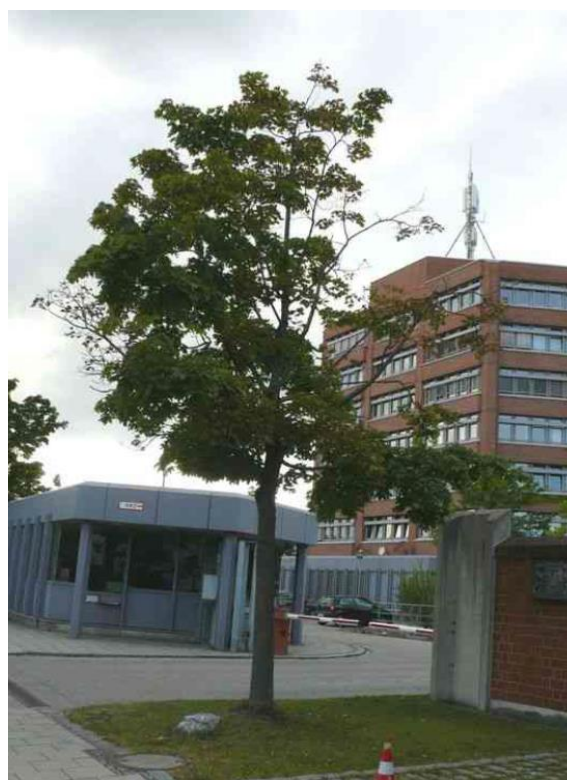
*Norway maple tree, August 2012
Badly damaged tree crown on the side
facing an RF transmitter*

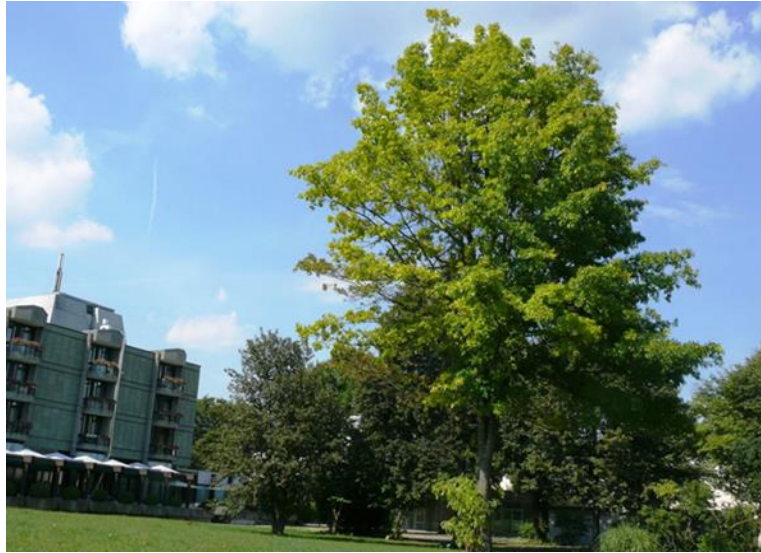
*Red oak tree,
August 2013*

At the location of the red oak tree shown here, none of the known stress factors are obvious. Still, the crown is damaged in a way that corresponds to the above-shown graph. The tree is in the line of sight of a nearby mobile phone base station.

The direction of the RF emission source and the location of the starting point of damage on the side of the tree facing the mobile phone base station coincide with each other.

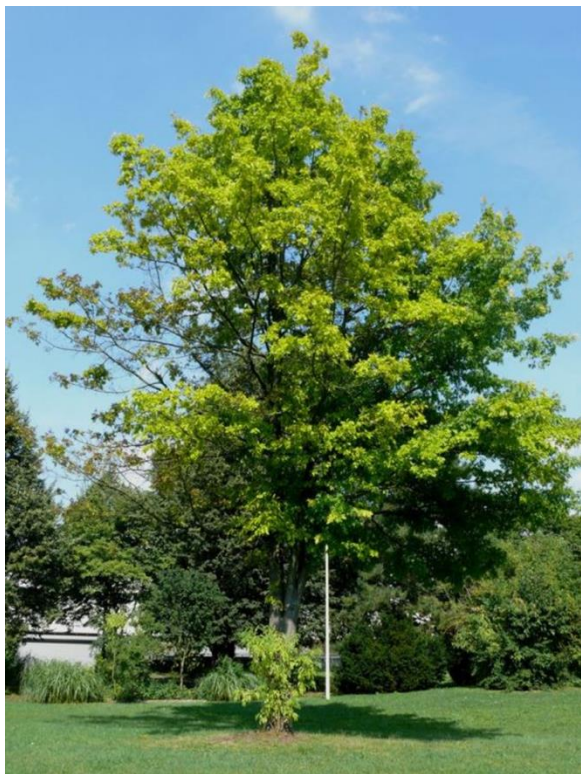
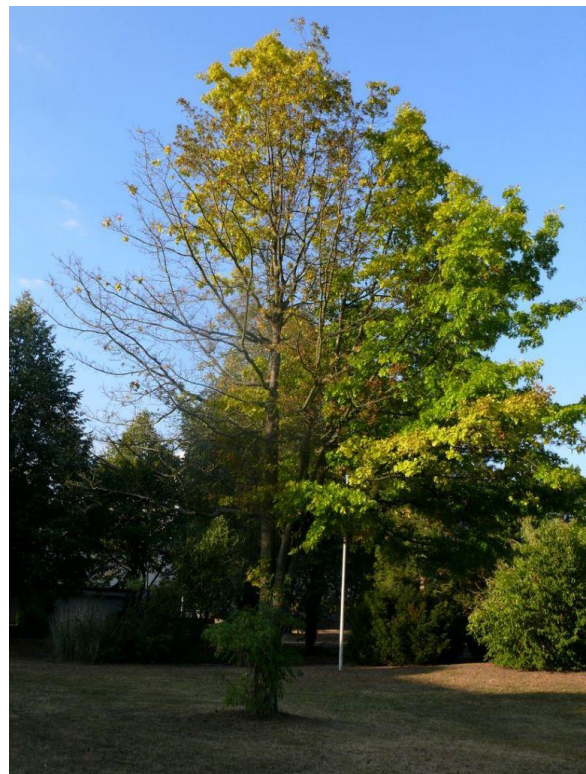
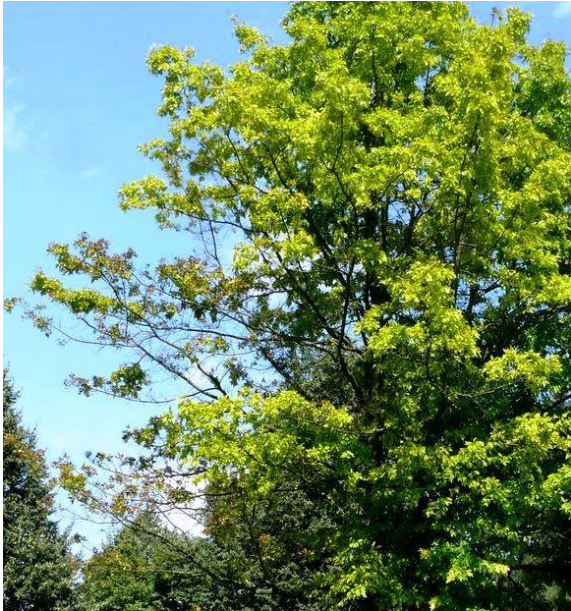
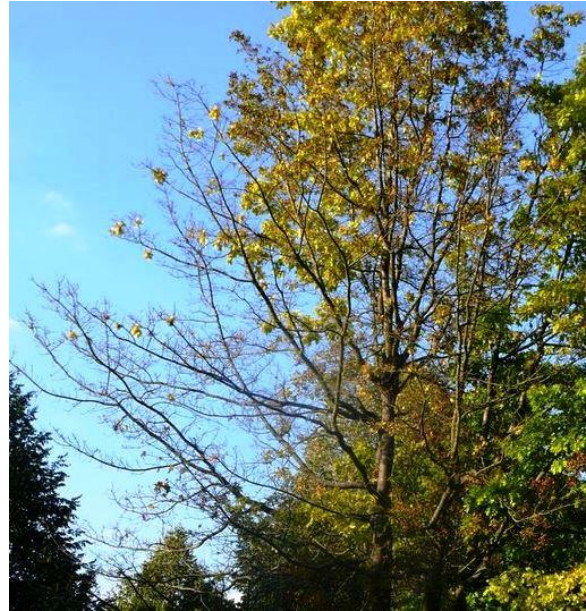
The damage area spreads across the crown over the course of the coming years. At the individual branches, the sight is similar to drought damage. The spatial and temporal development of the damage area as a whole, however, is not typical for drought damage that occurs as a result of a lack of water at the roots.

The loss and discoloration of the leaves is most prominent where the tree faces the RF transmitter. The spread of the damage area follows a pattern independent of the branch architecture of the tree.

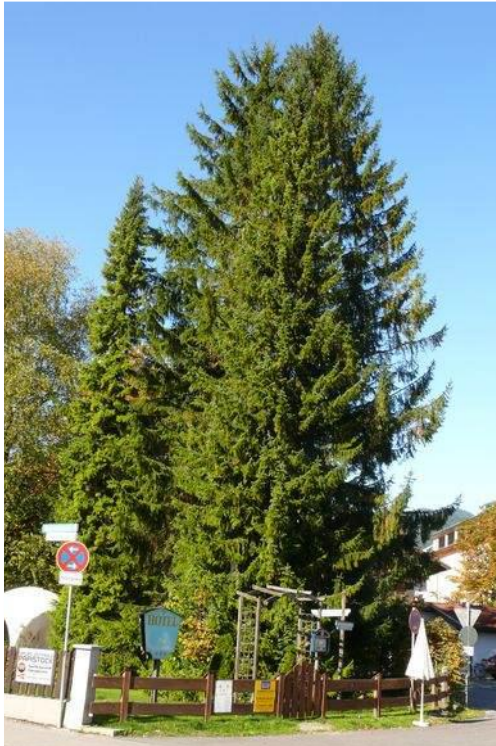
Spruce, October 2010

*Exposure from the right side,
260 m (ca. 850 ft)*

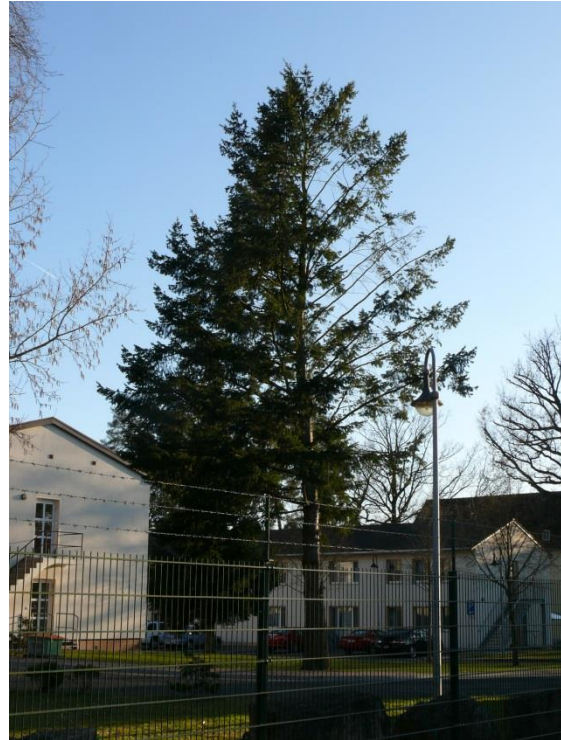
Spruce, March 2012

*Exposure from the right side,
190 m (ca. 620 ft)*

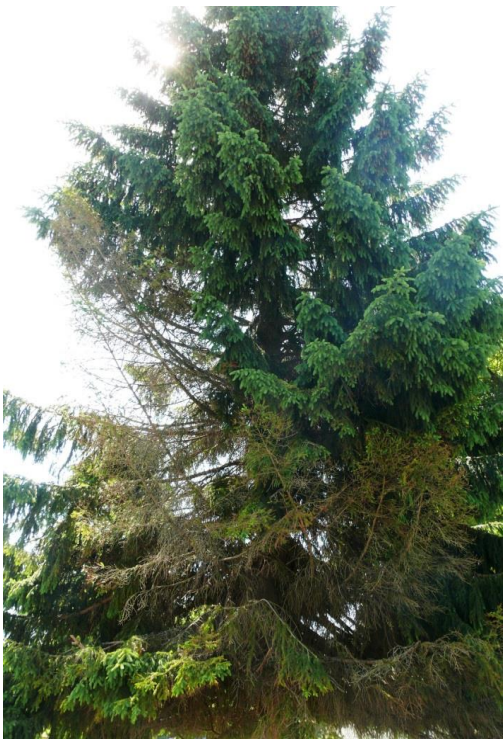
Spruce, June 2003

*Exposure from the left side,
200 m (ca. 660 ft)*

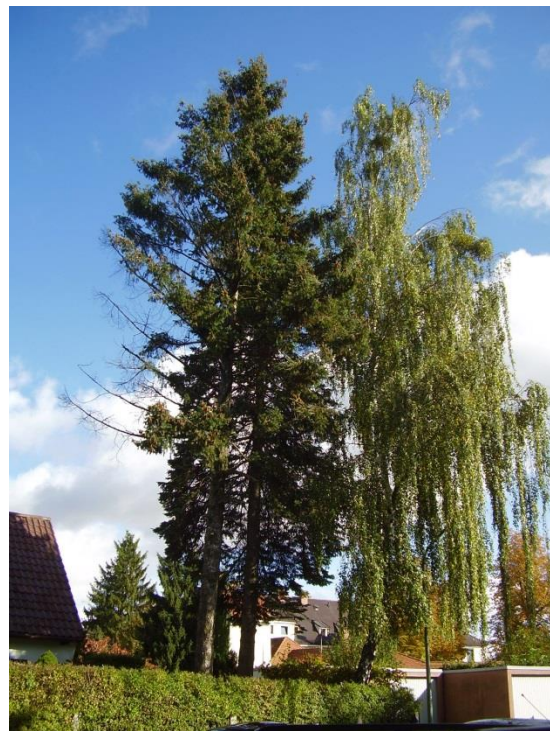
Spruce, October 2008

*Exposure from the left side,
310 m (ca. 1000 ft)*

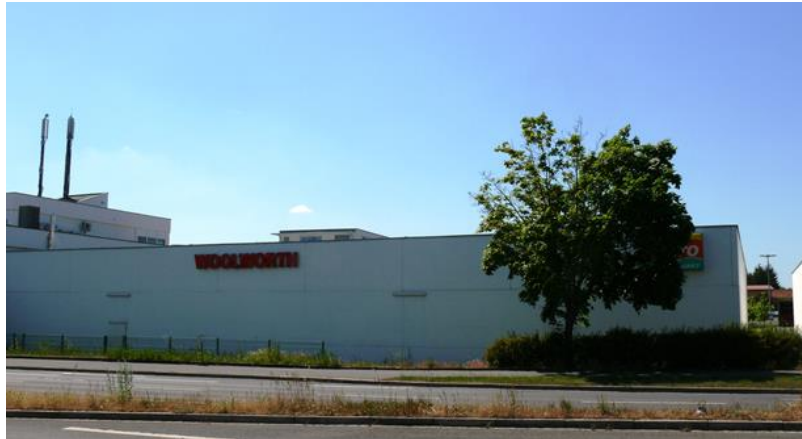
Norway maple tree,
June 2015

Exposure from
upper left ->

Measurement:	Side facing the RF transmitter:	Opposite side:
14 July 2015	2,100 $\mu\text{W}/\text{m}^2$	290 $\mu\text{W}/\text{m}^2$

The agreement between the spatial orientation of the damage gradient and the gradient of the RF measurements suggests that the damage is associated with the RF radiation exposure from the RF transmitter.

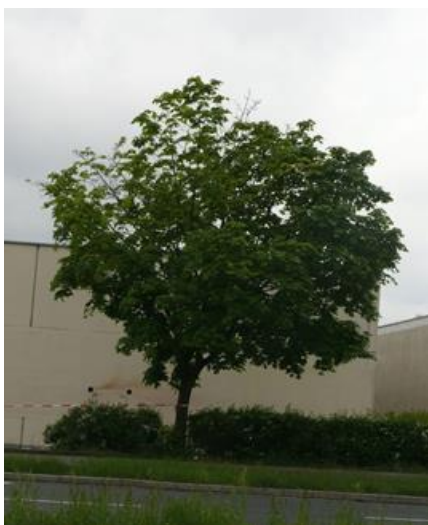
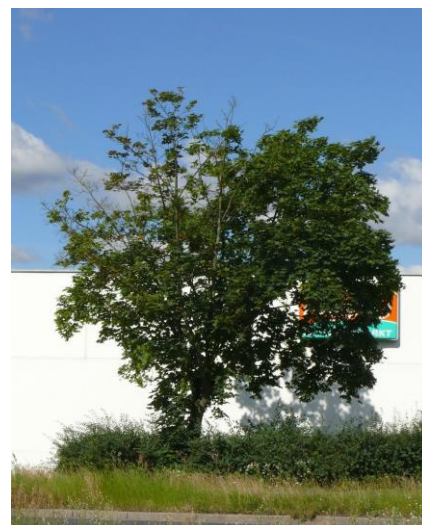
The damage increases over the years and spreads from the direction of the RF transmitter across the crown. No regeneration can be seen. This is a sign of chronic exposure to a damaging factor. The RF exposure from the mobile phone base station within sight began between 2006 and 2008.

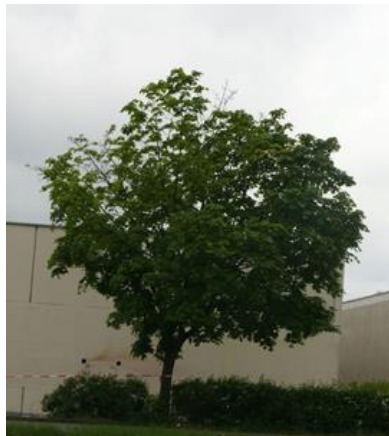
May 2013

The tree is located at a strip of greenery, running in a north-south direction. To the east (foreground), the root area is sealed by a traffic area. The damage area points toward south where the RF transmitter is located. Despite the less than favorable climate conditions at this side, the crown on the north side has expanded.

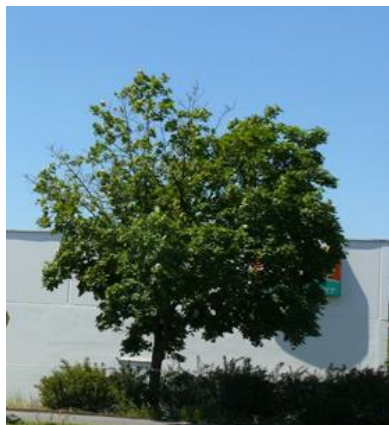
June 2014

At the upper left – where the RF radiation hits the crown – the dieback at the edge is the most severe.

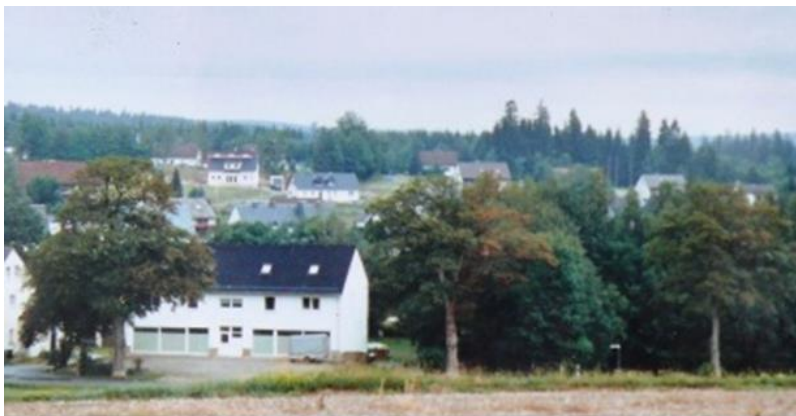
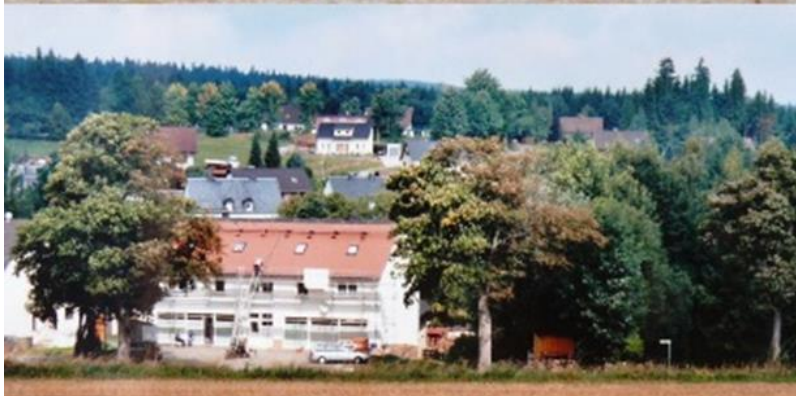
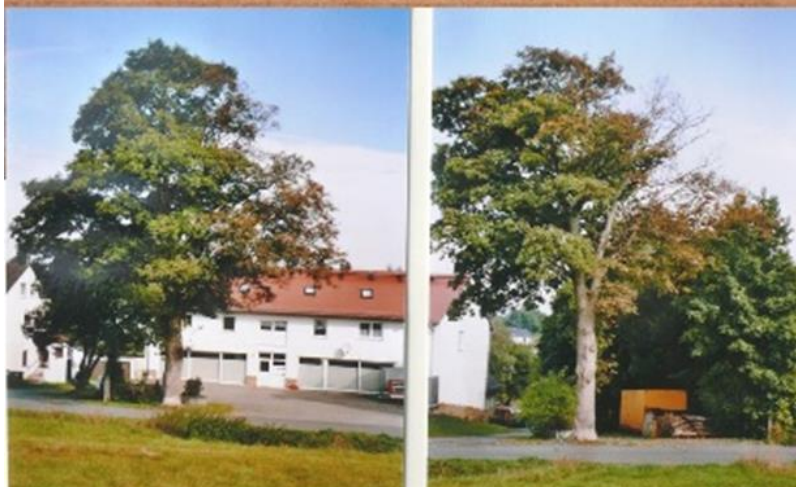
Sycamore maple tree

*<-Exposure from
upper right*

*Distance
730 m (ca. 2400 ft)*

Starting point of damage and damage gradient coincide with the direction of the RF emission source. The damage increases over the years.

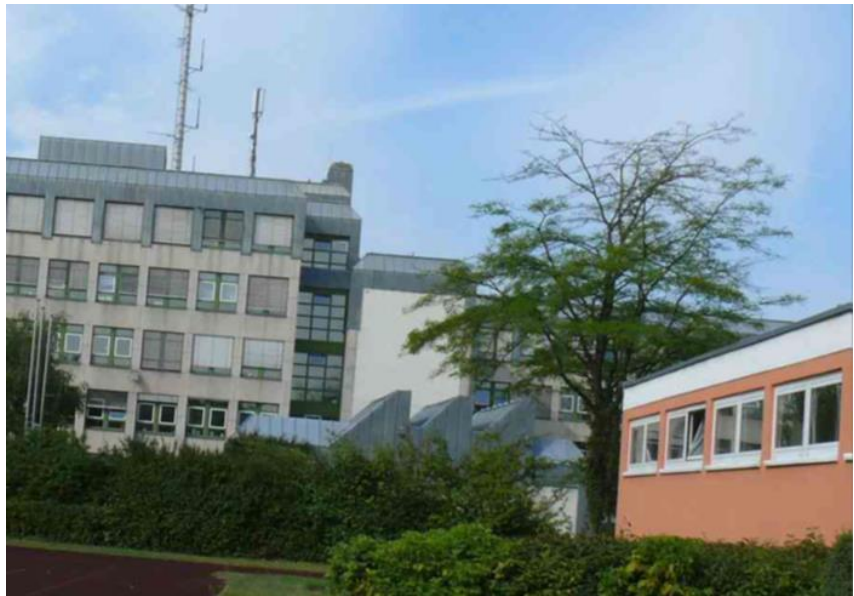
*Gleditsia tree
September 2011*

If the RF radiation exposure comes from above, the damage is particularly prominent at the top of the tree.

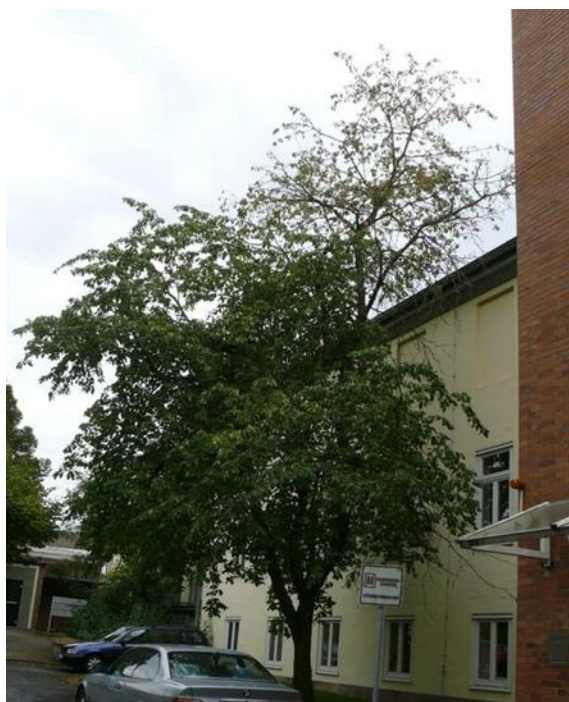
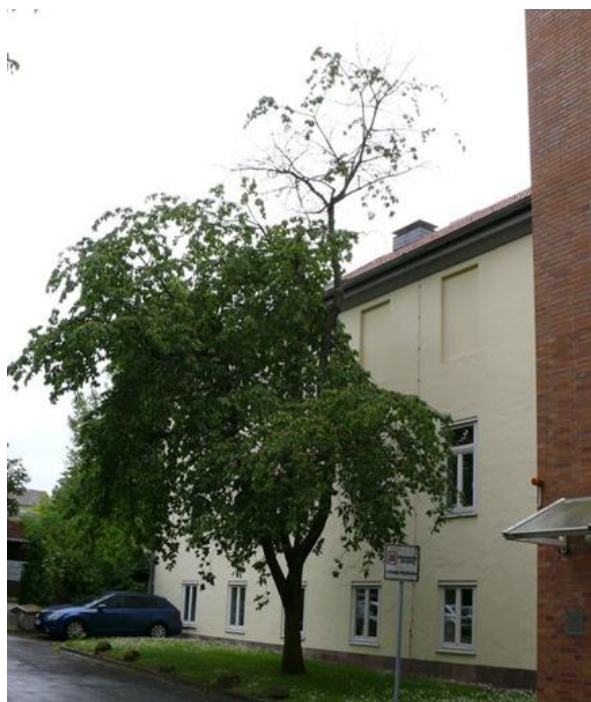
Cherry tree, September 2012

Exposure from the right
above the rooftop

Distance to multiple RF transmitters
150-500 m (ca. 500-1600 ft)

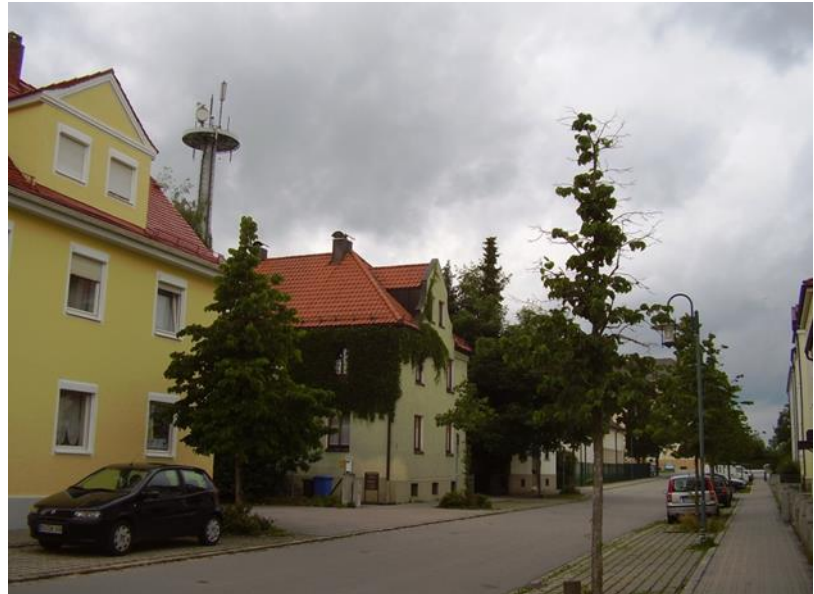
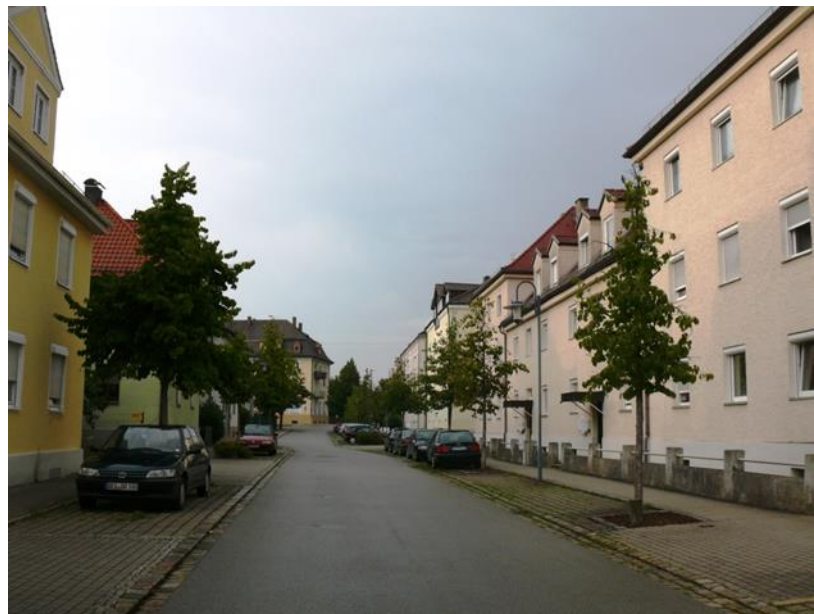
*RF radiation exposure
->*

The Turkish hazel trees on the left are mostly in the radio shadow of the buildings. The line of trees on the right side of the road are more exposed; both directly and indirectly (reflection from buildings). The bare shoots and dead twig tips of the transparent crowns of the trees on the right side of the road reveal the level of stress caused by the RF radiation.

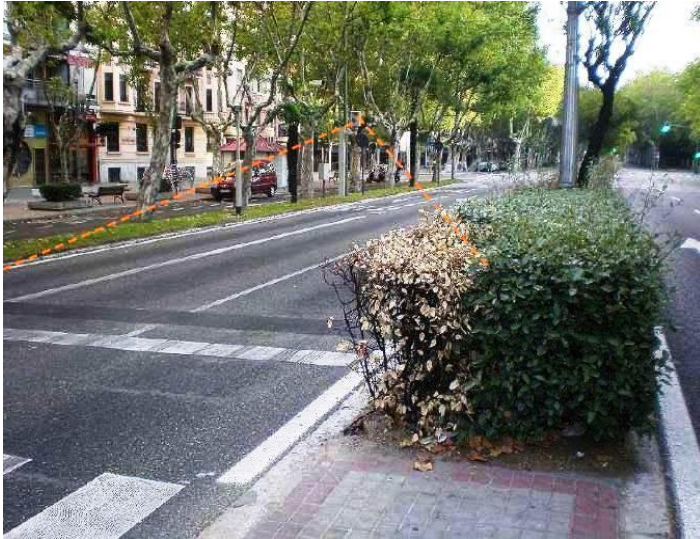
*Viburnum hedge
in a strip of greenery*

*Microwave exposure
from a traffic radar
<-*

The damage area in the foliage of the hedge clearly delineates the focused exposure area of the radar.

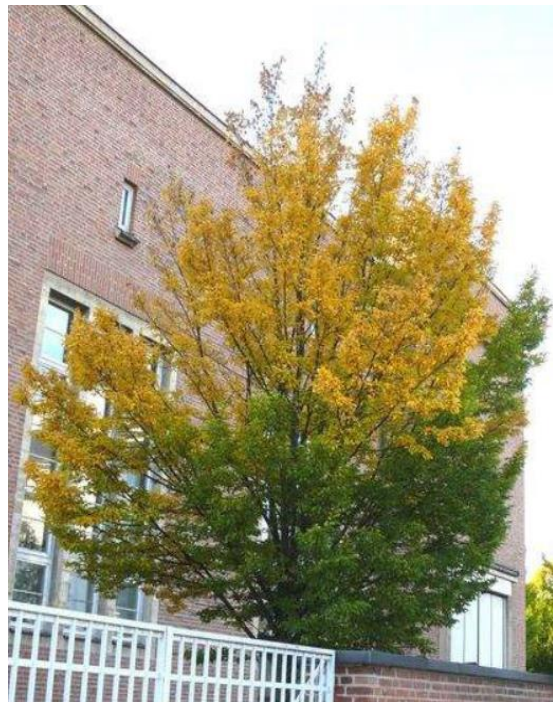
*Hornbeam tree,
October 2010*

*RF exposure from the upper
left*

*Distance to RF transmitter
60 m (ca. 200 ft)*

At the edge facing the RF transmitter, the leaf loss and the coloration differences within the crown show the damage gradient from the starting point of damage to the damage area.

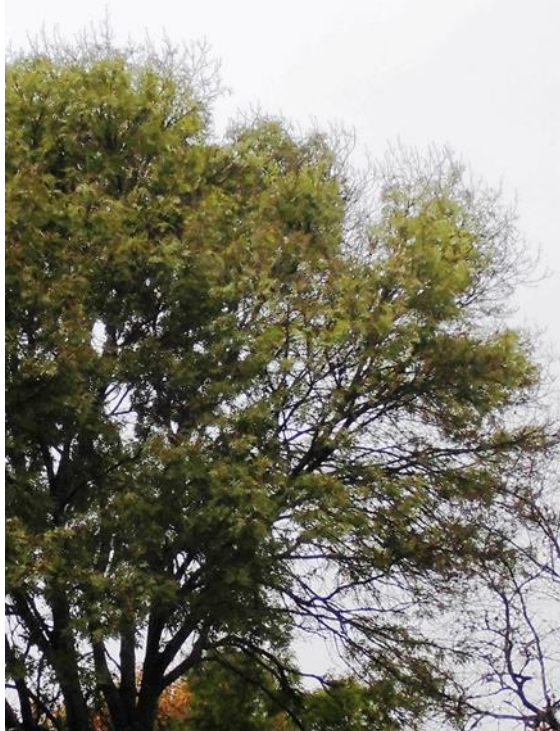
*<- Exposure from the right
from RF transmitter at
the same height,
distance 500 m
(ca. 1600 ft)*

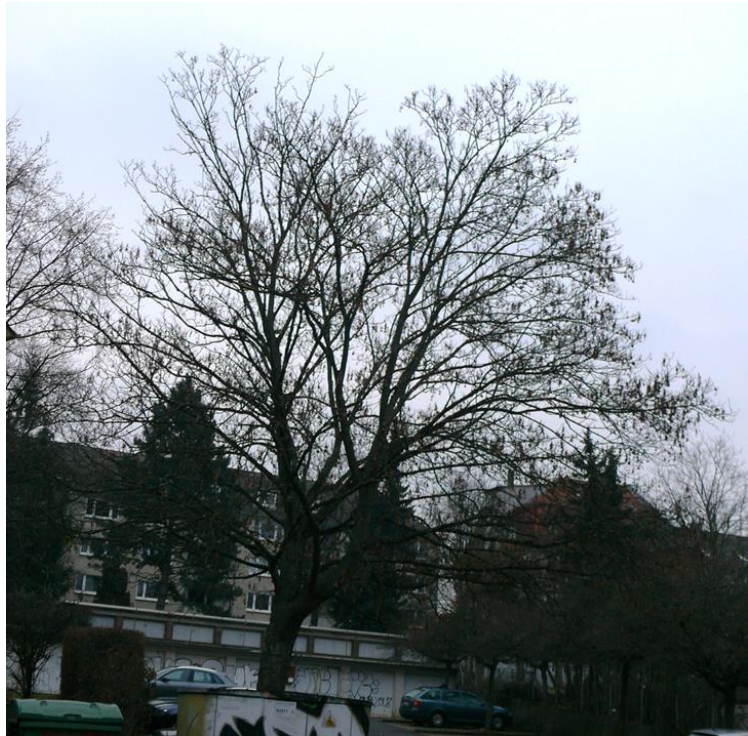
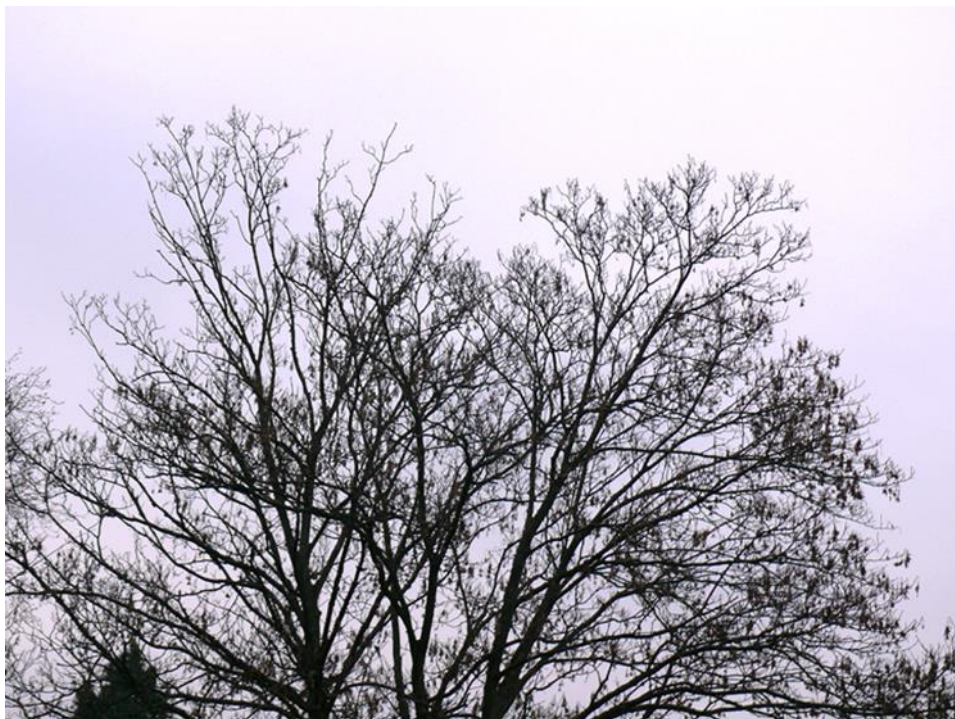
*Sycamore maple tree,
February 2017*

*RF exposure from the left
from a distance of 320 m
(ca. 1050 ft)*

*The branching differs between the left and the right side.
On the side of the crown facing the RF transmitter, less branching of
branches and shoots occurs. The closed crown starts opening from the left
and above.*

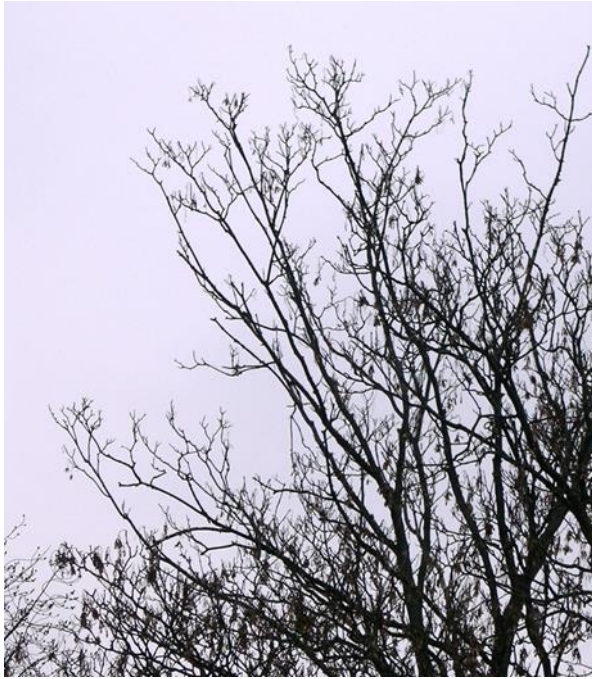
At the side facing the RF transmitter, the closed crown starts opening and areas of dieback become visible as a result of less branching.

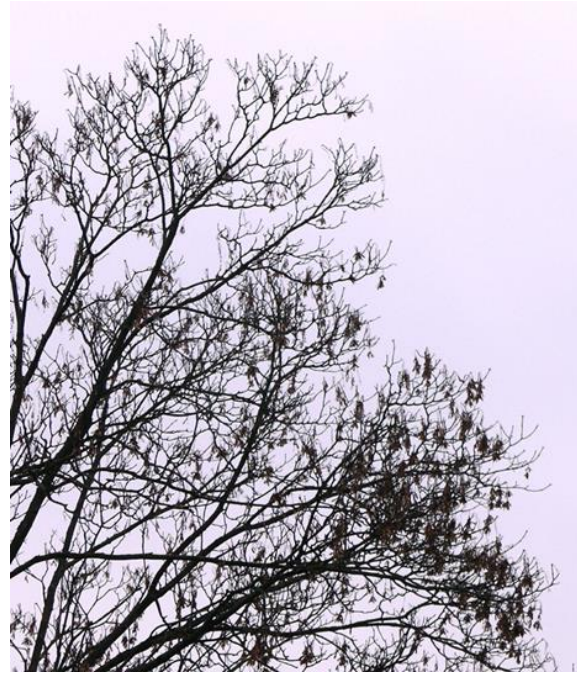
At the side of the crown facing away from the RF transmitter, branching is clearly much denser. The edge of the crown looks smoother and closed.

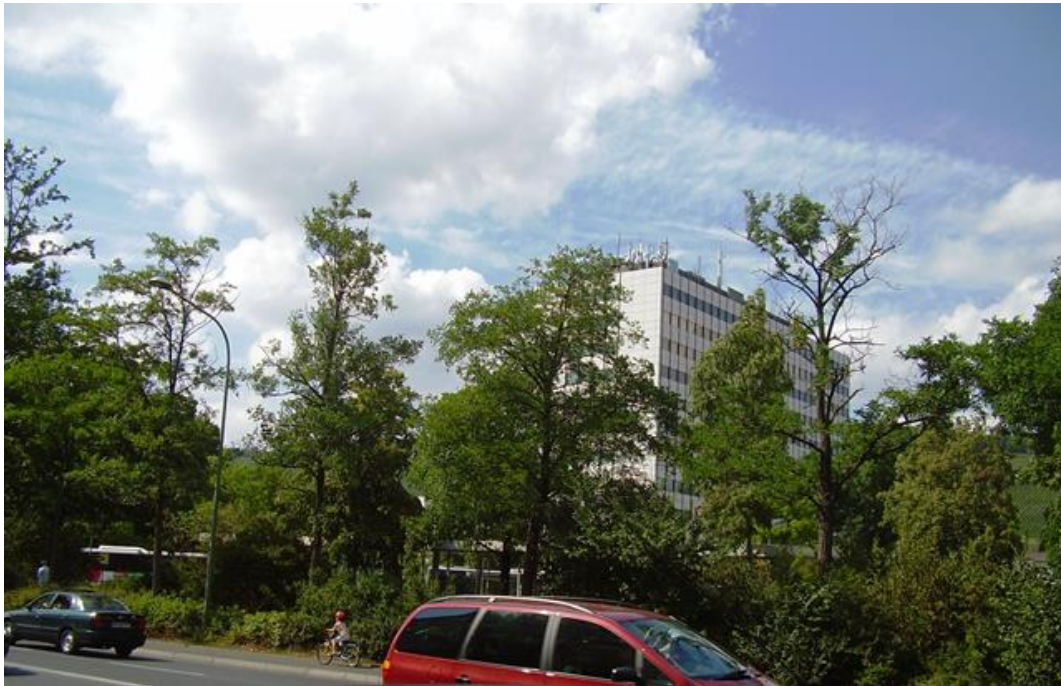
Tree crowns in a strip of greenery become damaged through the exposure to radiofrequency radiation
