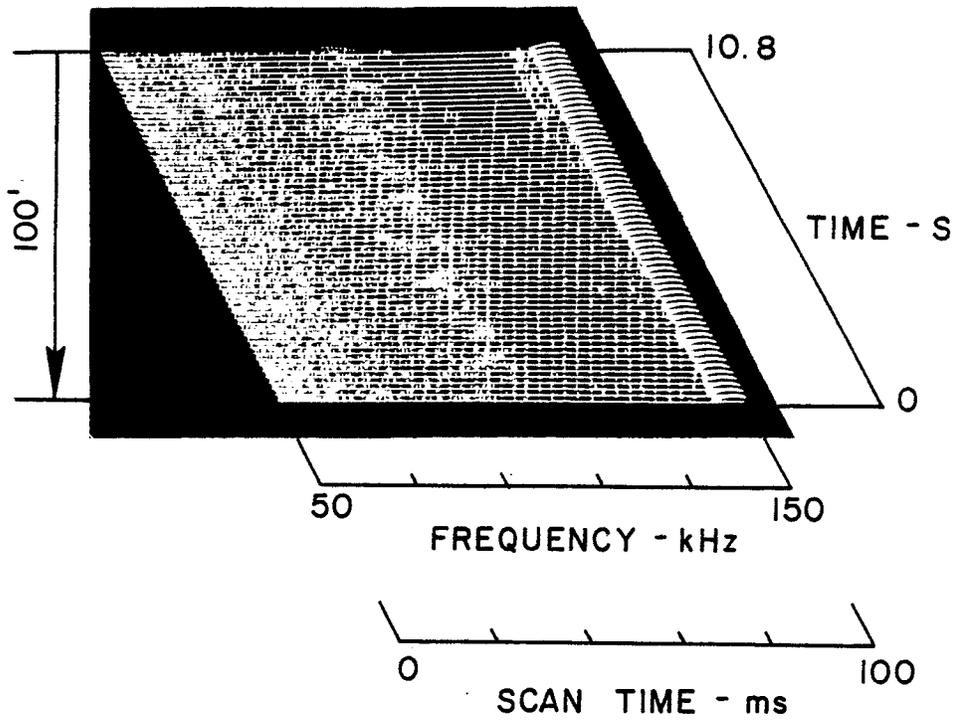
Figure 16 3-Axis View, 1/26/79, 0930, 109-018 Site 2

The top portion of the view in Figure 16 shows the lack of impulsive noise at site 109-018, while the bottom part of the view represents noise at the location used to obtain data in Figures 14 and 15. Figure 16 illustrates the critical aspects of site location and shows that drastically different noise conditions can be encountered only a few feet from a given site.

1/26/79, 0930, Approaching 109-018 Site 2  
HP 140, Whip, F 100 kHz, W 100 kHz, IF 3 kHz, ST 100 ms, A -20 dBm/0/+15 dB/NF

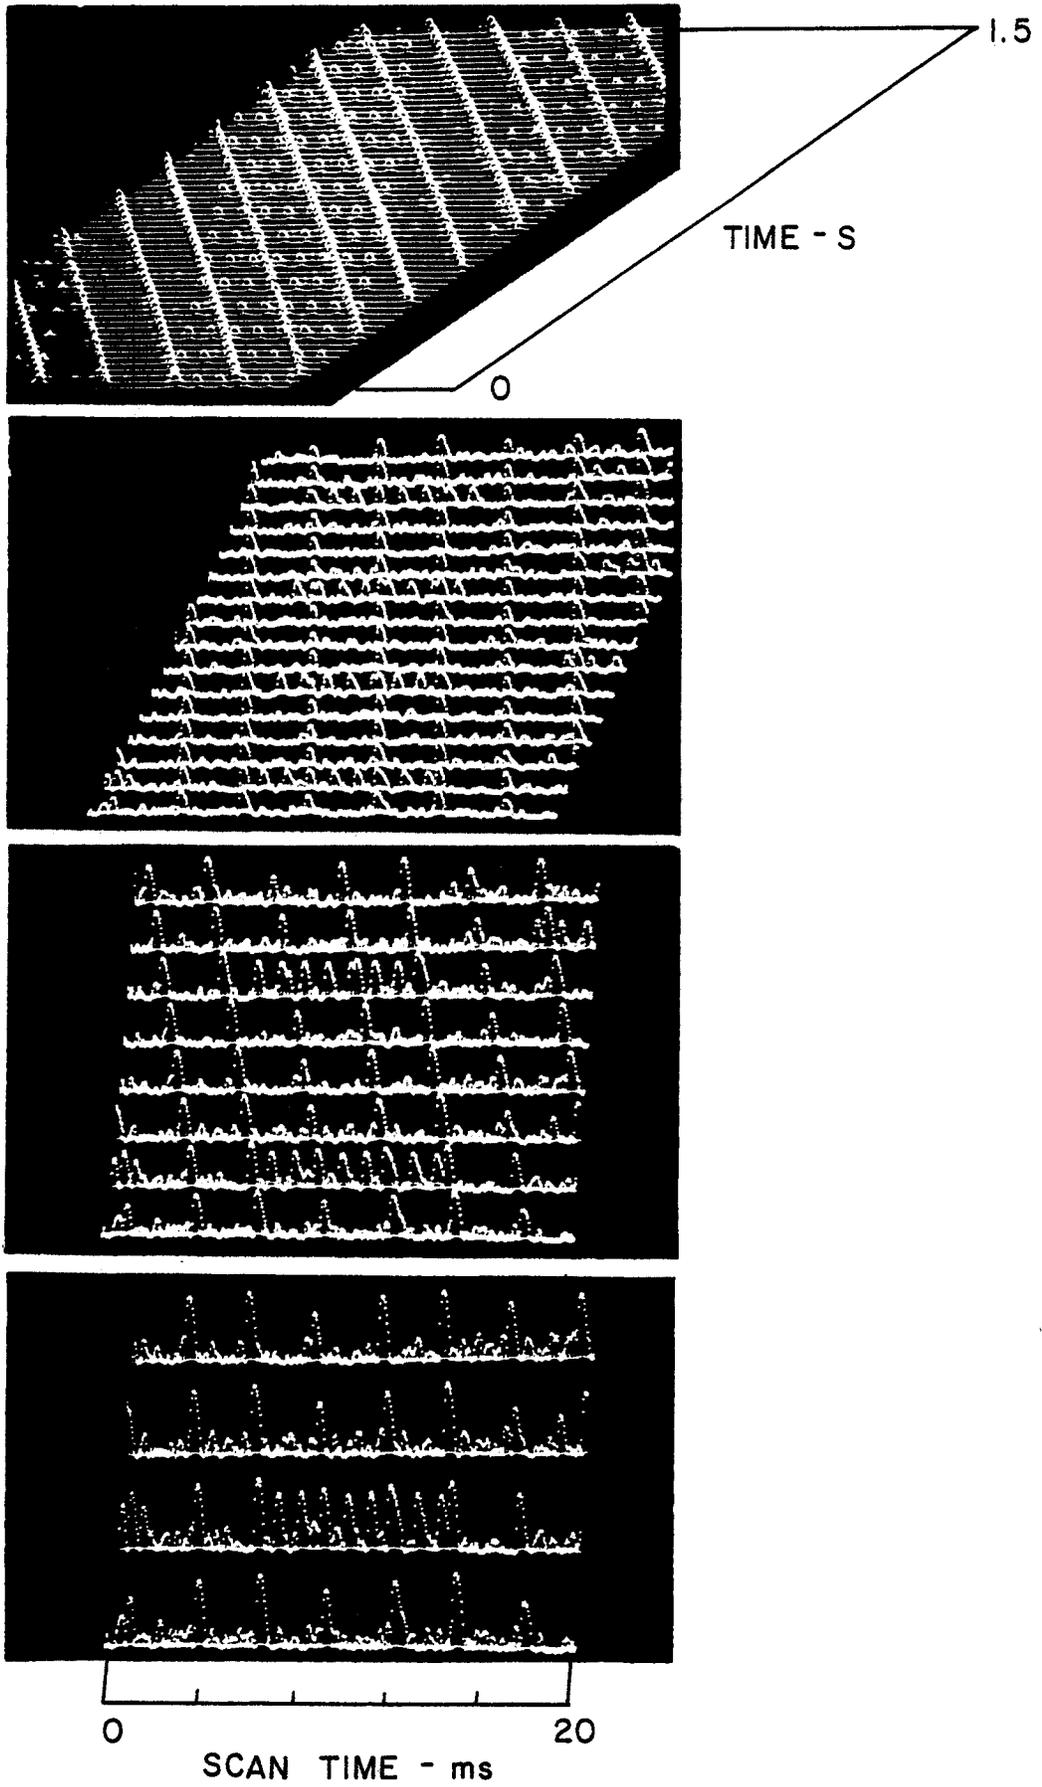
Figure 18 3-Axis View, 1/26/79, 0855, 109-018 Site 2

Since the site near 109-018 provided orderly and high levels of impulsive noise with impulses spaced at even intervals of about 2.6 ms, the site was used to obtain time-time views. An example of a time-time view (receiver frequency scanning process stopped) is shown in Figure 18, where the top view shows 15 sequential groups of eight pulses from Station Y along with power line-emitted pulses spaced at intervals of about 2.6 ms. The second view from the top shows 16 lines of data taken from the top view. The third view from the top shows the bottom eight lines taken from the view immediately above. The bottom view shows the bottom four lines from the view immediately above. In the bottom view an eight-pulse Loran-C group from Station Y is shown on line 2, along with four power line-associated impulses which are within or near the Loran-C pulse groups. The amplitudes of the Loran-C and power line-associated impulses are nearly the same. Other similar situations can be identified in the other views showing additional scan lines. The views illustrate how power line-associated pulses and Loran-C pulses are mixed together, and how the two appear to a Loran-C receiver.

The time-time views show that the impulsive noise at site 109-018 was definitely not random in amplitude. The lower two views of Figure 18 indicate that most pulse amplitudes fell into two main amplitude levels (neglecting some minor variations) which had a very orderly repetitive pattern. Only very minor variations in amplitude were found from one day to the next day. The consistent amplitude pattern, along with the consistent spacing between impulses, indicates that the source mechanism was a very stable and orderly process.

1/26/79, 0855, 109-018 Site 2  
HP 140, Whip, F 100 kHz, W T-T, IF 3 kHz, ST 20 ms, A -20 dBm/0/+15 dB/NF

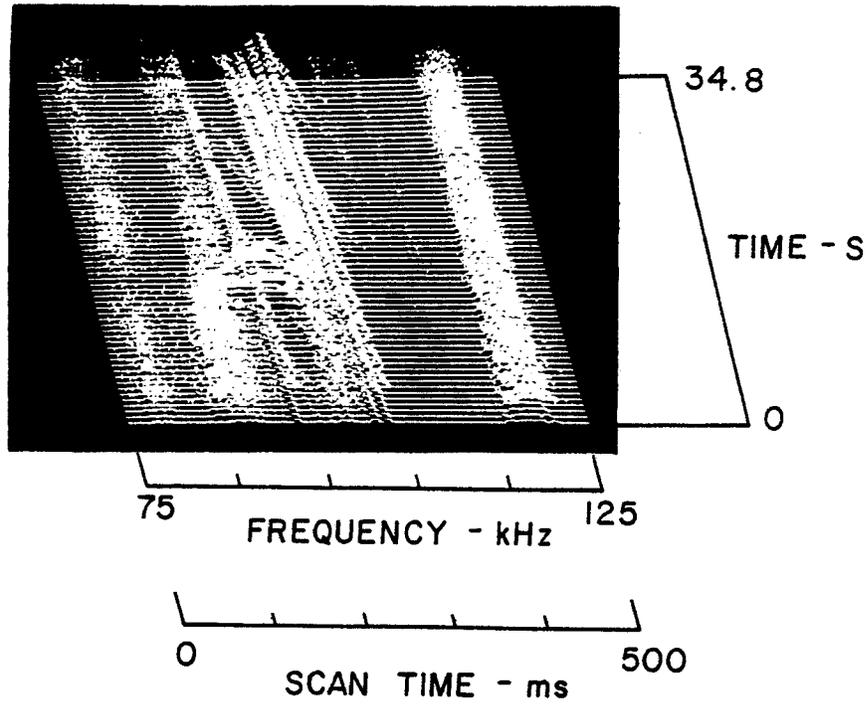
Figure 19 3-Axis View, 1/23/79, 1100, Between 108-023 and 108-024

The Phase I report gave examples of CW signals which briefly appeared as the measurement van moved along a street. These brief bursts of CW signals were tentatively associated with street corners containing traffic control devices and with unshielded overhead telephone lines. Numerous cases of brief CW signals associated with street corners containing traffic control devices were again noted in the Phase II measurements. Examples are shown in Figures 19 and 20. While many of these signals from the Phase I effort were multiple frequency, the signals observed during the Phase II measurements were of single frequency. The data gave no indication of the reasons for this discrepancy, and there was inadequate time to investigate the sources in sufficient detail to determine why multiple and single frequencies were observed.

1/23/79, 1100, between 108-023 and 108-024 (traffic control signal)  
HP 140, Whip, F 100 kHz, W 50 kHz, IF 3 kHz, ST 500 ms, A -20 dBm/0/+15 dB/NF

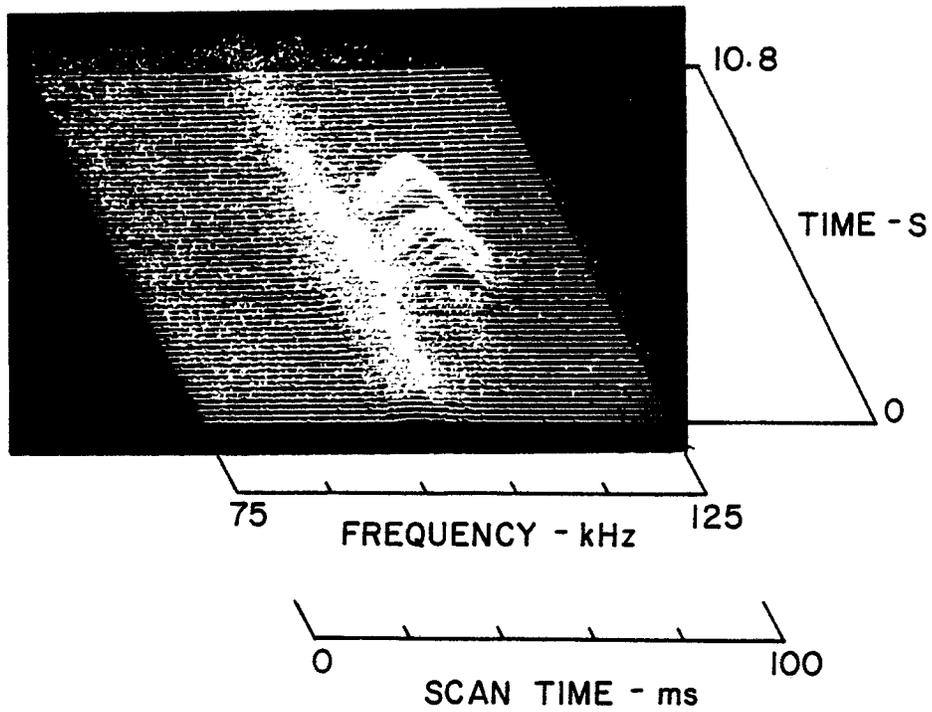
Figure 20 3-Axis View, 1/26/79, 1211, Rosecrans and Sepulveda

1/26/79, 1211, Rosecrans & Sepulveda  
HP 140, Whip, F 100 kHz, W 50 kHz, IF 3 kHz, ST 100 ms, A -20 dBm/0/+18 dB/BPF

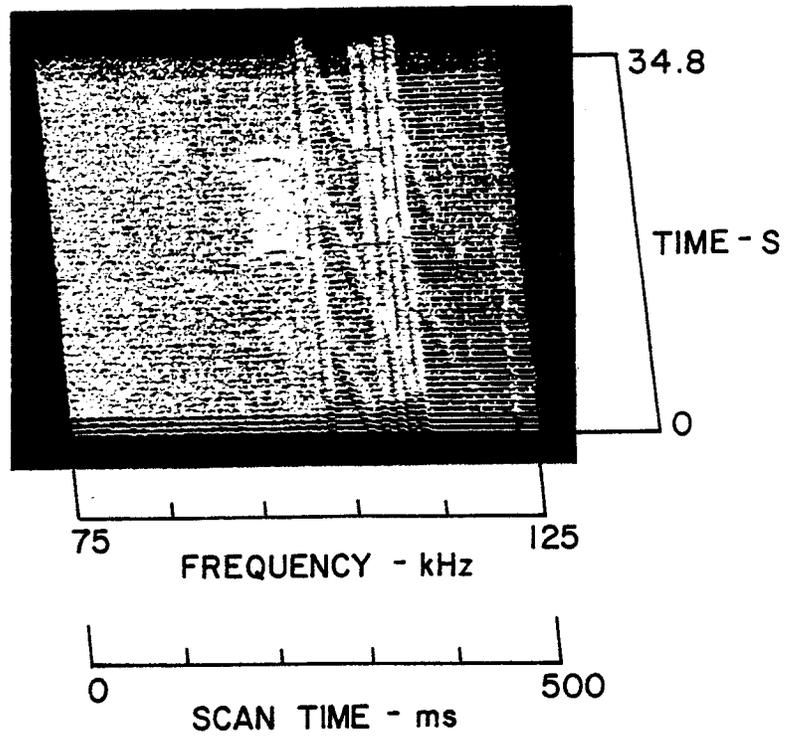
Figure 21 3-Axis View, 1/26/79, 1156, Downtown El Segundo

An example of a brief CW signal associated with an unshielded telephone line crossing the street in mid-block is shown in Figure 21. No other nearby structures were found which might be sources, and the signal peaked in amplitude when the measurement van was directly under the telephone line.

1/26/79, 1156, passing under overhead telephone line, downtown El Segundo  
HP 140, Whip, F 100 kHz, W 50 kHz, IF 3 kHz, ST 500 ms, A -20 dBm/0/+15 dB/NF

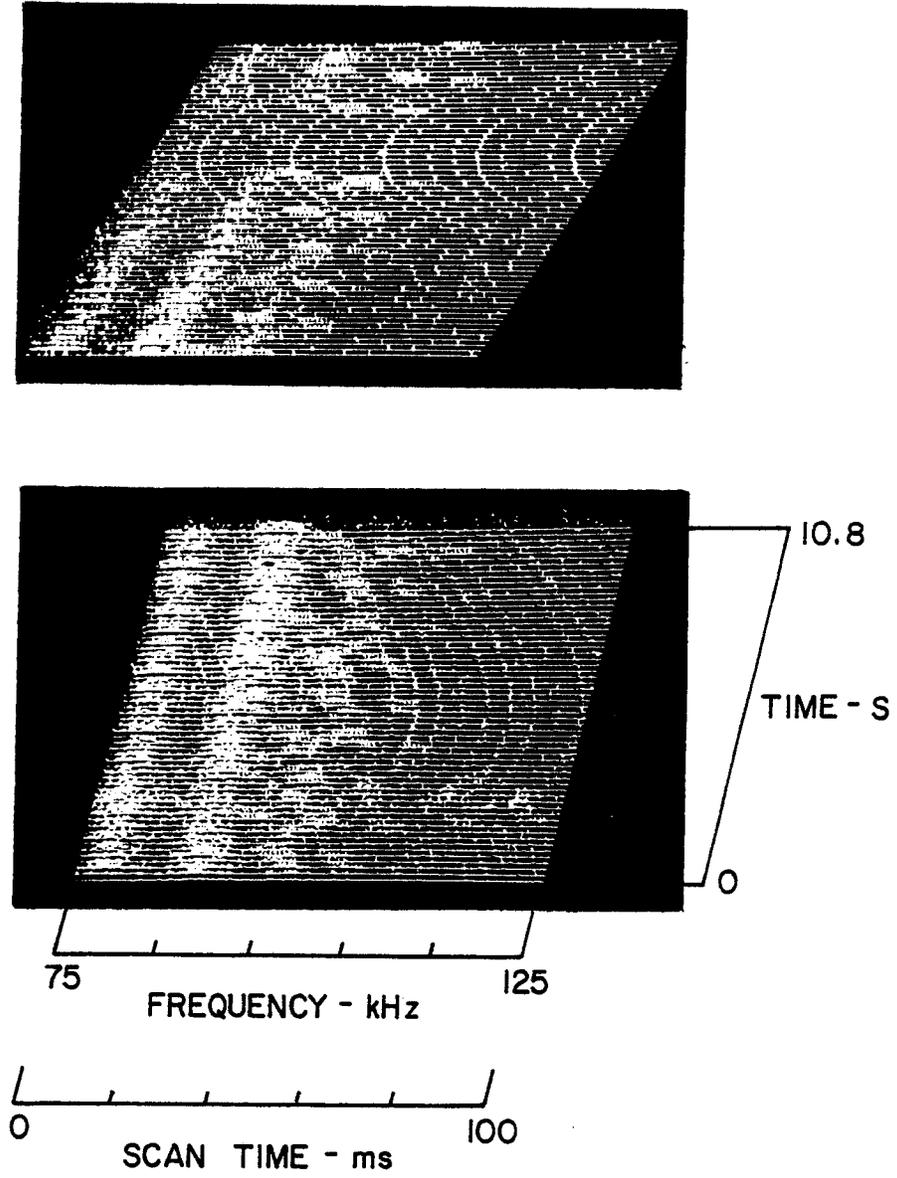
Figure 22 3-Axis View, 1/26/79, 0803, Harbor Freeway Ignition Noise

During the Phase II measurements a more noticeable type of ignition interference was present from a truck moving along a street parallel with the measurement van. When the truck was in a parallel lane of traffic and the engine area was in the vicinity of the whip antenna, consistent and longer duration ignition noise was observed, and ignition noise pulses occurred with amplitudes about equal to the Loran-C signals from Station Y. Two examples are shown in Figure 22. The curved lines show variations in the interval between ignition pulses as the truck engine RPM varied. At a highway speed of about 45 mph, the spacing from pulse to pulse was about 4 ms.

1/26/79, 0803, Harbor Freeway ignition noise (international truck)  
HP 140, Whip, F 100 kHz, W 50 kHz, IF 3 kHz, ST 100 ms, A -20 dBm/0/+15 dB/NF

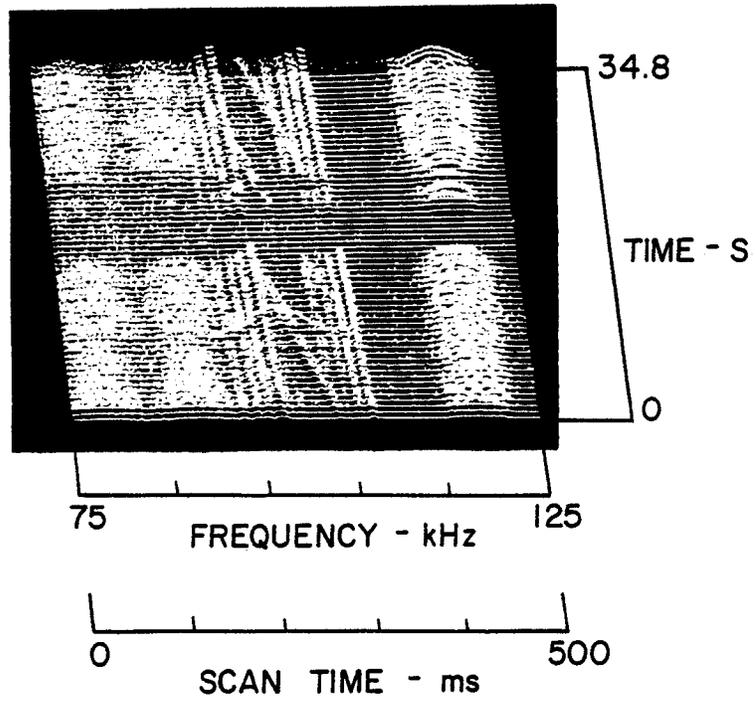
Figure 23 3-Axis View, 1/22/79, 1238, Harbor Freeway Underpass

Brief decreases in the strength of Loran-C signals and CW signals were observed as the measurement van passed under a cross street and through an underpass. The attenuation of the signals from the underpass structure is shown in Figure 23, where the van was traveling on the Harbor Freeway in an area containing occasional overhead street crossings. Also, a brief burst of CW signal at 100 kHz can be seen in Figure 23 about 1/4 of the way from the bottom scan line. The CW signal was observed immediately after passing through the underpass, and it probably originated from a traffic control sensor on the overhead street.

1/22/79, 1238, Harbor Freeway underpass  
HP 140, Whip, F 100 kHz, W 50 kHz, IF 3 kHz, ST 500 ms, A -20 dBm/0/+15 dB/NF

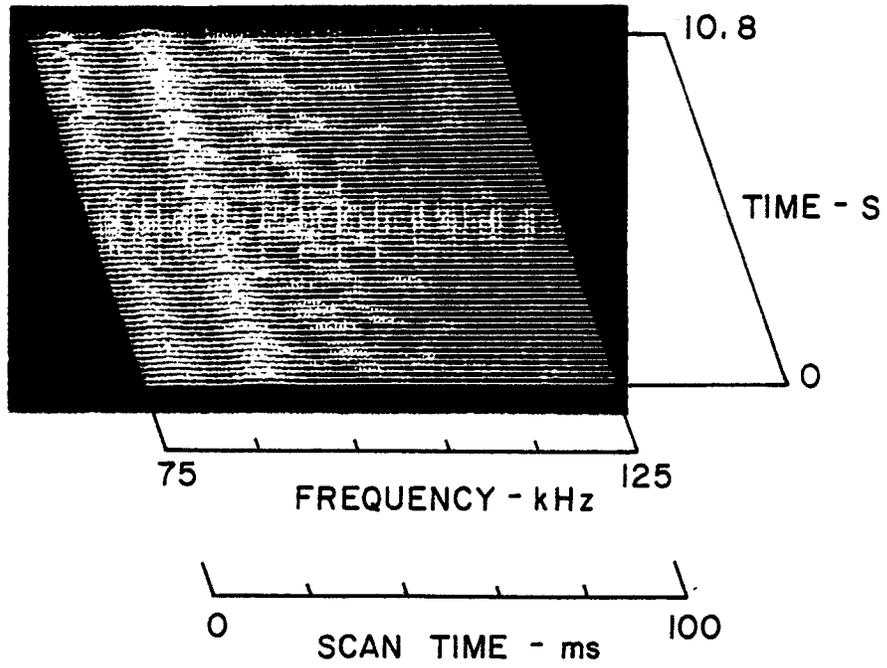
Figure 24 3-Axis View, 1/26/79, 0808, Harbor Freeway Overpass

Brief periods of impulsive noise were frequently observed when the measurement van proceeded along the freeway and traveled over a cross street on an overpass. An example is shown in Figure 24, where a burst of impulsive noise approximately two seconds long occurred. The noise probably originated from utility distribution lines along the cross street.

1/26/79, 0808, Harbor Freeway overpass impulse noise  
HP 140, Whip, F 100 kHz, W 50 kHz, IF 3 kHz, ST 100 ms, A -20 dBm/0/+15 dB/NF

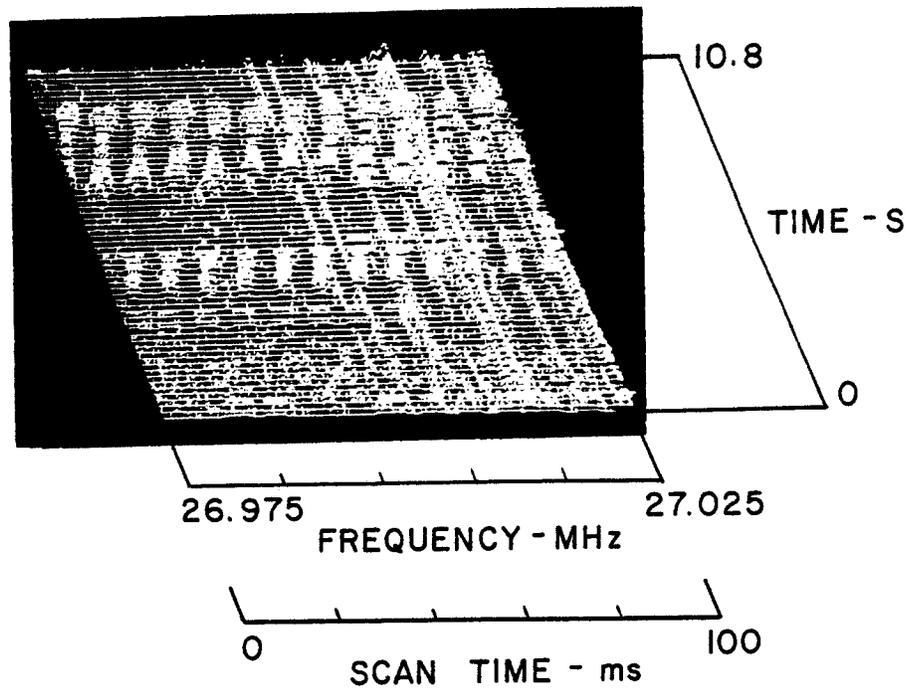
Figure 25 3-Axis View, 1/26/79, 1017, Rosecrans  
between Sepulveda and Vista Del Mar

Bursts of noise were observed to be emanating from a high voltage utility transmission line crossing Rosecrans between Sepulveda and Vista Del Mar. These bursts are shown in Figure 25. Two bursts of noise can be seen in the upper portion of the view, each with a duration of about one second and spaced about 0.2 seconds apart. Downward in the view about 1.5 seconds further, another one-second burst of noise can be seen. About 0.4 seconds further down the view, two closely-spaced, very brief bursts occurred.

Signal structure during each burst had maximum and minimum energy at 8.3 ms intervals as shown by the slanting lines within each noise burst. Also, the maximum overall strength of the bursts peaked as the measurement van passed directly under the overhead transmission line.

1/26/79, 1017, Rosecrans  
HP 140, Whip, F 27 MHz, W 50 kHz, IF 3 kHz, ST 100 ms, A -10 dBm/0/0/NF

Similar bursts of power line-associated noise have been observed in prior measurements at sites in Los Altos Hills, California, and Skaggs Island, California. The noise bursts have been observed to occur for periods up to a few hours and then to disappear for long periods of time. Their origin has not been determined, and possible source mechanisms have been the subject of much speculation. The on-off noise bursts remain a puzzle. While the Rosecrans transmission line provided a case where the source could probably have been tracked down with a small additional measurement effort, the time was not available for additional diagnostic effort.

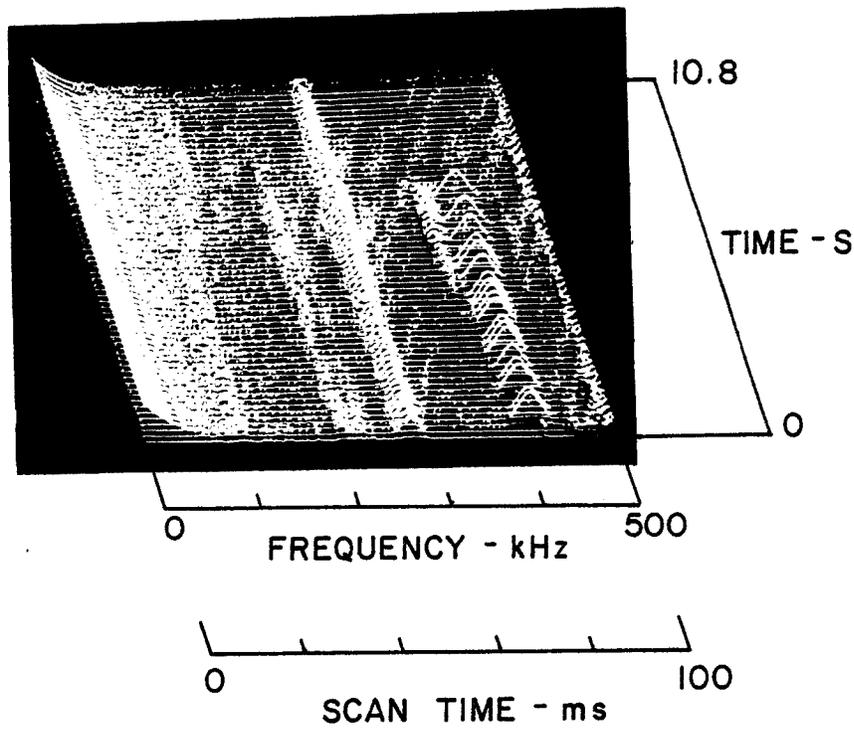
Figure 26 3-Axis View, 1/26/79, 1042, Vista Del Mar

Power line-associated noise was investigated at the output transmission lines for the Southern California Edison El Segundo power plant. The measurement van passed directly under the output lines on Vista Del Mar immediately adjacent to the power plant. Noise was not observed on a typical Loran-C measurement pass directly under the line. On a subsequent measurement pass, the receiver scan width was increased to cover the 0 to 500 kHz band as shown in Figure 26. Very weak slanting lines can be seen in portions of the view which were synchronized with the electric power frequency. Also, a brief and weak CW signal was observed at about 380 kHz when the measurement van was directly under the transmission line.

1/26/79, 1042, on Vista Del Mar passing under El Segundo power plant output lines  
HP 140, Whip, F 250 kHz, W 500 kHz, IF 10 kHz, ST 100 ms, A -20 dBm/0/0/NF

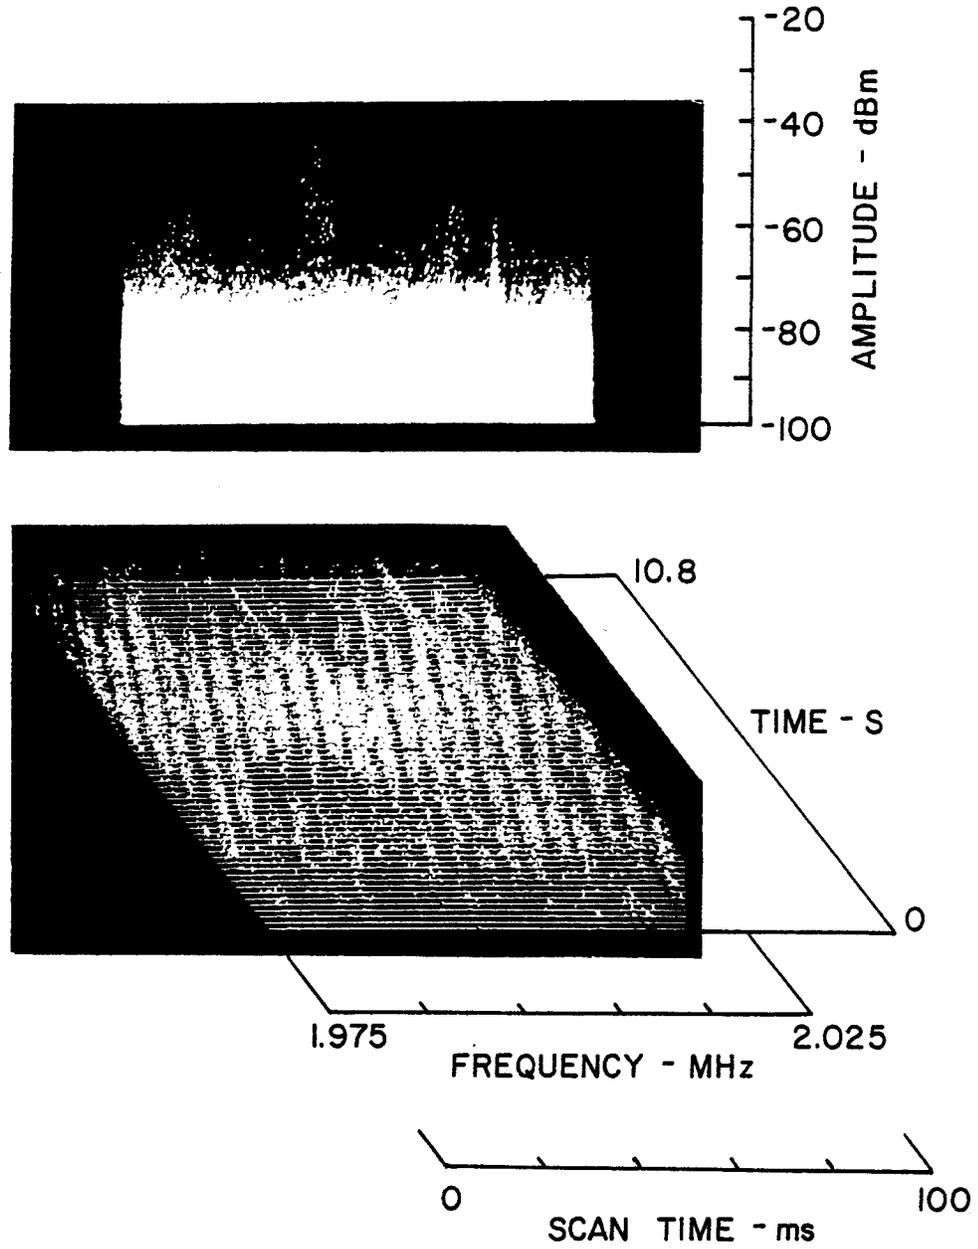
Figure 27 3-Axis View, 1/26/79, 1038, Vista Del Mar

Since very little power line-associated noise was observed at LF frequencies, an additional measurement was made in the 2 MHz region, as shown in Figure 27. Low levels of power line-associated noise were observed when directly under the line. This noise could not be detected a few hundred feet from the transmission line.

1/26/79, 1038, on Vista Del Mar and passing under output lines El Segundo power plant  
HP 140, Whip, F 2 MHz, W 50 kHz, IF 3 kHz, ST 100 ms, A -20 dBm/0/0/NF

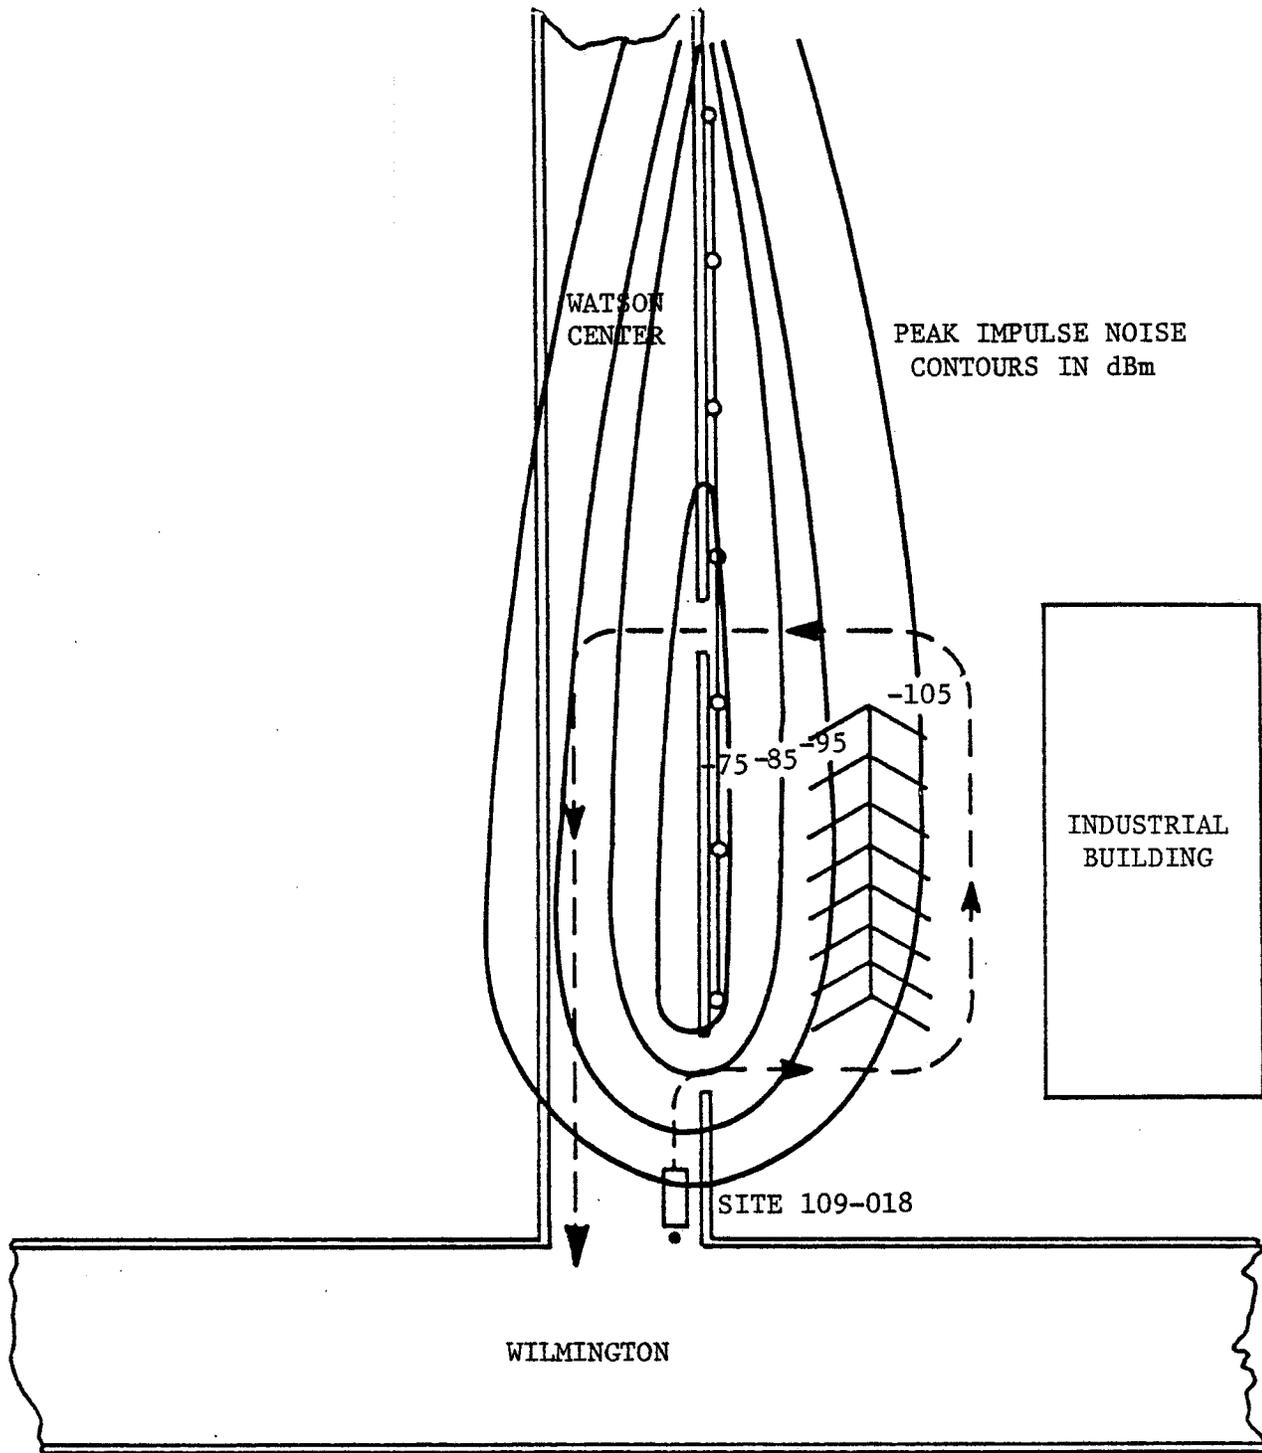
Figure 28 Physical Layout of Site 109-018

Sufficient measurements were taken at and around site 109-018 (Watson Center/Wilmington) to establish approximate fine scale contours of peak impulsive noise levels for the immediate area. Figure 28 shows the main physical features of the site including the location of a nearby utility distribution line which radiated significant impulsive noise. The distribution line ended about 100 feet from the 109-018 site. Ten dB contours of noise (see Figures 13, 14, 15, and A-29 for noise detail) are superimposed on the physical map. The contours of peak impulsive noise level show very low noise levels at site 109-018 itself and high noise levels when closer to the distribution line. The noise level decreased somewhat with distance along the distribution line along Watson Center, causing the contours to pinch inward near the top of the area shown. The distance scale on the map shows the relatively small area with significant levels of impulsive noise. A vehicle with a Loran-C receiver turning off Wilmington onto Watson Center would abruptly encounter impulsive noise shortly after the turn. The noise would gradually decrease in level as the vehicle proceeded along Watson Center.

The noise contours in Figure 28 show the relationship between the impulsive noise encountered by a Loran-C receiver installed in a vehicle and the noise radiator (a 13.6 KV distribution line). Similar contour maps can be established for all other noise and CW signals found in the Phase I and Phase II effort with a few additional measurements and a description of the physical properties of the noise radiator.

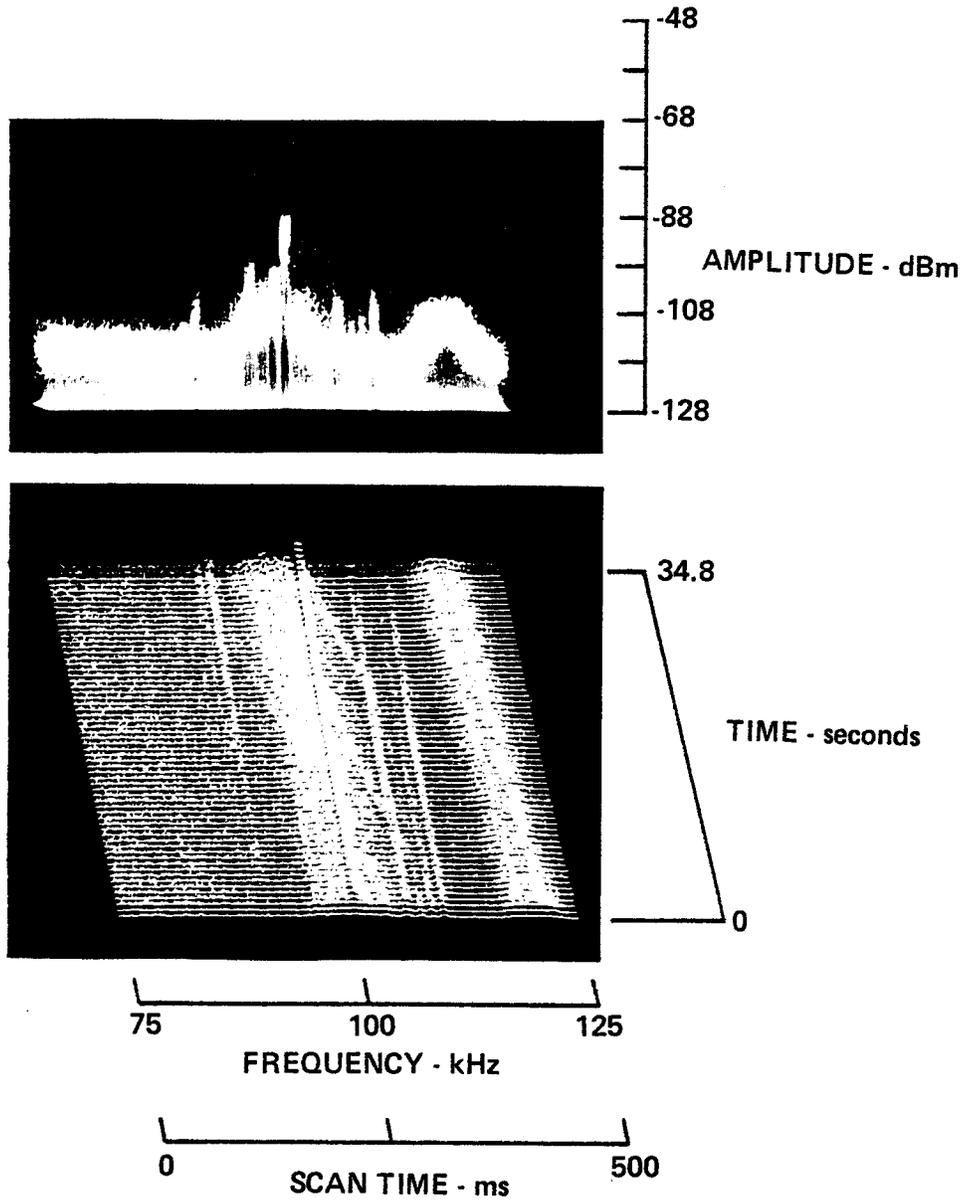
1-22-79, 0831, 106-001  
HP140, Whip, F100, W50, IF3, ST 500, A -30/0/+18/BPF

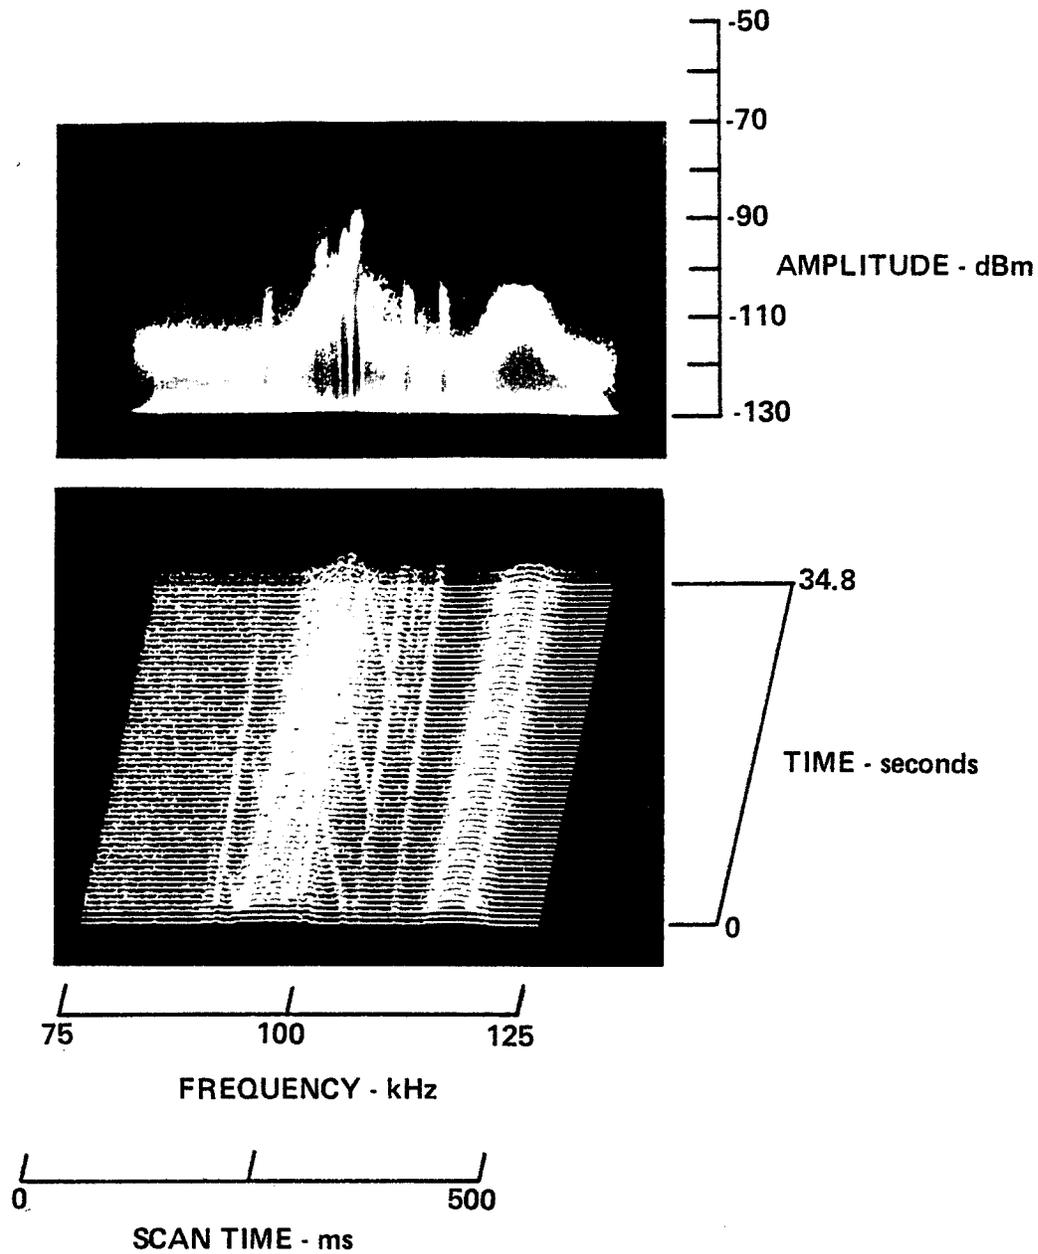
1-22-79, 0845, 106-002  
HP140, Whip, F100, W50, IF3, ST 500, A -32/0/+18/BPF

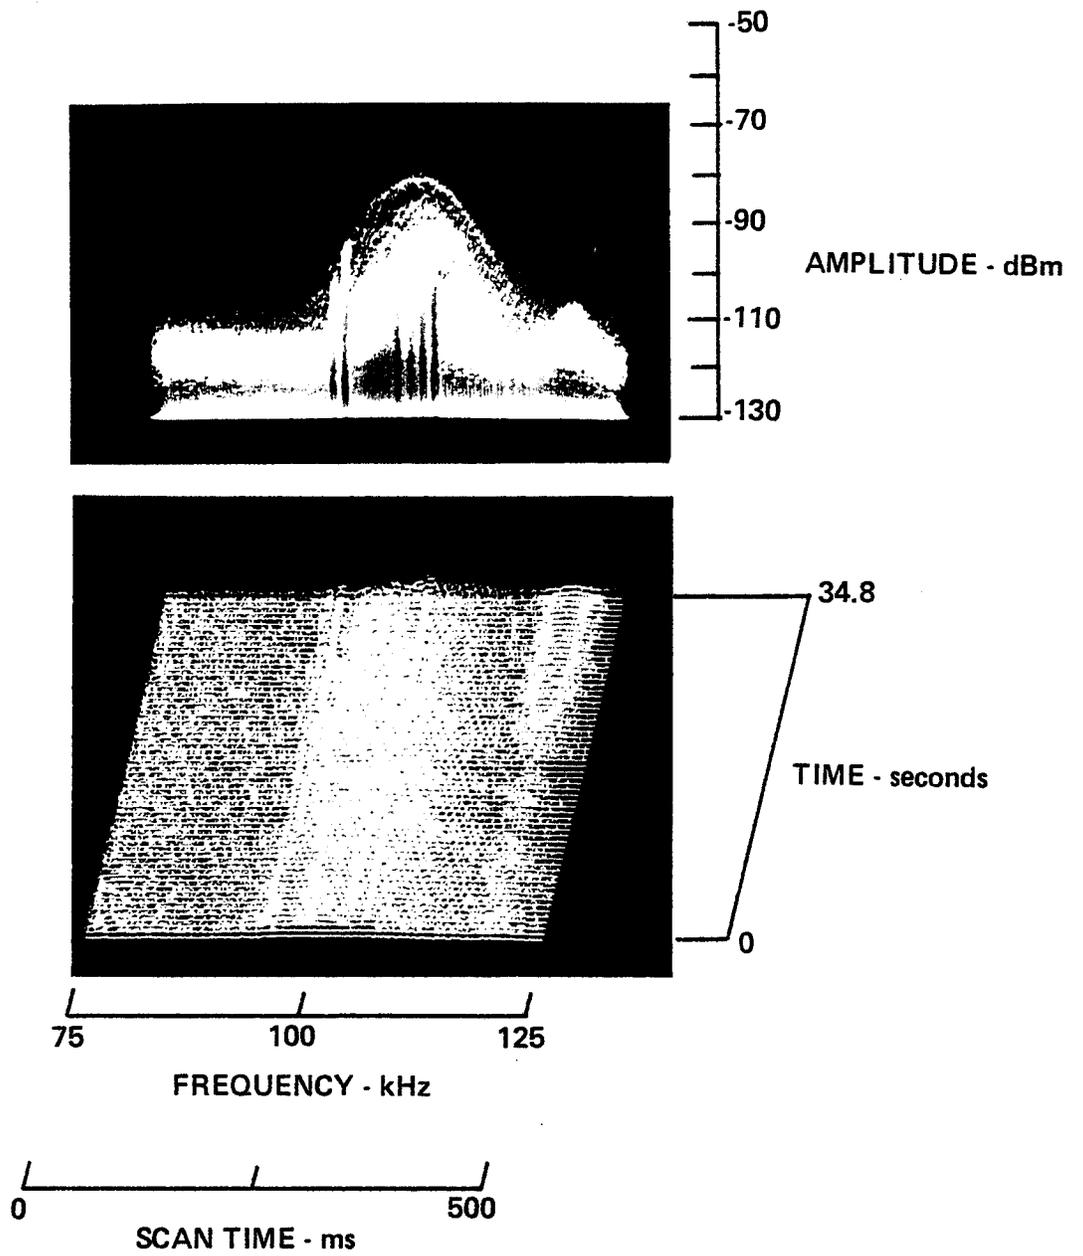
1-22-79, 0905, 106-003 (under 12 kV line)  
HP140, Whip, F100, W50, IF3, ST 500, A -32/0/+18/BPF

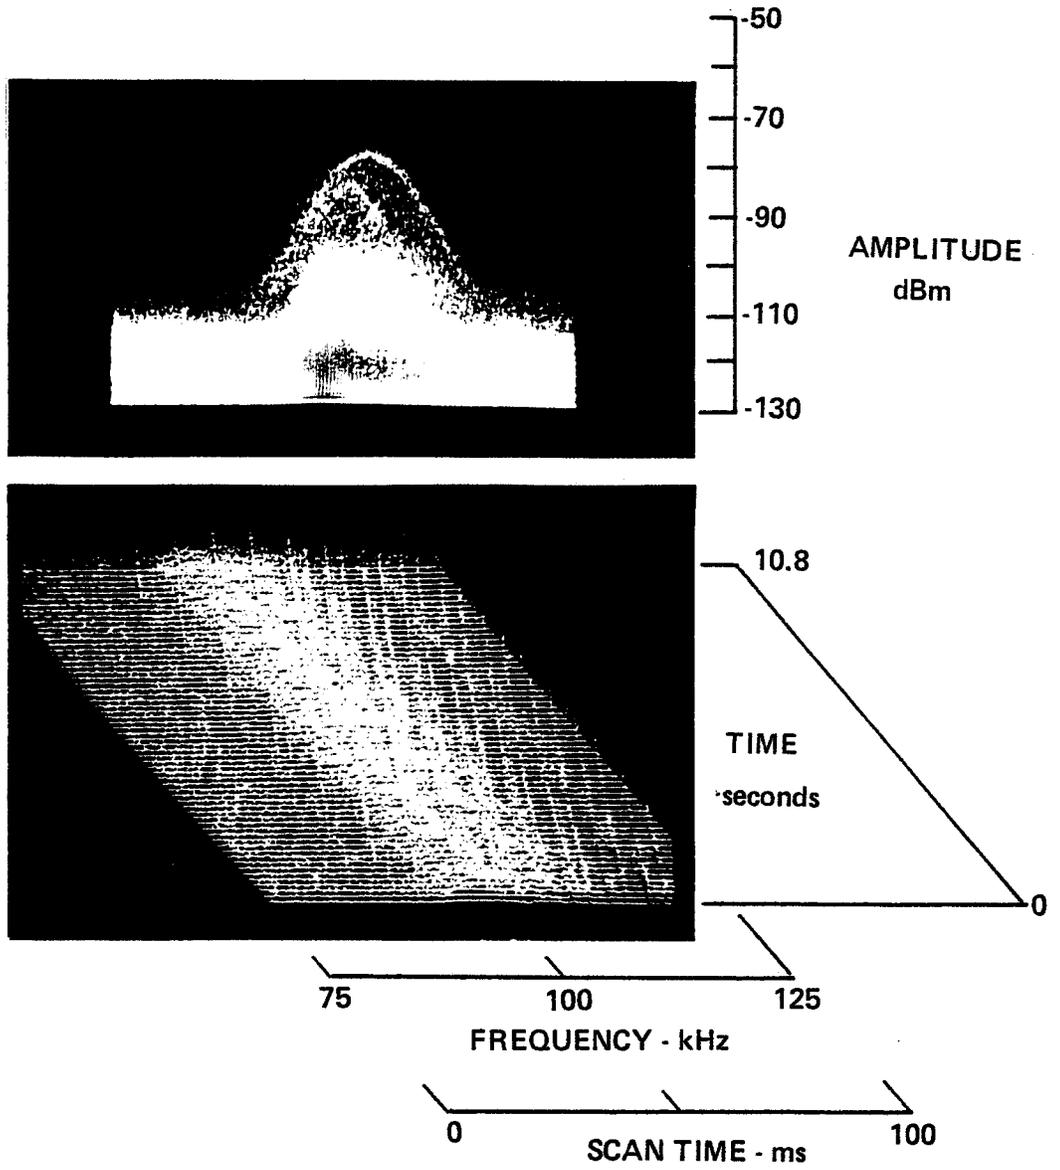
1-22-79, 0928, 106-003 (under 12 kV line)  
HP140, Whip, F100, W50, IF3, ST 100, A -32/0/+18/BPF

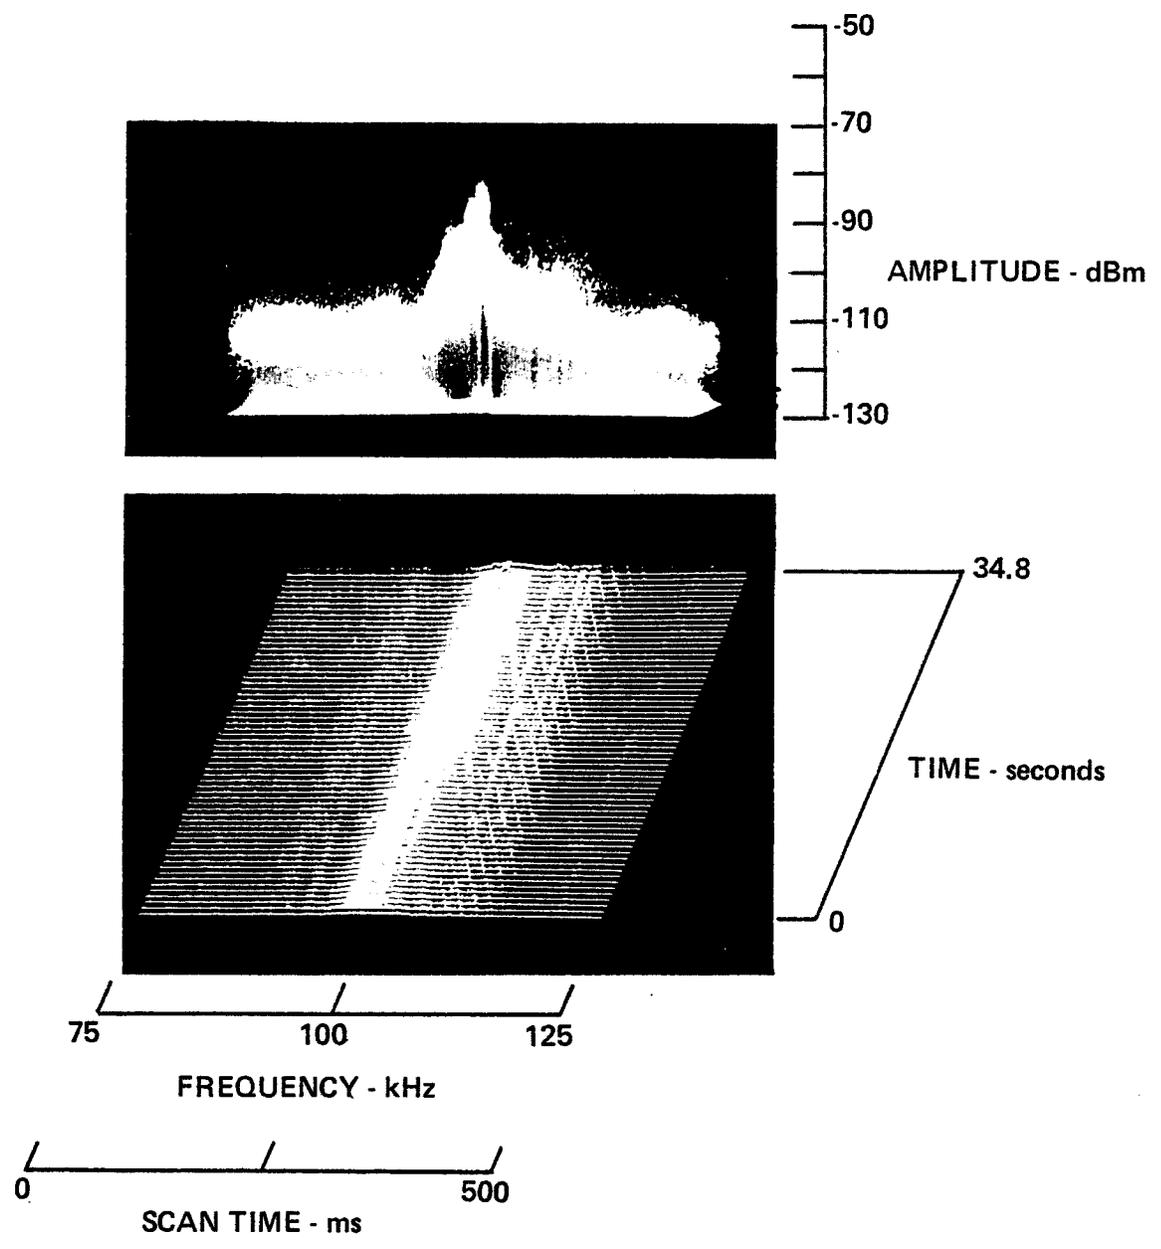
1-22-79, 0946, 106-004  
HP140, Whip, F100, W50, IF3, ST 500, A -32/0/+18/BPF
