From: kit [kit@ka0wuc.org]
Sent: Thursday, October 07, 2004 4:06 PM
To: Anh Wride; Alan Stillwell; Riley Hollingsworth; James Burtie; Sheryl Wilkerson
Cc: w1rfi@arrl.org
Subject: BPL comments

Cottonwood Arizona, and BPL

During the weekend of September 25th, 2004 a road trip was taken to Cottonwood, Arizona. The destination is nationally known for the BPL (Broadband over Power Lines) test site by APS (Arizona Public Service) using equipment manufactured by Mitsubishi. Data was collected at the three sites in the Cottonwood area; Sawmill Cove, American Heritage Academy, and Birch Street. The purpose of the trip was to measure, and gain a better understanding of BPL technology. To understand the effects of BPL, test equipment was verified for calibration, and a method of measurement was established.

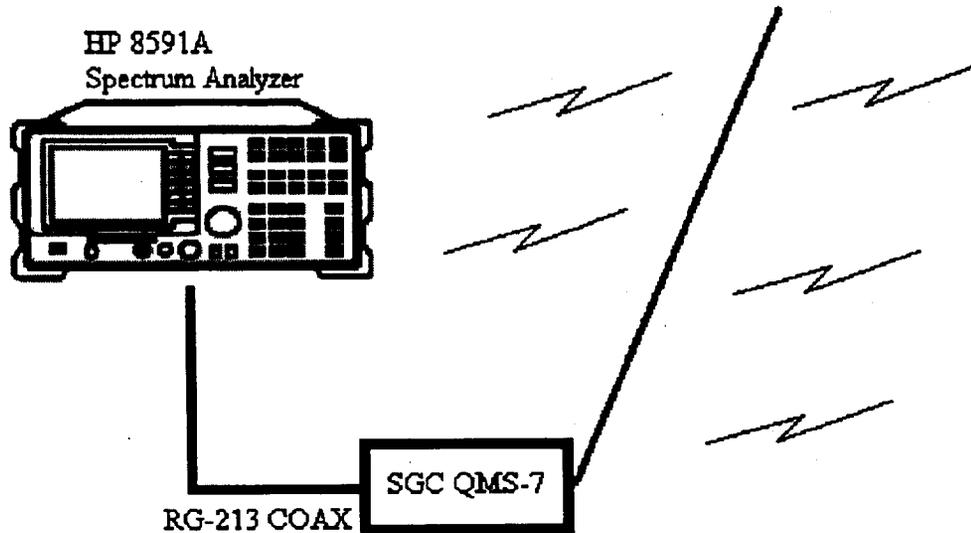
(Figure 1. Test setup)

Above is a block diagram showing the test configuration used for measuring the BPL signals. The QMS-7 with the 7-foot whip antenna was mounted on the lift gate of a 1996 Jeep Cherokee. The RG-213 was attached to the spectrum analyzer with a SO-239 to N male adaptor, as the instrument has an N female jack on the front.

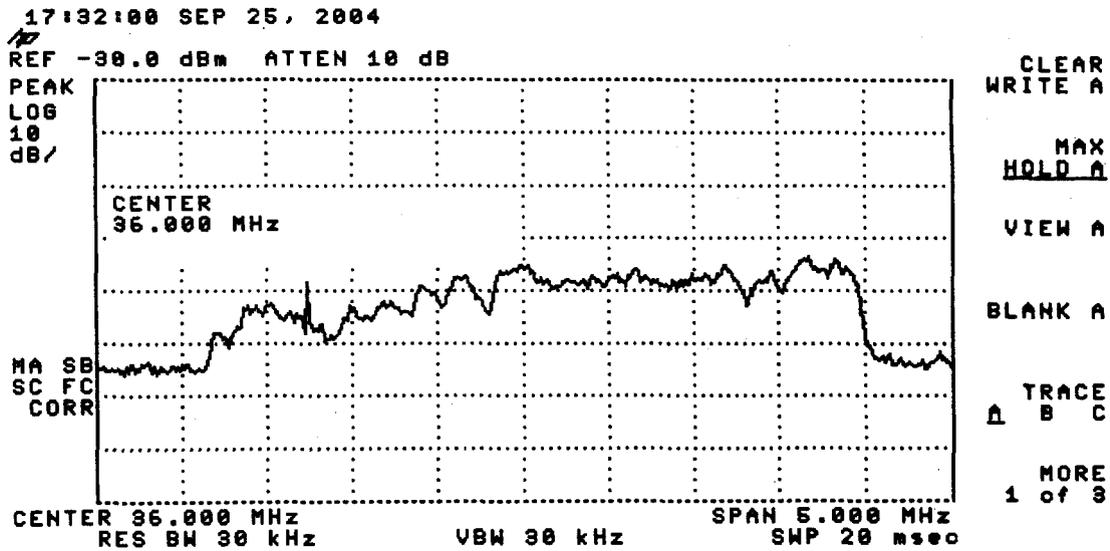
(Plot 1)

A sample of HF spectrum around 36Mhz, the width of the span is 5Mhz; each division is 0.5MHz. The range of the plot is from 33.5Mhz to 38.5Mhz, there are no HF amateur bands in this portion of the spectrum. The signal is on average S9+ on an HF receiver.

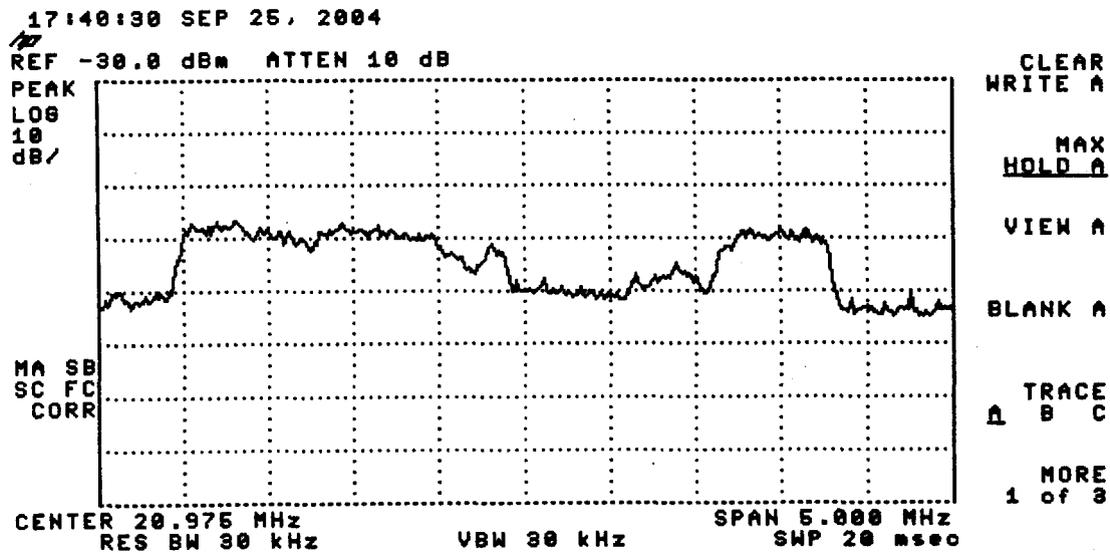
(Plot 2)

This plot shows a second set of carriers, 18Mhz and 22Mhz at -60dBm. The 4th vertical column from the far right is the amateur 15-meter band (21.100MHz to 21.450MHz). The signals represent S9+10dB on an HF receiver.

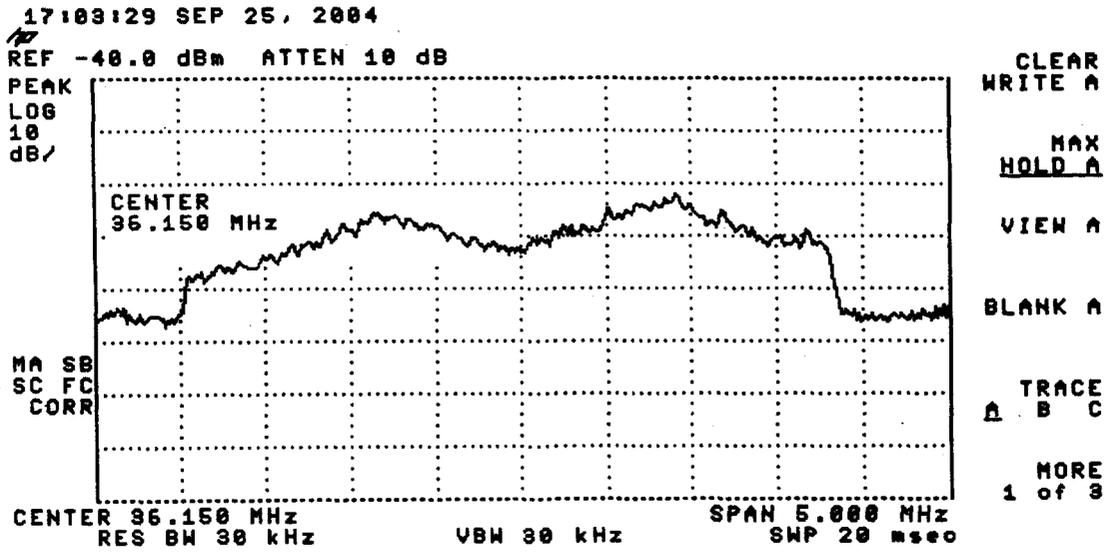
(Plot 3)

The signal looks like two broadband carriers positioned side-by-side in the spectrum. These carriers are not within amateur radio allocation, but again sampled to learn the effects of BPL. When monitored with a HF receiver the signal strength would exceed S9+10dB.

To determine the field strength of the measured signals on the spectrum analyzer, the frequency and amplitude must both be known. Looking on plot #3 from American Heritage Academy, it shows a point around 35MHz that is approximately -65dBm .

$-65\text{dBm} + 107\text{dB} + 12.3\text{dB (Antenna Factor at 35MHz)} = 54.3\text{dB}\mu\text{V/m}$

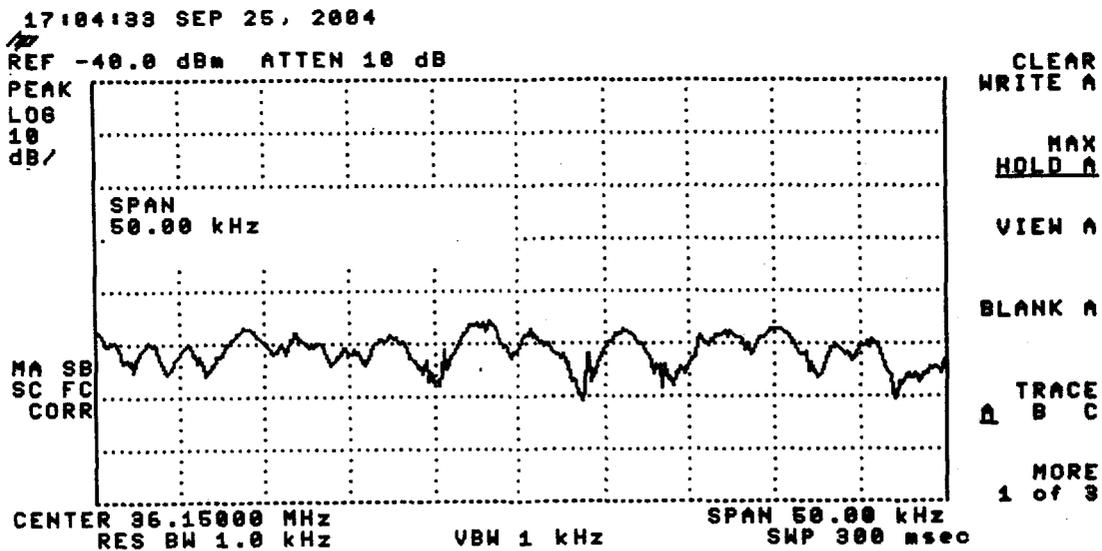
(Plot 4)

Span zoomed to show individual carriers randomly spaced near 5KHz from each other. As the ICOM R-10 receiver was tuned anywhere between 34.150MHz and 37.900MHz a tone with a cyclic clicking was heard on the receiver in the following modes: CW-N, USB, and LSB.

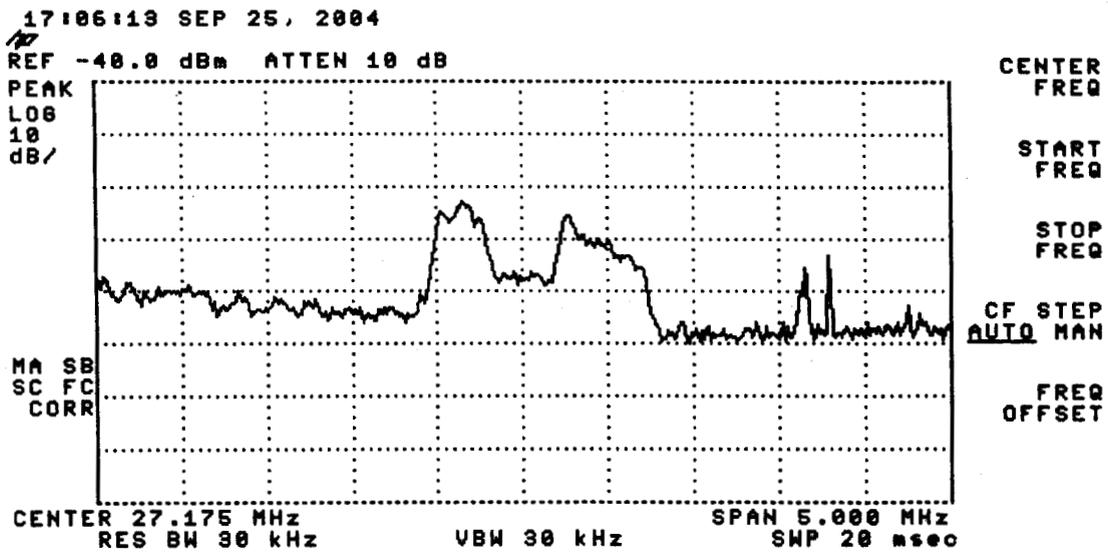
(Plot 5)

These carriers were also noticed, and are in the Citizens Band portion of the HF spectrum. While watching the site in a broader span, these carriers along with the carriers present at 36MHz came up and down together.

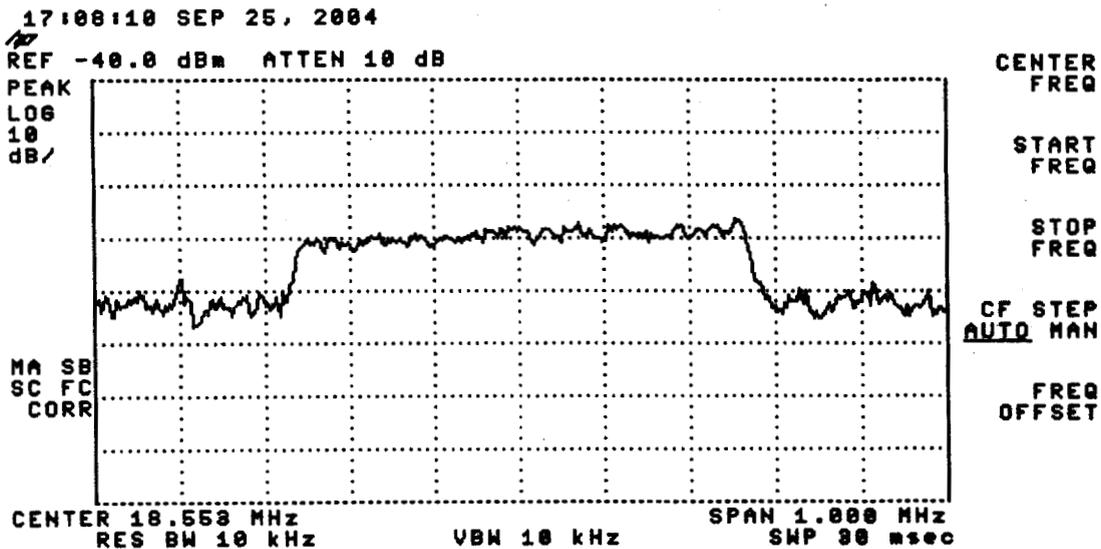
(Plot 6)

This carrier is centered on 18.55MHz, but with a bandwidth of 600KHz, it does approach the 17-meter band (18.068MHz to 18.168MHz) at a level equal to S9+ on an HF receiver.

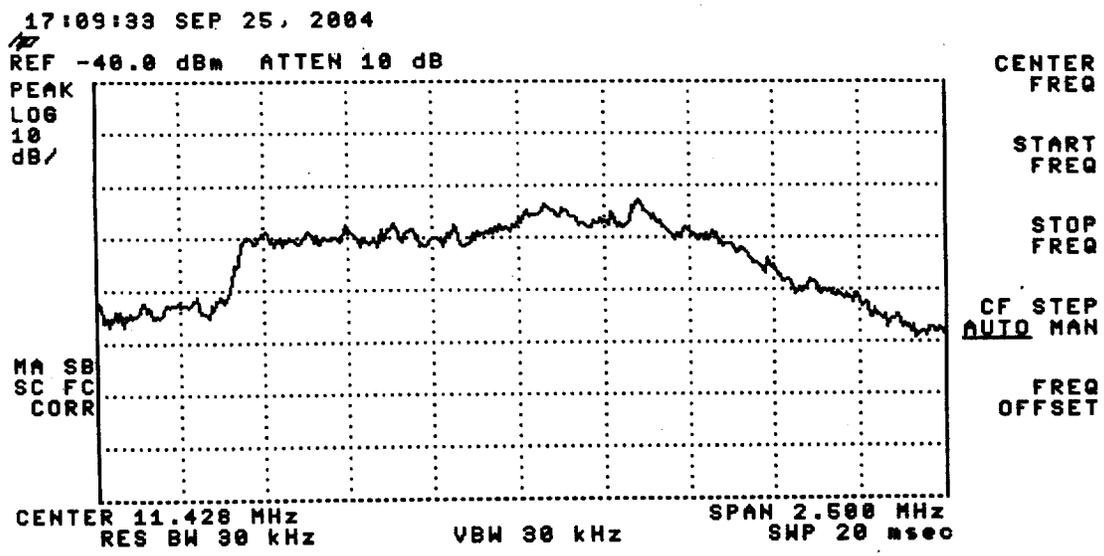
(Plot 7)

This carrier is also out of the amateur radio bands, but is close enough to interfere with 10MHz WWV reception. I was able to receive 10MHz WWV when this site was at least ¼ mile away. As I approached this BPL test site, the noise floor captured the receiver. This carrier also hampers the ability for amateur radio operators to use the 30-meter band (10.100MHz to 10.150MHz) with a reading approaching S9+ on an HF receiver.

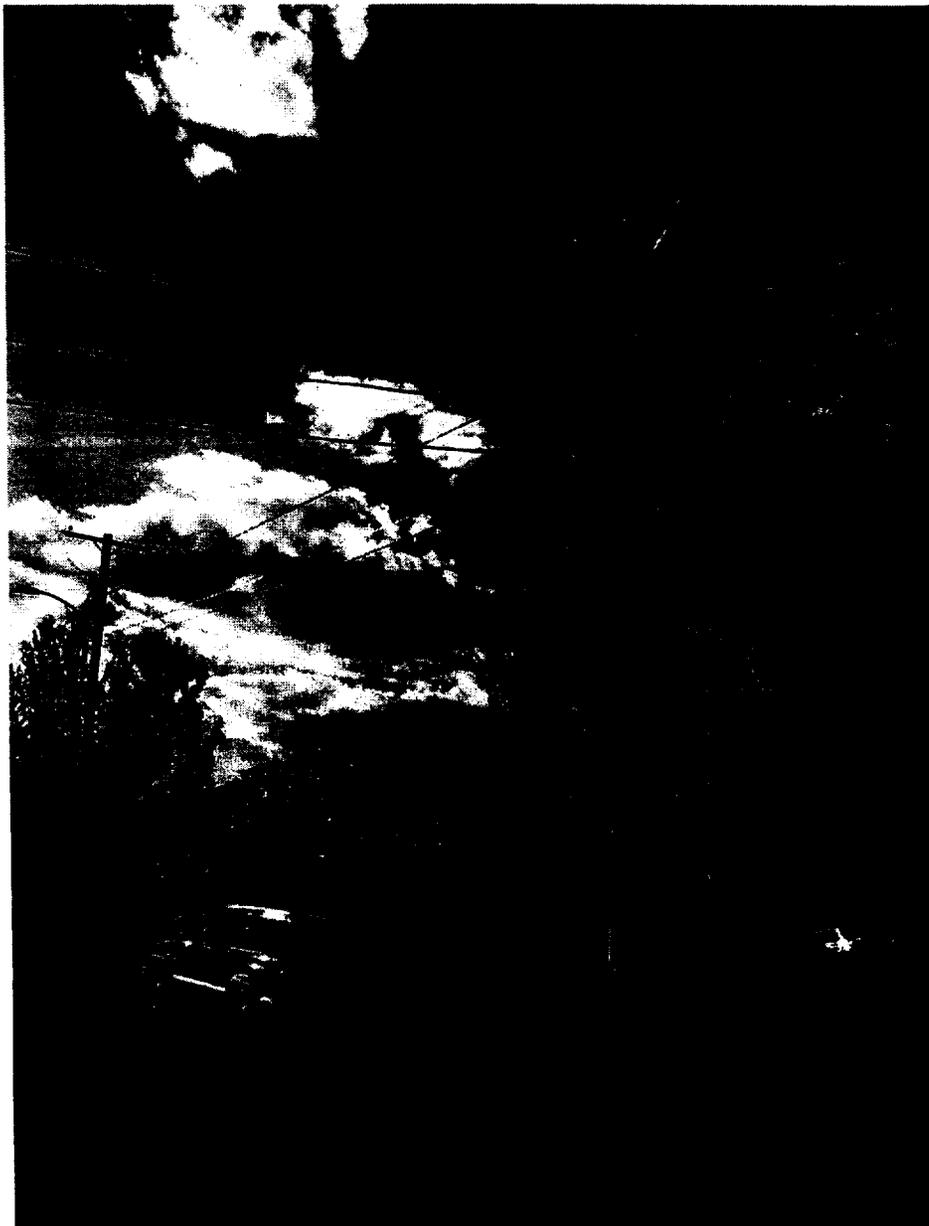
(Photo 6)

Birch Street shown with the equipment mounted on the pole on the right side of the photo. The Jeep was moved around this block and found uniform signal strength from the BPL equipment. The vehicle was positioned 10meters from the coupling point of the BPL equipment when the measurements were taken.

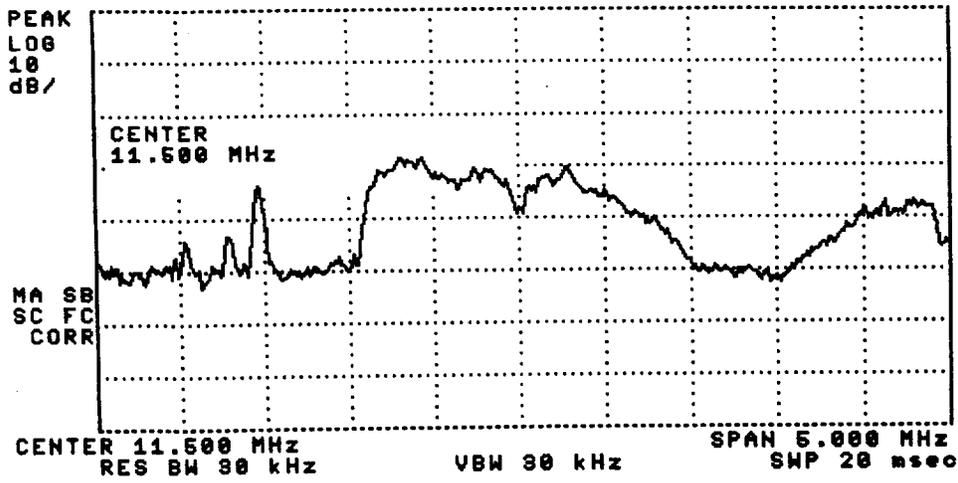
(Plot 8)

The carriers centered around 11.5MHz are strong enough to interfere with 30-meter (10.100MHz to 10.150MHz) operations. WWV on 10MHz was difficult to receive.

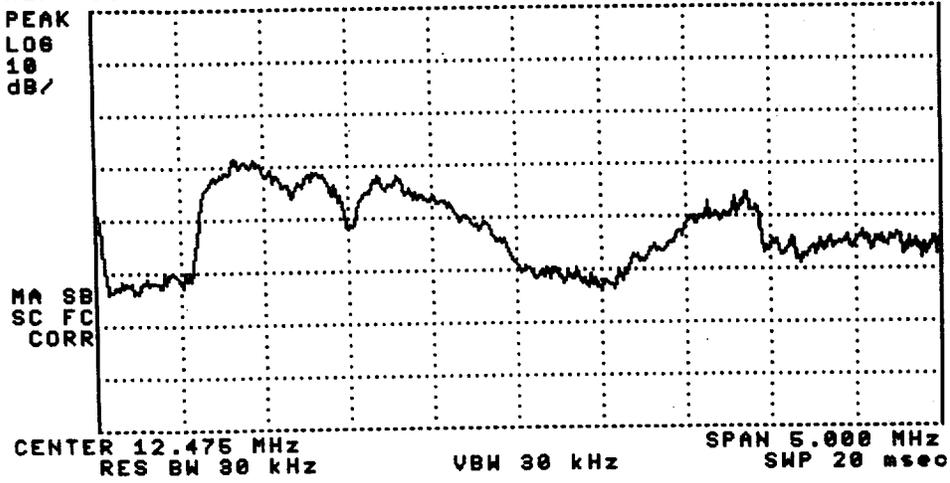
(Plot 9)

Additional carriers from the same BPL test site are present around 12.5MHz. This is strong enough to eliminate any ability to receive short wave broadcast services.
