CEDAR RAPIDS, IOWA, BPL Trial System Radio Frequency Interference Tests

Cedar Rapids BPL Steering Committee
June 18, 2004

1. EXECUTIVE SUMMARY

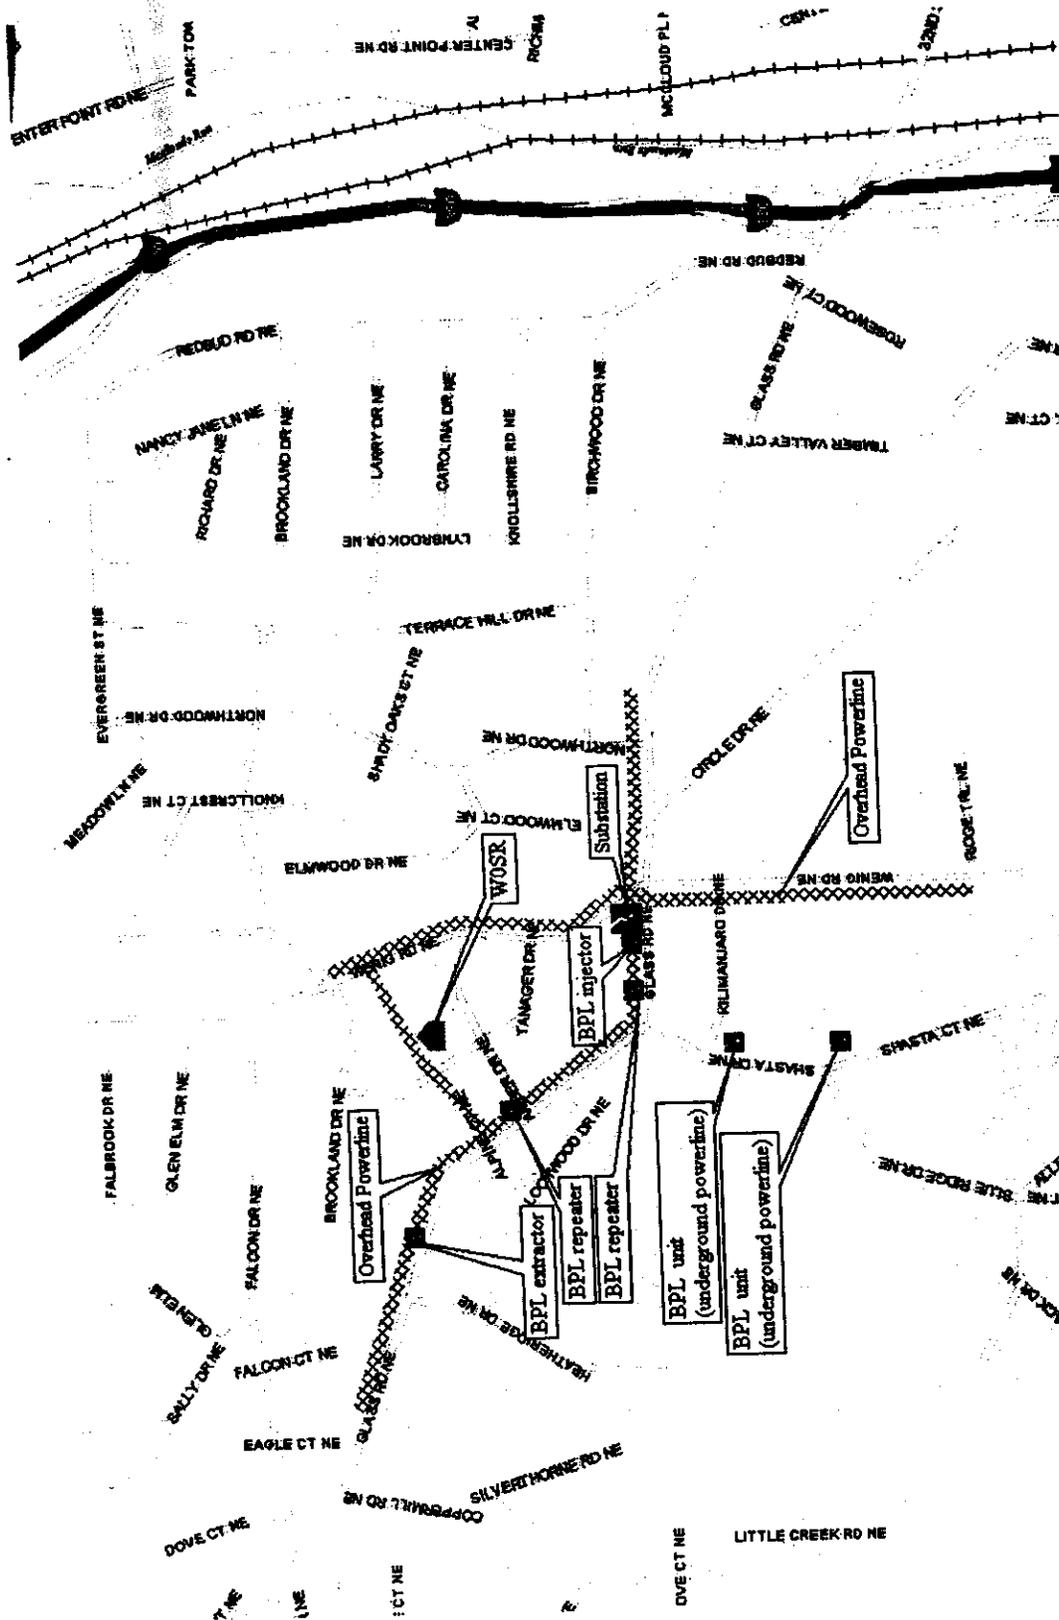
Figure 3-1: Map of BPL trial area and location of the W0SR station and residence (North is top of map.)

The Alliant Energy trial BPL system includes a segment of overhead medium voltage distribution lines, as well as a short segment of buried medium voltage distribution lines. This BPL system is configured to interface with subscribers via Wi-Fi (antenna located on each test unit), and the system runs along Glass Road. Figure 3-1 is a map which shows the geographic relationship between the BPL trial system along Glass Road and Mr. Spencer's residence. The map shows the location of the BPL trial system hardware as it existed at the time of testing, and it helps to understand the location of Mr. Spencer's residence and antenna system relative to both the actual BPL trial lines and other neighborhood power distribution lines that connect to the BPL trial lines, but which are not intentional data carriers at this time.

Note that the Spencer residence is not located directly adjacent to any lines carrying the BPL test signals. Mr. Spencer's antennas are approximately 183 meters (600 feet) from the Glass Road lines. They are approximately 30.5 meters (100 feet) from the distribution line which runs just northwest of the property.

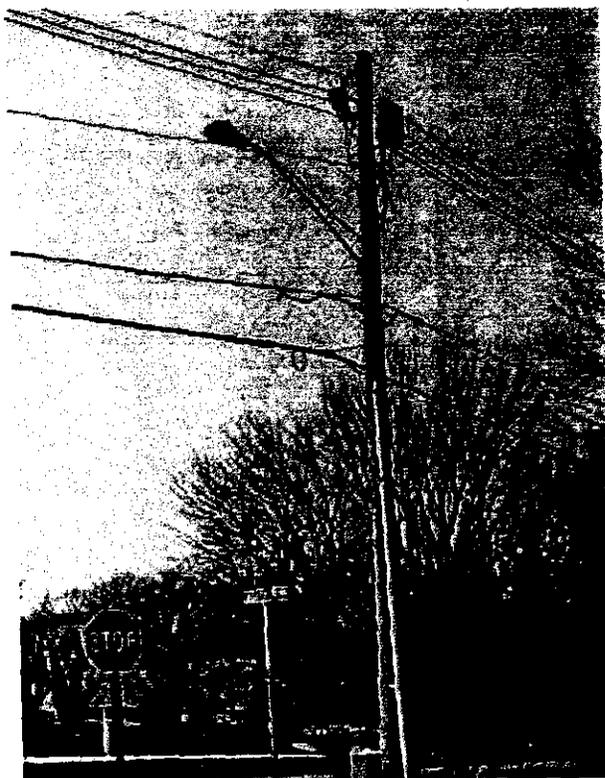
The actual BPL hardware nearest to Mr. Spencer's Amateur Radio station is at the intersection of Glass Road and Amber Drive, shown below. (The BPL repeater is the gray box located on the right hand side of the power pole, near the top.)

Figure 3-2: BPL Repeater at intersection of Glass Road and Amber Drive

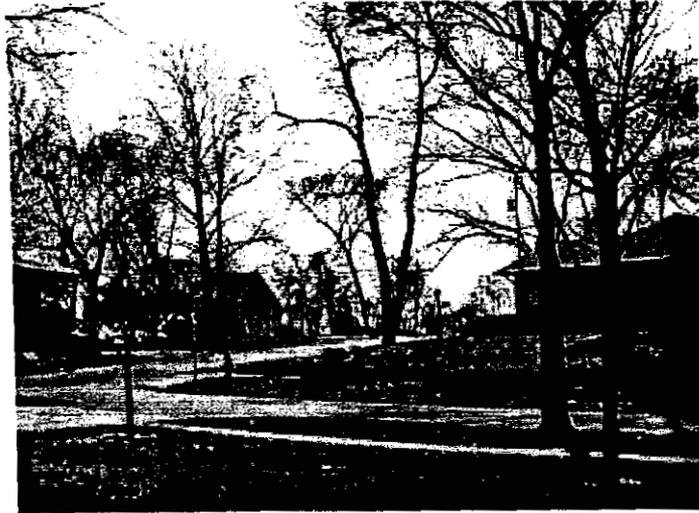
Figure 3-3: Intersection of Amber Drive and Tanager Drive, as viewed from the Spencer residence

This location is southwest of the Spencer residence. Figure 3-3 is a view taken from Mr. Spencer's property looking toward the northeast. The roadway extending across the picture, in the foreground, is Tanager Drive, which runs approximately northwest-southeast in this area and is generally parallel to Glass Road. The intersecting roadway is Amber Drive. The power lines carrying the BPL signals along Glass Road are visible in the background.

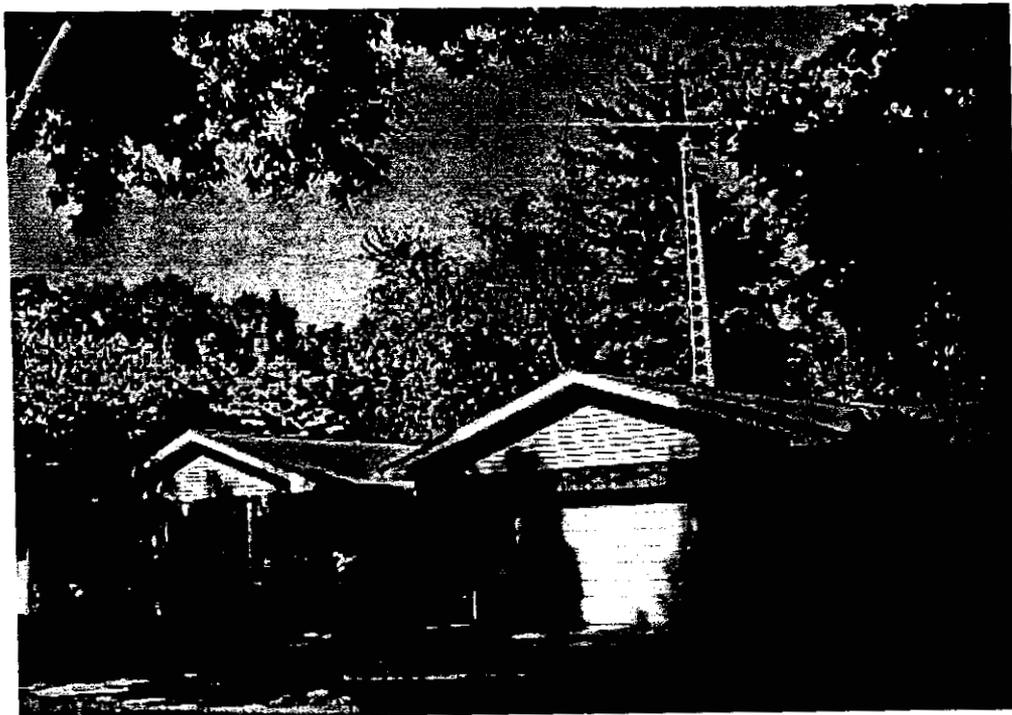
Figure 3-4 is a view of Mr. Spencer's residence looking toward it from the direction of the Amber Drive-Tanager Drive intersection. Not clearly visible, but present in the background of this photo, are another set of overhead power lines which run approximately east-west (shown in Figure 3-1 map in blue) and appear to be a branch-off from the Glass Road lines. (A small portion of the branch power line is visible in the area just above the house roof.)

Figure 3-4: View of the Spencer residence showing front of the house and the back yard antenna tower. Other neighborhood distribution lines are visible above the house roof, in the open sky area.

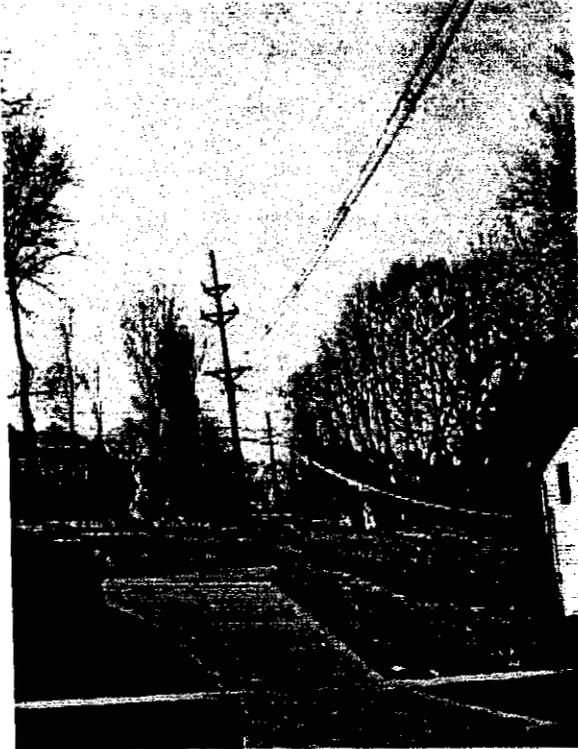
Figure 3-5: View to the west from Tanager Drive, looking toward Glass Road. These power lines are connected to Glass Road lines, but are not equipped with BPL communications hardware boxes. These lines are just west of the Spencer residence.

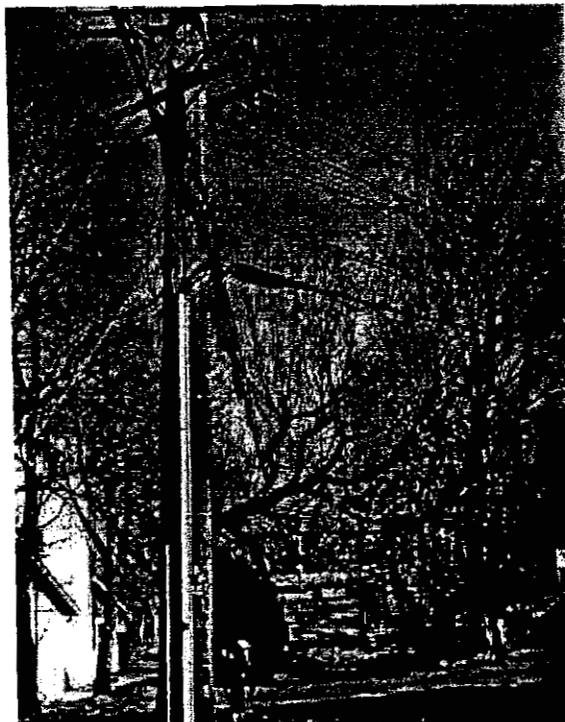
Figure 3-6: View to the east from Glass Road looking toward Tanager Drive. This is the connection point for the above circuit.

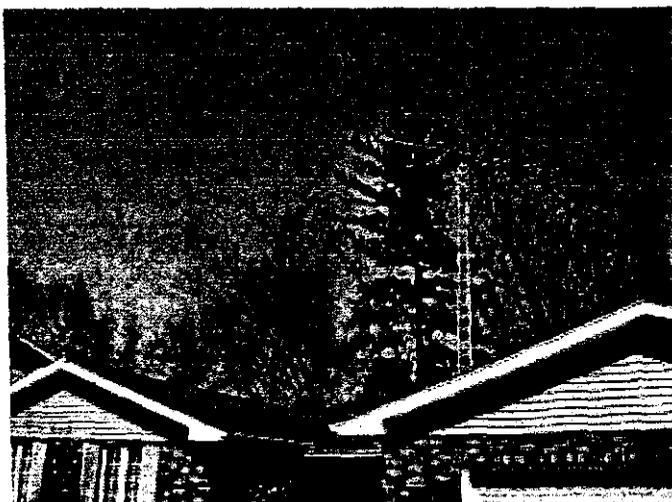
Figure 3-7 shows the antenna support tower and some of the antennas used in the operation of station WØSR. This view is toward the front of the house.

Figure 3-7: View from Tanager Drive of WØSR antenna tower

The antennas and related hardware in use at WØSR are as follows:

- ❖ Tower: Commercial self-supporting steel type, 48 feet overall height
- ❖ Antenna mounting: Side arms on tower for wire antennas; rotating mast for the Tri-Band Beam and WARC Dipole.

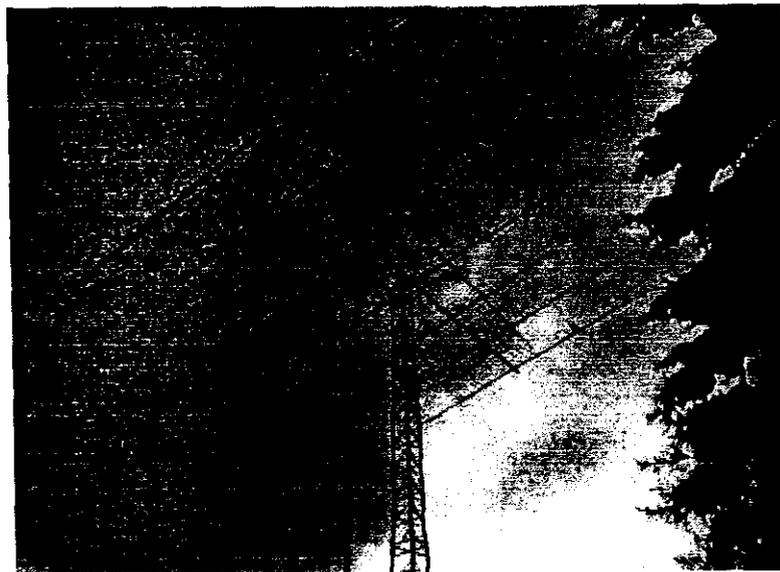
Figure 3-8: General view of antennas: (top to bottom) WARC band dipole; TH7-DXX Tri-Bander; side arm support for Inverted-V; top of ground-mounted vertical is in foreground.

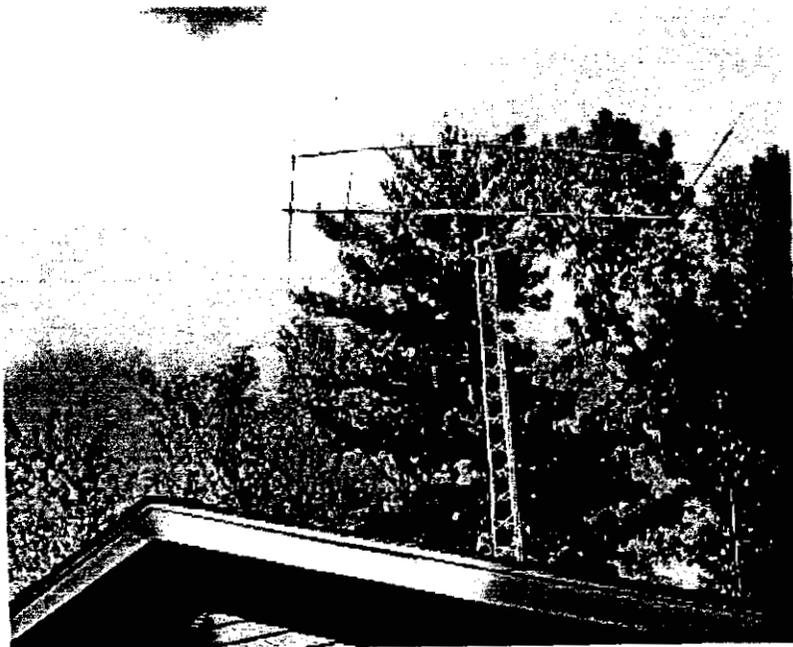
Figure 3-9: The 160m Inverted-L antenna is a horizontal wire visible to the left of the tower, above the roof peak.

- ❖ 160 m Antenna (1.8 to 2.0 MHz): Inverted-L (wire) supported by the tower at 46 feet, coax is RG-58, 32 feet long. This antenna runs from the tower at a compass bearing of approximately 240 degrees.

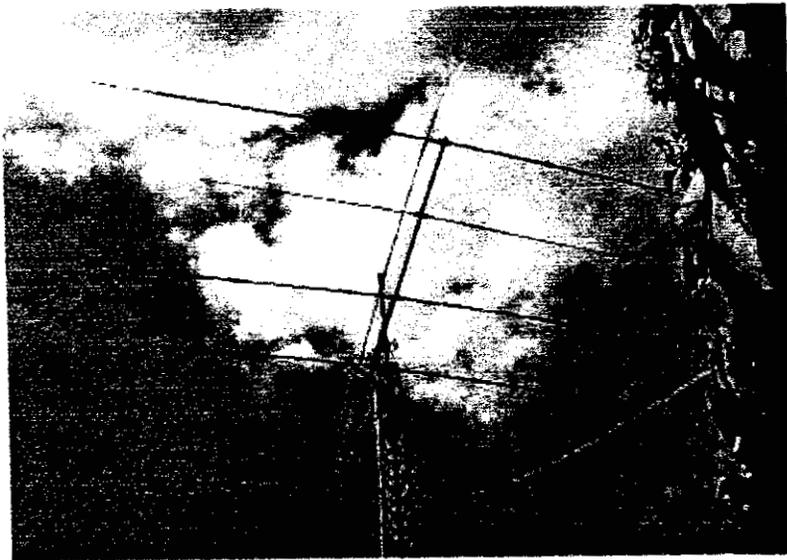
Figure 3-12: Tri-Band Beam and WARC Dipole, and one side of the 40m Inverted-V

- ❖ Tri-Band Beam³: Hy-Gain™ TH7-DXX (Yagi-type) at 49 feet fed with RG-213 coax, 75 feet long. This antenna is rotatable.
- ❖ WARC Dipole⁴: Cushcraft™ D3W rotatable dipole at 54 feet fed with RG-213 coax, 80 feet long. The antenna is a single element dipole which

employs traps as tuned elements for each of the bands. It is mounted above the Tri-Band Beam on the tower mast and is orthogonal to the orientation of the Tri-Band Beam.

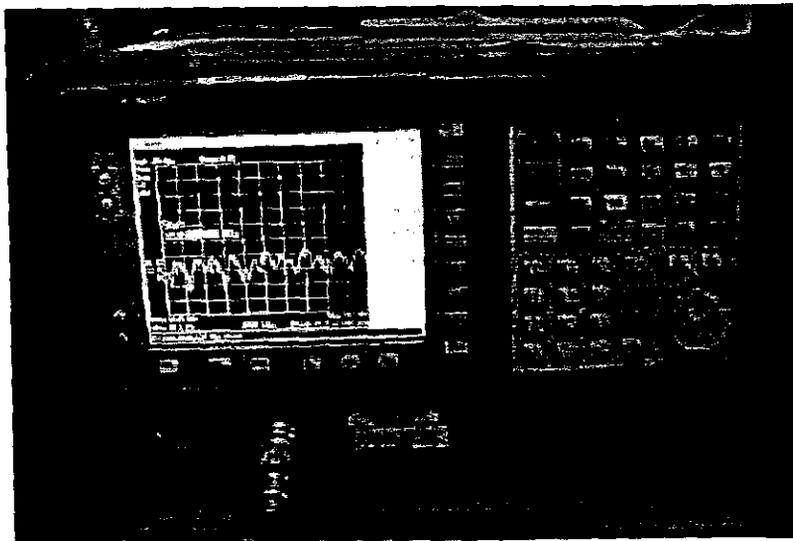
Fig. 4-1

Agilent E4411B Spectrum Analyzer with spectrum plot showing BPL signals between 18.05 and 18.10 MHz. The floppy disc drive for recording data is visible at the right edge of the photo.

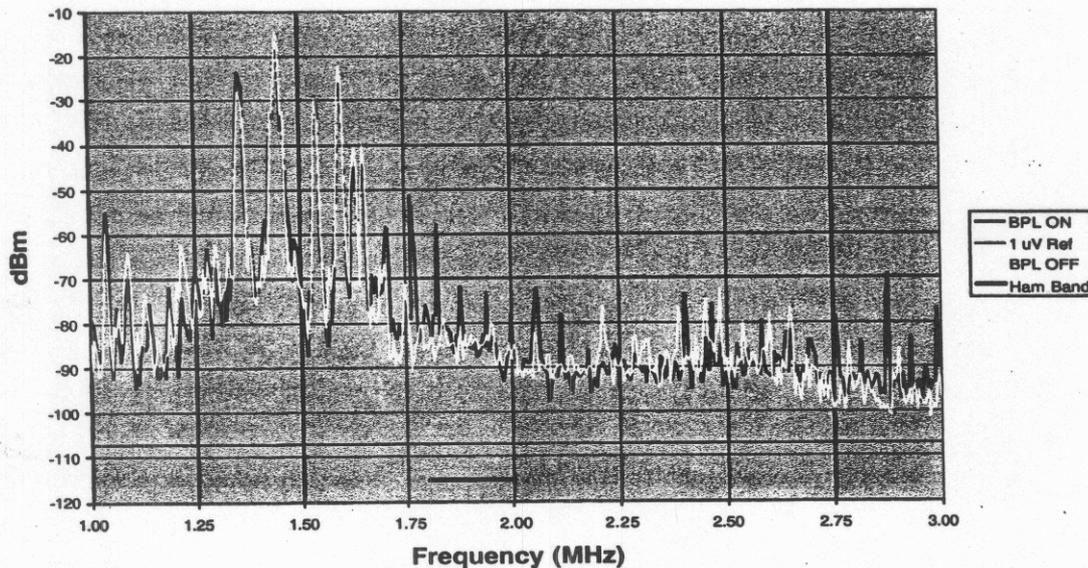
1-3 MHz 160m Inv-L 3kHz Res BW

Fig. A1A-1: The spectrum from 1 to 3 MHz as "seen" by the 160m Inverted-L antenna. The Amateur Band of 1.8 to 2.0 MHz is at the center of the plot. The yellow trace shows strong AM broadcast band signals (left side) and various impulse noise s (right side).

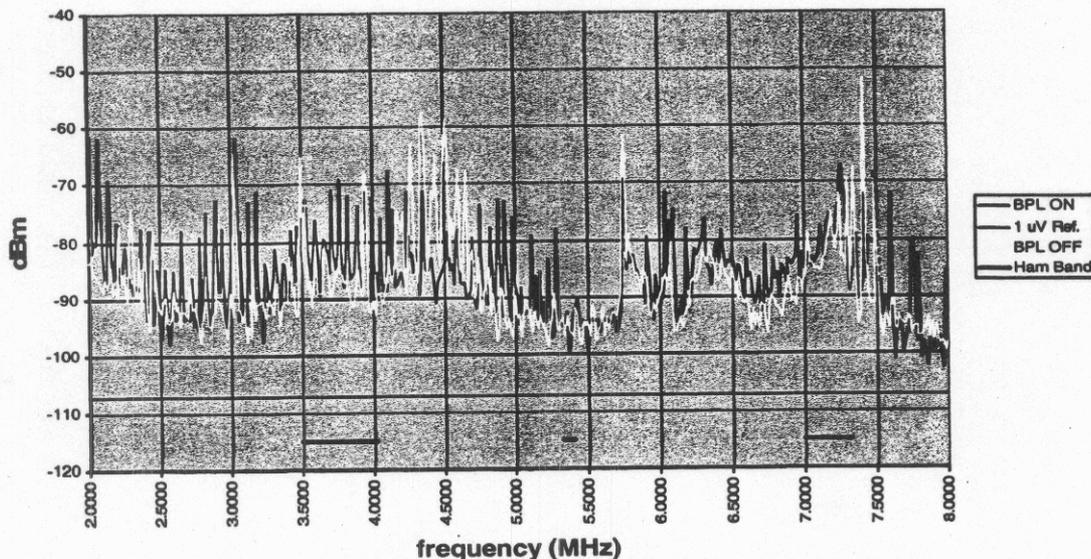
2-8MHz Inv-V 3kHz res BW

Fig. A1A-2: The spectrum from 2 to 8 MHz as "seen" by the dual band Inverted-V antenna. This view actually encompasses three (3) Amateur bands: 80m (just left of center), 60m (center), and 40m (right end). Note the BPL notching for 80m that isn't quite at the correct frequencies, and for 60m. There does not appear to be an effective notch for 40m at the

time this data was taken. The signal peaks on the yellow trace were audibly identified as typical of noise from power lines due to corona and arcing.

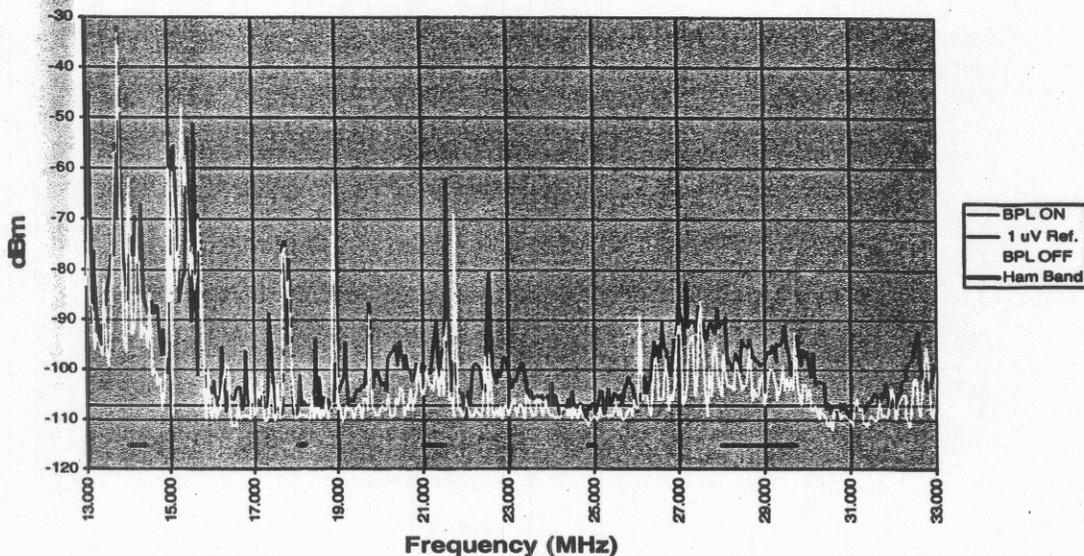
13-33 MHz Tri-Band 3kHz Res BW

Fig. A1A-3: The spectrum from 13 to 33 MHz as seen by the Tri-Band beam. This range includes five (5) Amateur bands, although the antenna is designed for just three of them. The 20m band is to the left, the 17m band is one-third from left, the 15m band is just left of center, the 12m band is just right of center, and the 10m band is one-third from right. Note the high BPL and noise levels in and near the 20m and 10m bands. Some of the large signal peaks in yellow were audibly identified as short wave broadcast.

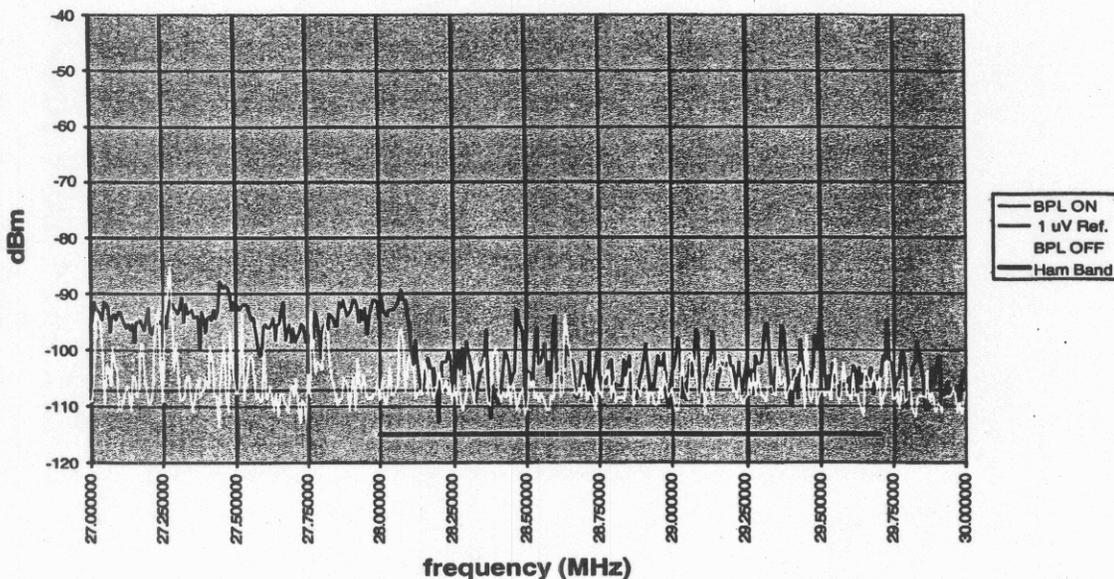
27-30MHz Tri-Band 3kHz res BW

Fig. A1A-4: A close-in view of the 10m band as seen by the Tri-Band beam. The decrease in BPL signal (blue trace) is probably notching. Note that even the reduced level is several dB above the 1 μ V reference line, meaning that these would still be loud signals into the receiver.

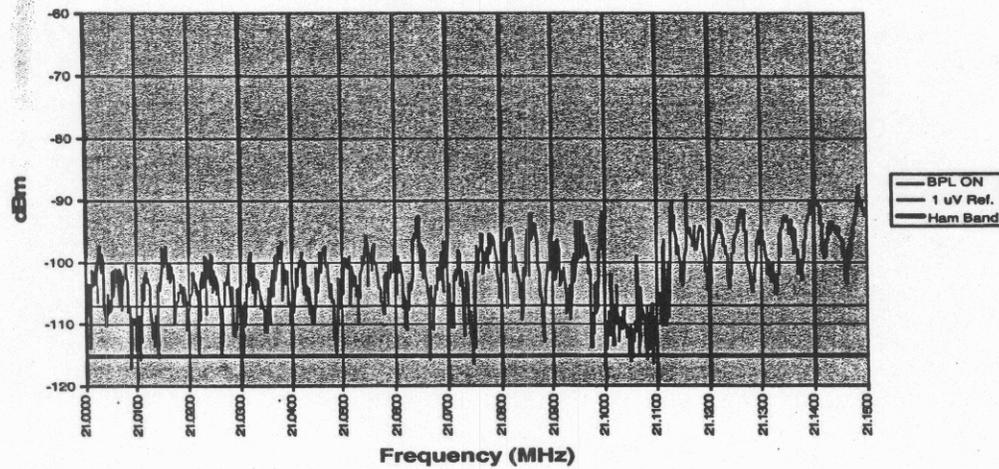
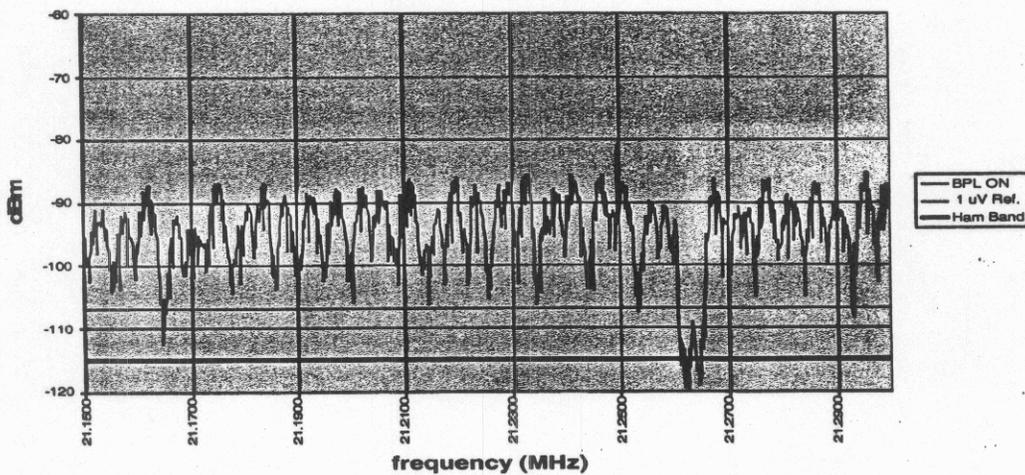
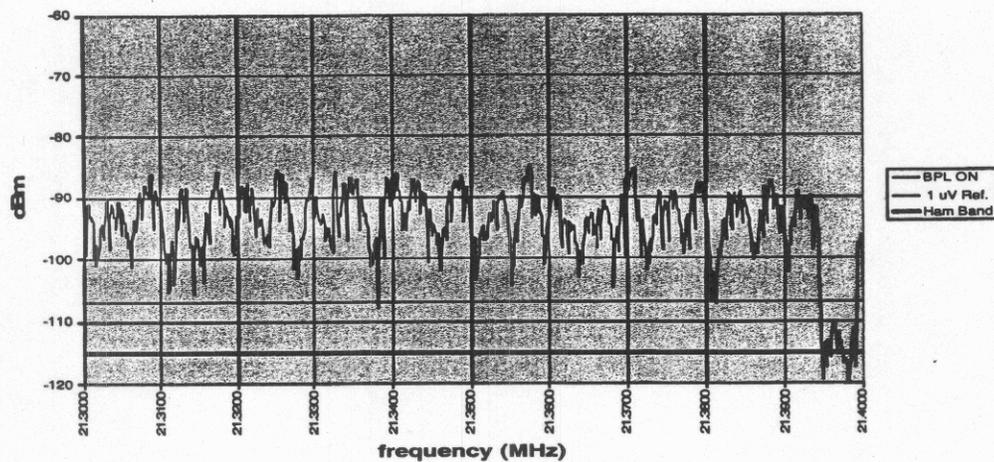
The three graphs which comprise Figure A1A-5 are a detailed scan with the relatively narrow spectrum analyzer IF filter of 1 kHz. Keeping the video filter wider (at 3 kHz) meant that the BPL signal "signature" was more readily visible. Because of the resolution obtained with this method,

the plots shown are each the composite result of stringing three consecutive frequency range sweeps together. (Each sweep was only 50 kHz wide.) The data for these graphs was taken on the evening of May 19th after the BPL system re-started, following the 2 hour shut-down.
