Birch Street

**Re: Experimental Station WB9XVP (File No. 0136-EX-ST-2004)
At Cottonwood (Yavapai County) Arizona; Broadband Over Power
Line System; Evaluation and Critique of 6-Month STA Report.**

Analysis of Electric Broadband 6-Month Report, Experimental Authorization WB9XVP

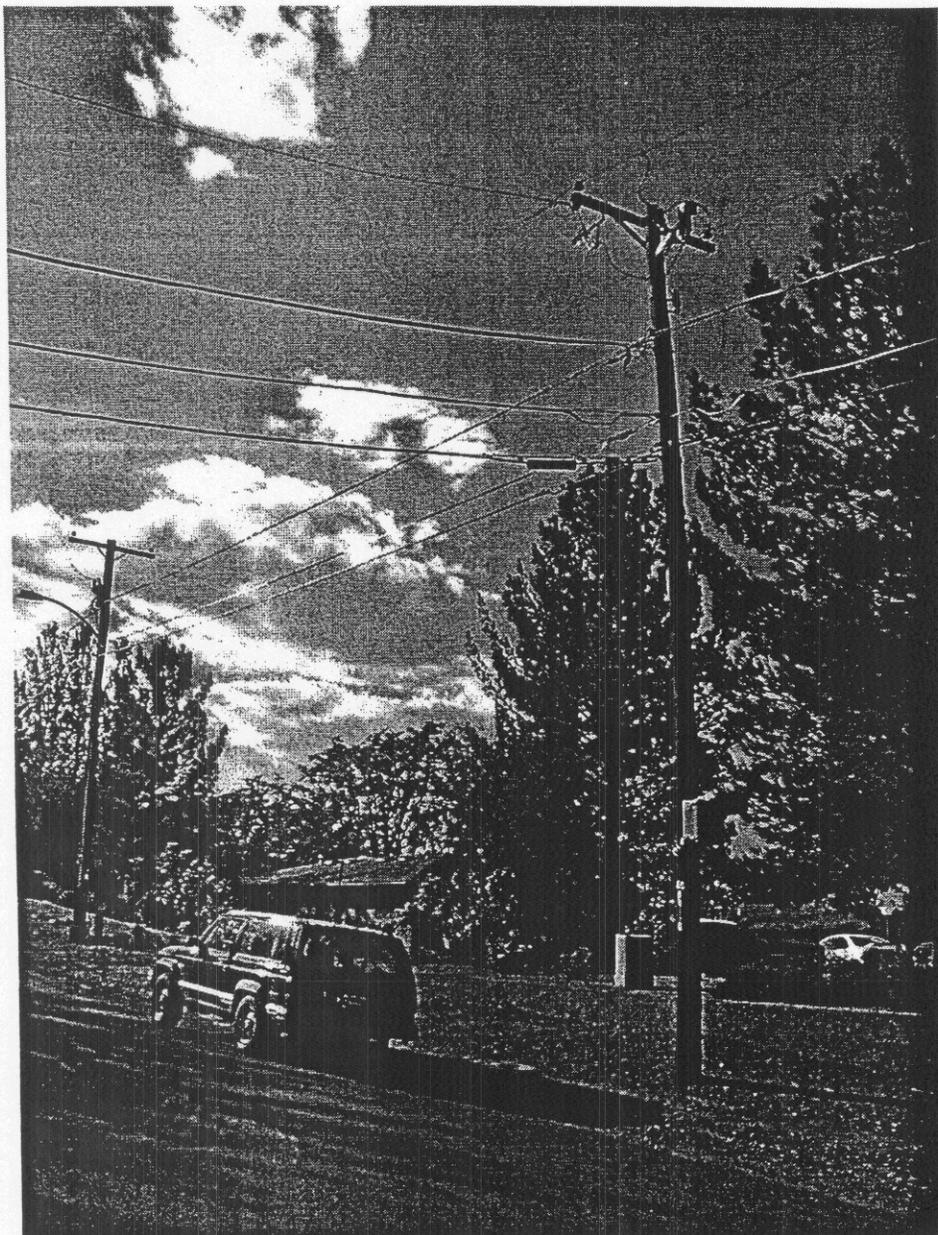
(Photo 6)

Birch Street shown with the equipment mounted on the pole on the right side of the photo. The Jeep was moved around this block and found uniform signal strength from the BPL equipment. The vehicle was positioned 10meters from the coupling point of the BPL equipment when the measurements were taken.

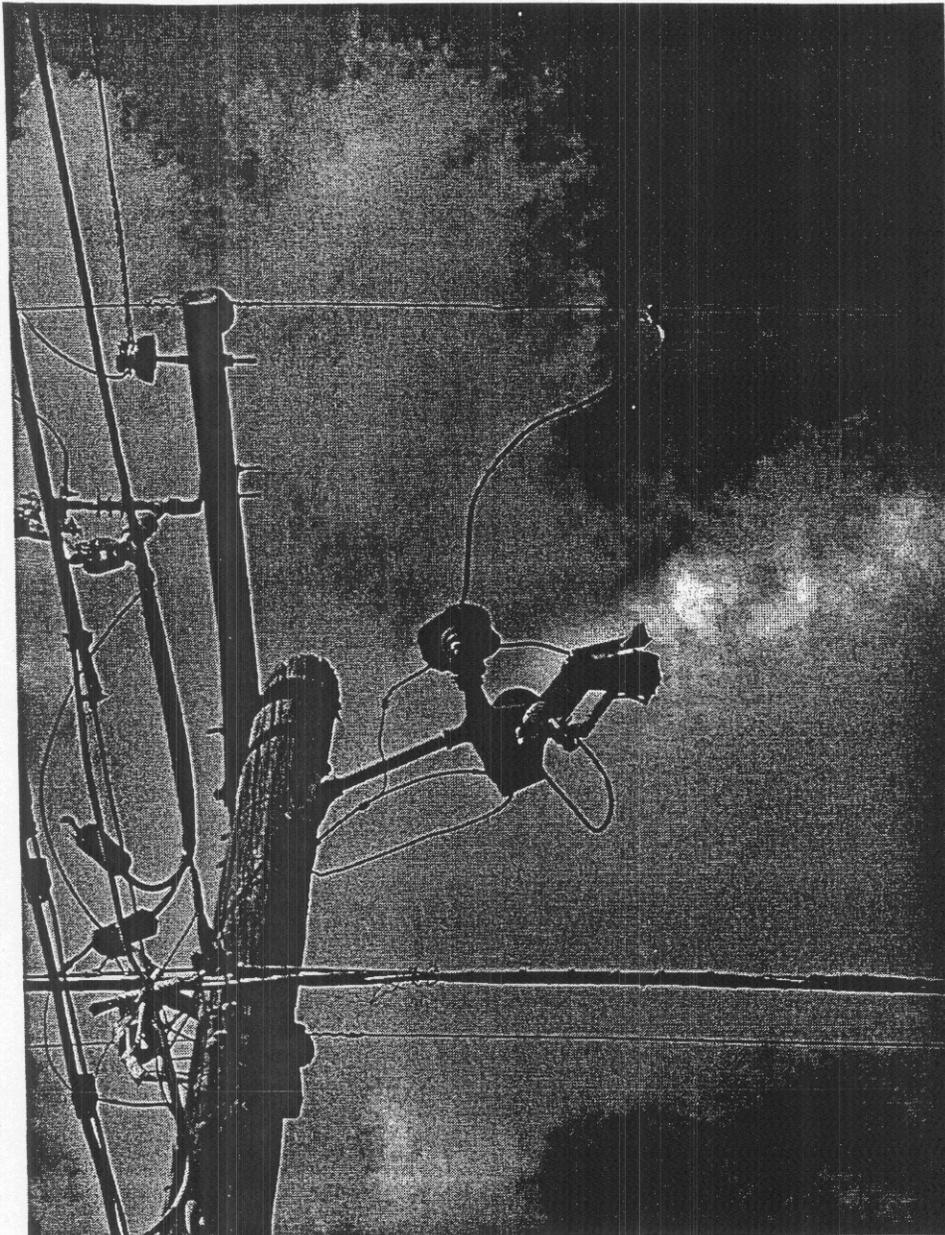
(Photo 7)

Birch Street BPL test site showing the red insulator and wire that is run from the medium voltage, down the pole, to a box that houses the electronics equipment used for BPL transmission.

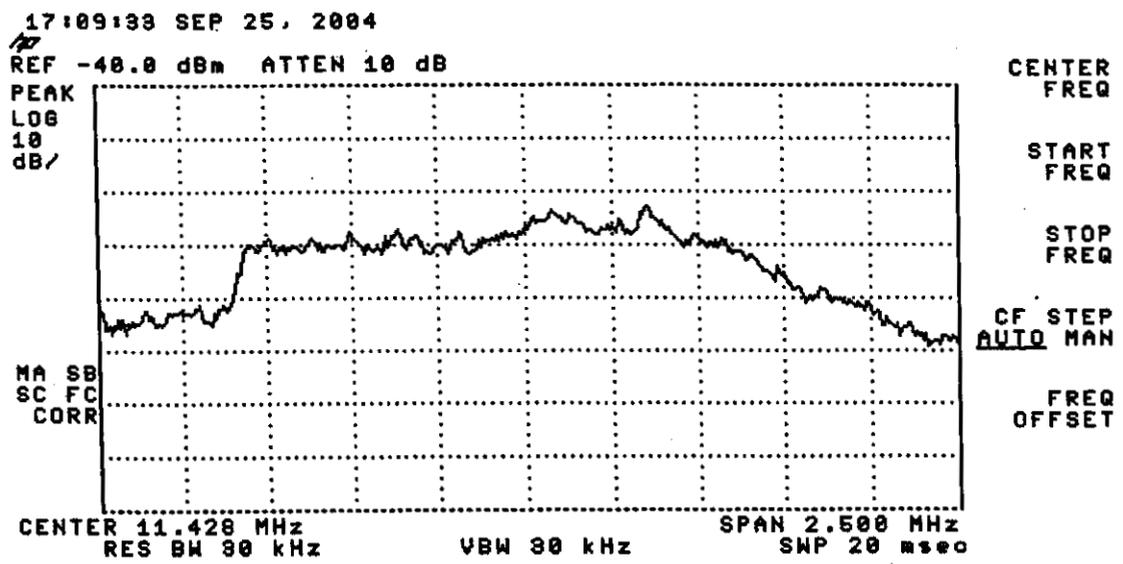
(Plot 7)

This carrier is also out of the amateur radio bands, but is close enough to interfere with 10MHz WWV reception. I was able to receive 10MHz WWV when this site was atleast ¼ mile away. As I approached this BPL test site, the noise floor captured the receiver. This carrier also hampers the ability for amateur radio operators to use the 30-meter band (10.100MHz to 10.150MHz) with a reading approaching S9+ on an HF receiver.

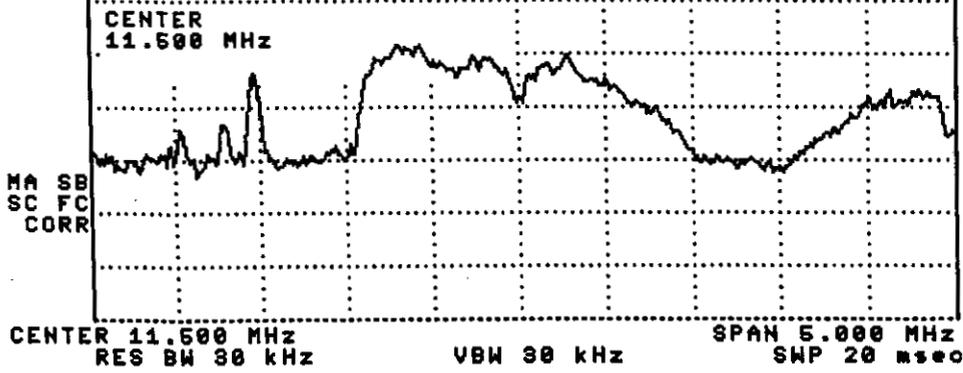
(Plot 8)

The carriers centered around 11.5MHz are strong enough to interfere with 30-meter (10.100MHz to 10.150MHz) operations. WWV on 10MHz was difficult to receive.

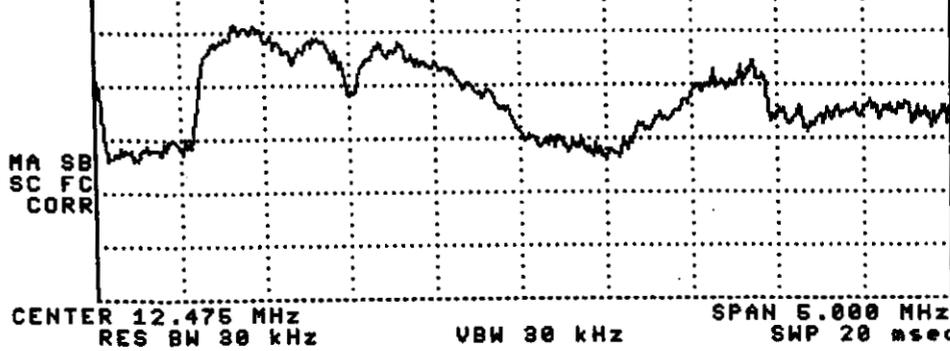
(Plot 9)

Additional carriers from the same BPL test site are present around 12.5MHz. This is strong enough to eliminate any ability to receive short wave broadcast services.

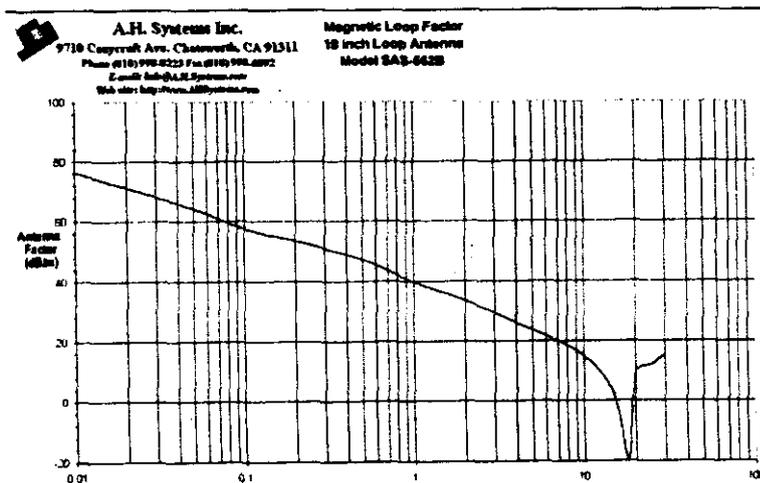
Figure 2: This is the typical antenna factor data for the AH Systems model SAS-562B calibrated loop antenna.

Frequency	Antenna Factor dB/m
2 MHz	33.4
5 MHz	23.4
10 MHz	14.8
15 MHz	1.8
18 MHz	-19.8 ²
20 MHz	9.3
25 MHz	12.3
30 MHz	15.3

² This data point is not a typographical error. The antenna shows a strong resonance near 18 MHz that significantly increases its sensitivity on or near that frequency. This antenna factor is equivalent to an antenna gain of 15.1 dBi. This is typical of an amplified small loop near its resonant point.

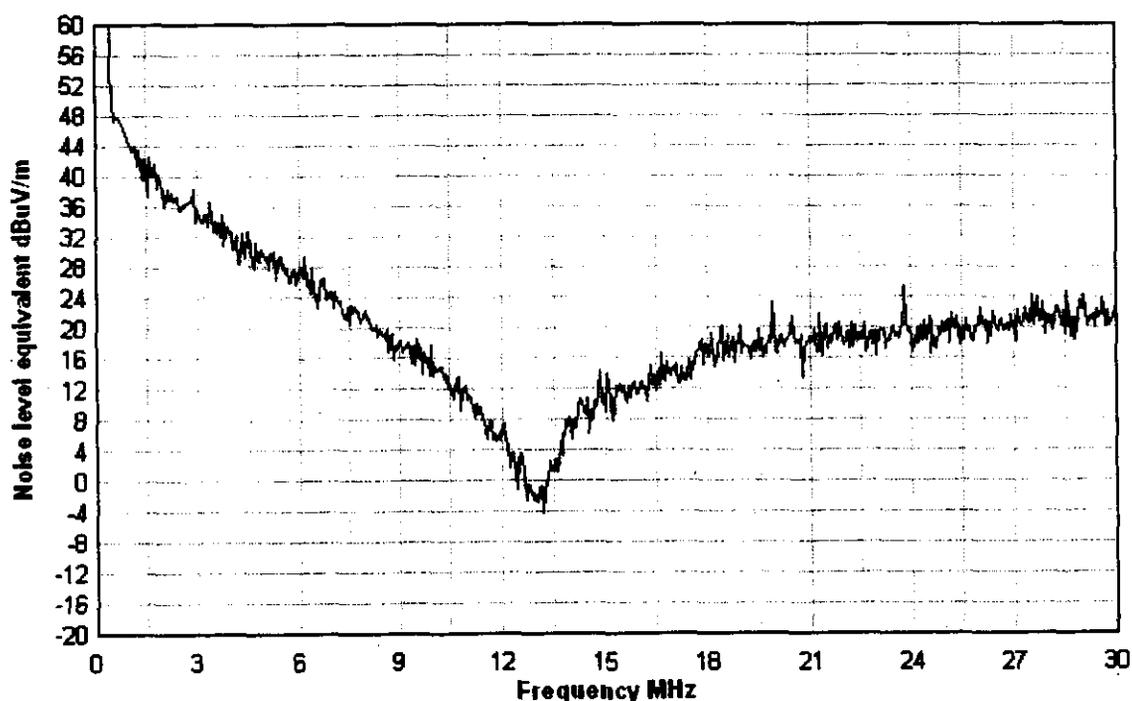
AH Systems SAS-563B Measurement Noise Floor Broadband Noise Corrected for Antenna Factor Serial number: 326

Figure 3: This figure shows the noise floor of the antenna and HP-8653B spectrum analyzer, corrected for antenna factor. This is the minimum sensitivity of the test equipment, and measurements cannot be made below this level. While ARRL's specific serial number is a bit different than the one used by EB, this test-fixture noise floor corresponds well to the levels reported by EB and APS as "ambient noise levels." Their results may be the ambient noise levels of their test fixture, but the relative noise levels made by amateurs using their receiver signal-strength meter readings show that the ambient noise level in the area is much lower than what was reported by EB and APS. A simple analysis of the specifications of the test instrumentation explains their results and incorrect conclusion.

The following graph shows measurements made in ARRL's screen room of the broadband noise response of ARRL's AH Systems SAS-563B amplified loop antenna. The broadband noise response is actually flat vs frequency, but this graph has been corrected for the specific antenna factors for SAS-563B serial number 326.

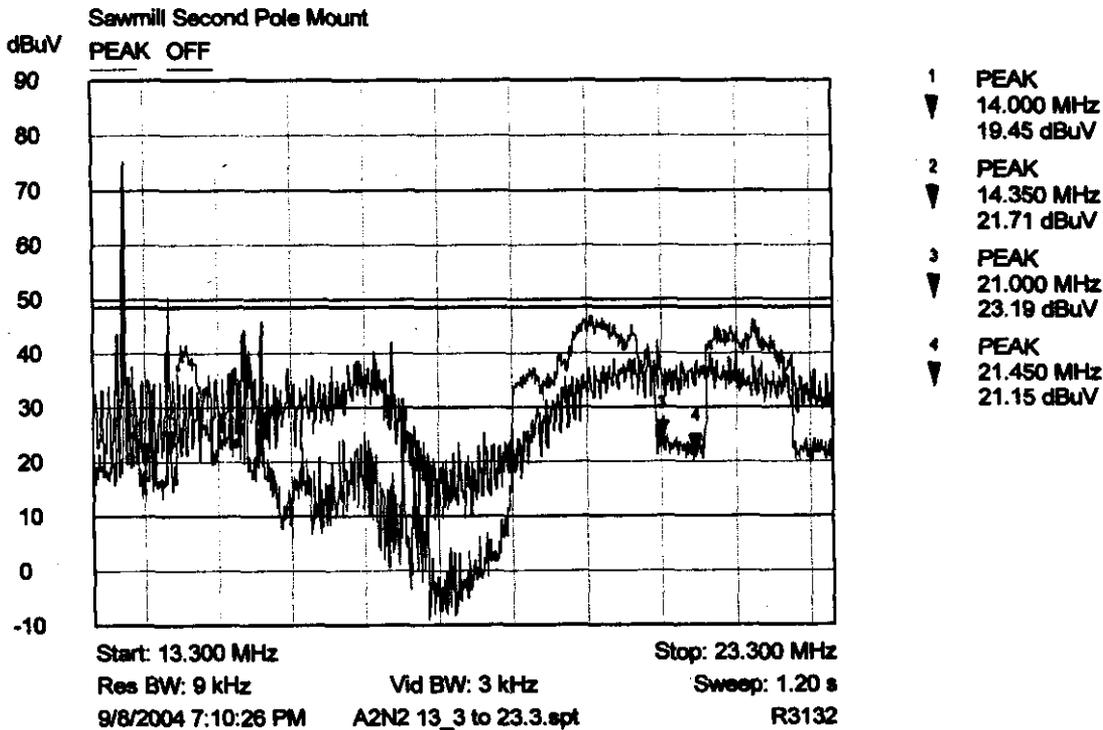
Figure 6: This graph purports to show the measured levels with the BPL system on and then off between 13 and 23 MHz. Green shows the BPL system and red shows the BPL system off. If these data are accurate, one would have to conclude that turning the BPL system reduced the ambient noise and signal levels by 20 dB across part of the frequency range being measured. Most dramatic is the notch that is shown between 21 and 21.45 MHz. The ambient conditions on this spectrum are shown to be 35 dBuV/m, yet when the system is turned on, these data show that a measurement can somehow be made 15 dB below this level. If the measurement of ambient levels is correct and the bandwidth between the two measurements is the same, the only way this ambient-level-vs measurement-level can be reconciled would be to increase the level of the BPL-measurement line (green) until the ambient noise levels in the notched spectrum match. If this were done, however, the BPL signal would increase a corresponding amount, and would thus exceed the Part-15 emissions limits by a considerable margin. The notching in the ambient and BPL-signal data is a representation of the antenna factor data programmed into the analysis software used to capture and display the spectrum-analyzer information.

The graphs shown above are examples from EB's report. Taken as a whole, most of the graphs show a decrease in the ambient noise and signal levels for the BPL "on" data. In all cases where this occurs, the BPL signal is shown to be just below the FCC limits, with the decrease in BPL-on ambient noise levels just sufficient to show the BPL-on signal just below the limits. The amount of difference varies from graph to graph, yet the end result in each case is that the BPL signals are always shown below the limits. In those graphs where there is no appreciable difference in ambient levels, the BPL signal is seen to be well below the FCC limits.

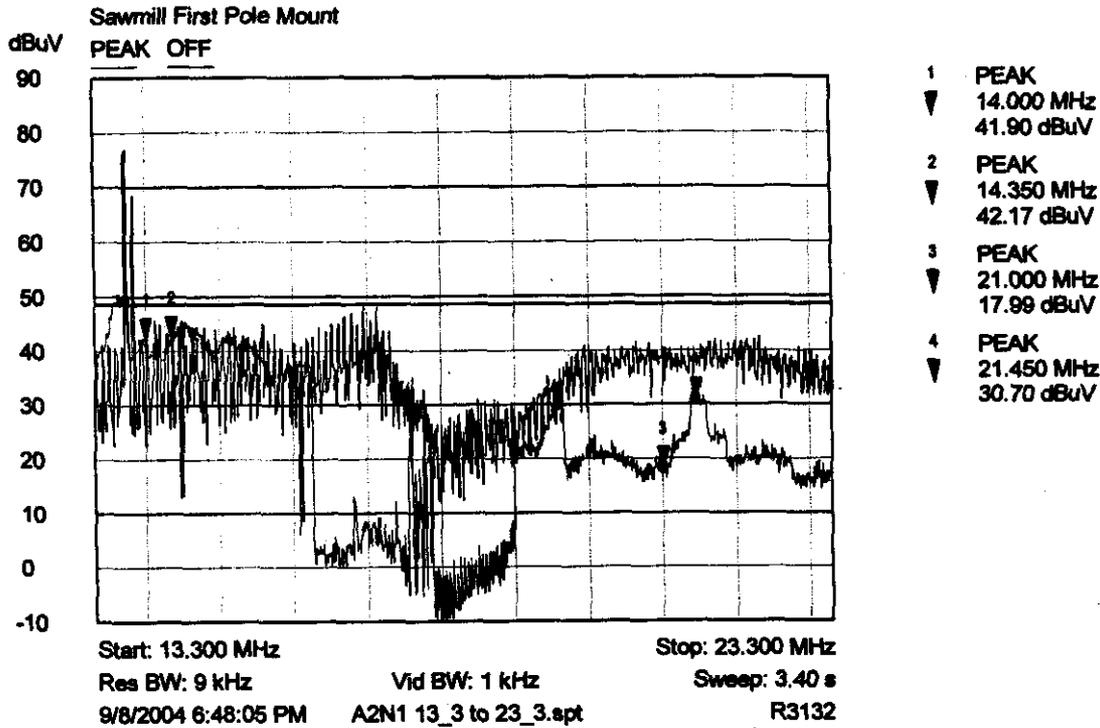
Figure 7: This graph shows the same problem, at a different test location. In this case, the apparent decrease in ambient signal and noise levels is about 30 dB in part of the spectrum. If these data were presumed to be correct, turning the BPL system on would be having the impossible effect of dropping the noise level in the spectrum it uses by 30 dB. This graph also shows that Based on the difference in the amount of noise shown on each line, it is possible that the bandwidth was smaller for the "BPL on" measurement or different analyzer reference level settings were used for each of the data lines shown in this graph. It is not possible that turning on a BPL signal would decrease the ambient noise levels by 30 dB. If the BPL data were increased by 30 dB to match up the ambient noise levels, the BPL signal would exceed the FCC Part-15 emissions limits.

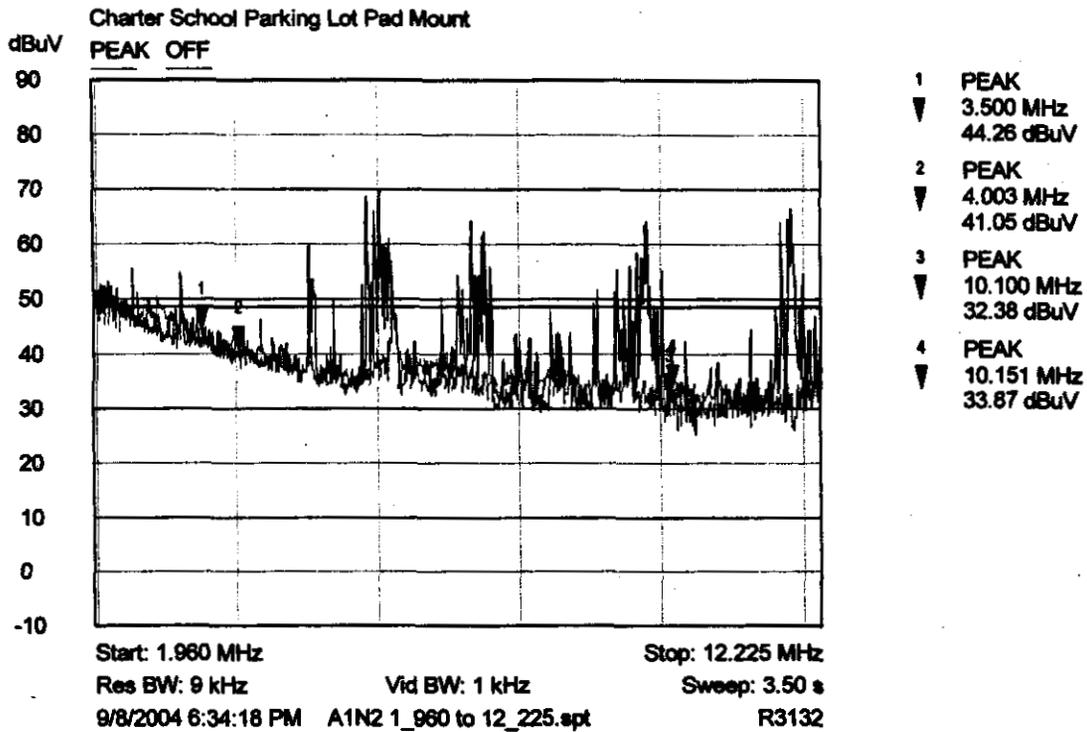
Figure 8: In this graph, on spectrum that the BPL system does not appear to be using at this location, the ambient noise levels match up. However, the graph with the BPL system "on" does not show most of the much stronger ambient over-the-air signals seen on the graph of the BPL system off. If these data were taken at the times indicated with the same test conditions, the stronger ambient signals levels would have been approximately the same in both graphs. The presence of the BPL signal would not have reduced the level of all of the ambient signals propagating to the area at that time. Incidentally, Most of the ambient noise in this frequency range shows the lower limit of the test fixture, not the level of the local ambient noise levels in between the on-the-air signals.

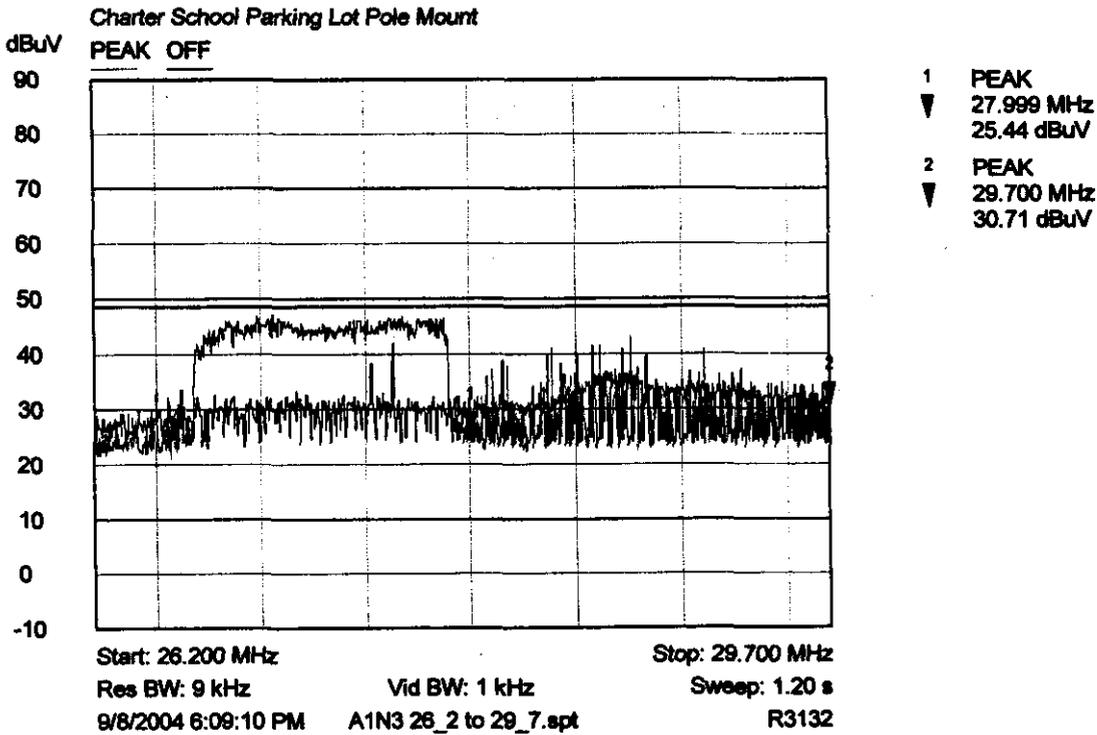
Figure 9: The EB report indicates that no BPL signals were present in any amateur band. This graph, however, shows the BPL system on with the green line and the BPL system off with the red line. It is clear that there are strong signals present – above 40 dBuV/m in some case – in the amateur band when the BPL system is operating. At 40 dBuV/m, these would be typically reported by licensees as "S9" level signals, very strong compared to the weaker licensed signals that are typical on this spectrum. If the ambient noise levels were set the same on both data sets shown in this graph, the BPL "on" signal would increase by a corresponding amount. As shown in an earlier section of this document, their reported "ambient" levels really show the noise floor of their test fixture. The BPL signals in the 28-29.7 MHz amateur band are well above the ambient noise level seen in that spectrum.
