Site 07 – Single Residence 1313 35th St, San Pedro, CA

Site 08 – 36 Unit Apt. Complex 4646 Cahuenga Blvd, Toluca Lake, CA

Site 09 – Parking Garage 11239 Ventura Blvd., Studio City, CA

Site 10 – Parking Garage 211 N. Glendale Ave., Glendale, CA

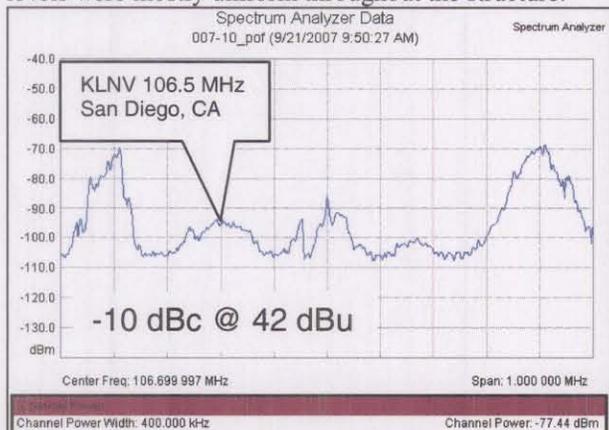
Figure 1 - #7 1313 (Inside POF @ -10 dBc)

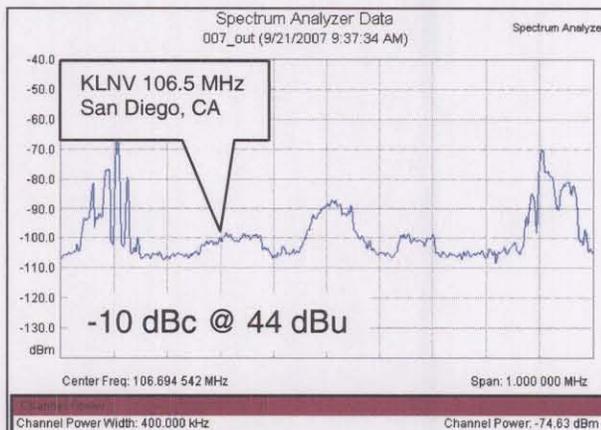
Figure 2 - #7 1313 (Outside @ -10 dBc)

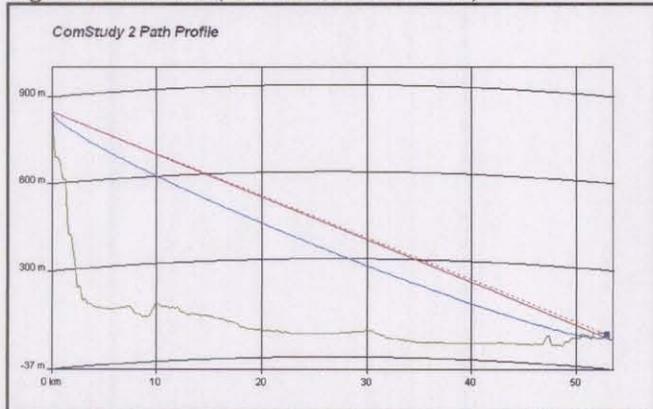
Figure 3 - #7 1313 (Terrain to Tx)

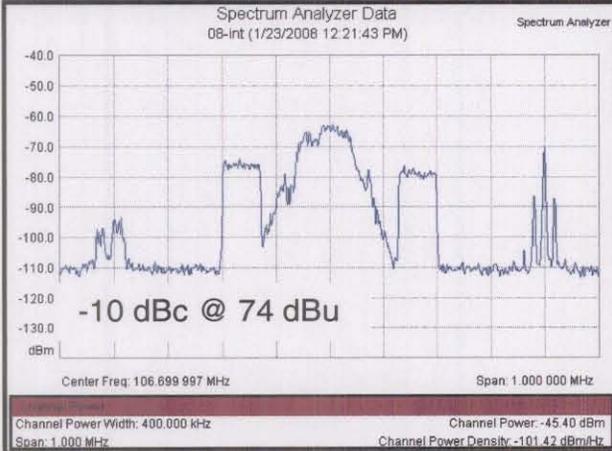
Figure 1 - #8 4646 (Window @ -10 dBc)

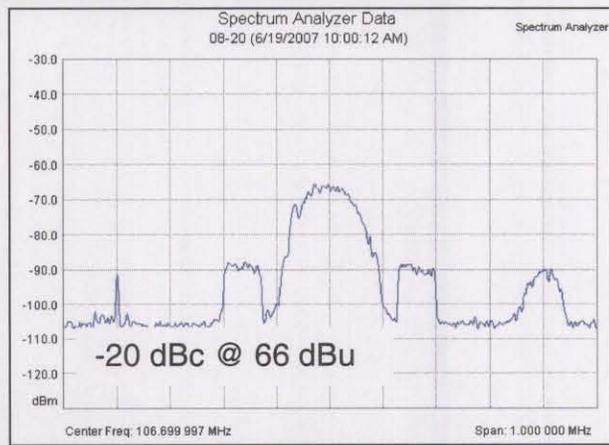
Figure 2 - #8 4646 (Inside @ -20 dBc)

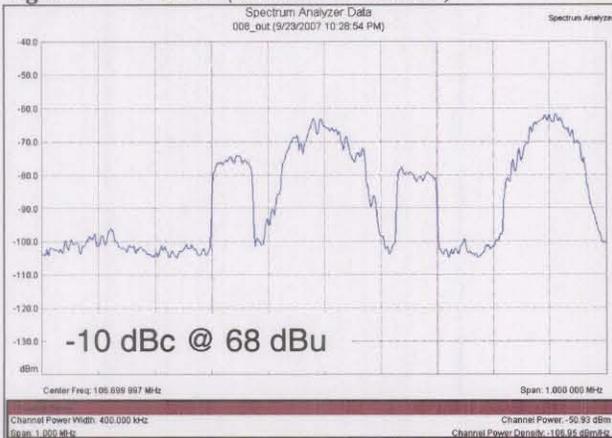
Figure 3 - #8 4646 (Outside @ -10 dBc)

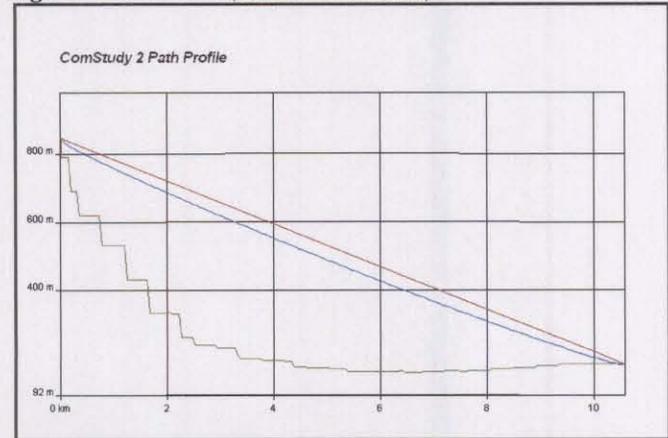
Figure 4 - #8 4646 (Terrain to Tx)

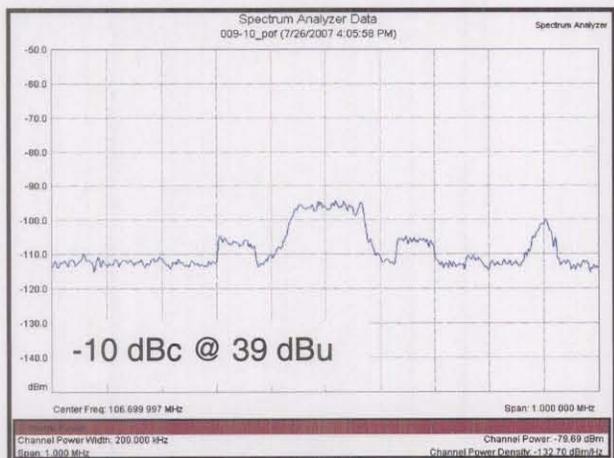
Figure 1 - #9 Parking Garage POF @ -10 dBc

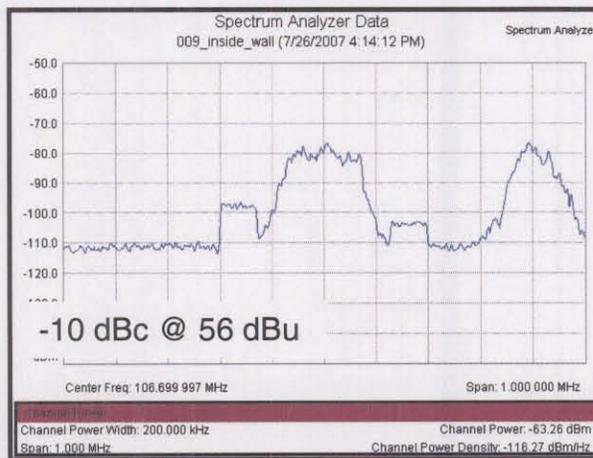
Figure 2 - #9 Parking Garage (Inside @ -10 dBc)

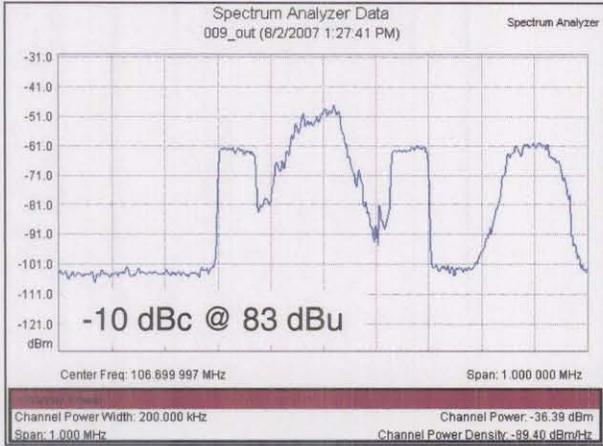
Figure 3 - #9 Parking Garage (Outside @ -10 dBc)

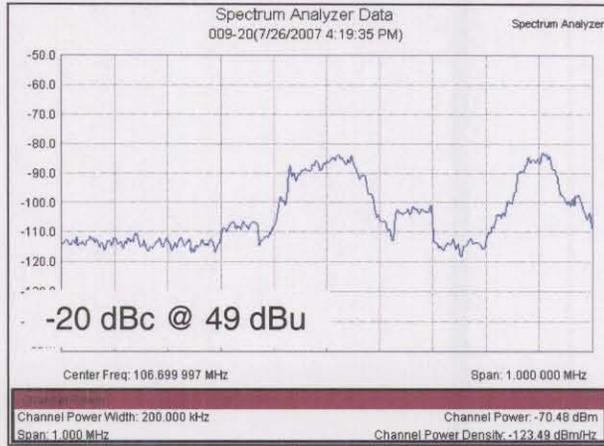
Figure 4 - #9 Parking Garage (Outside @ -20 dBc)

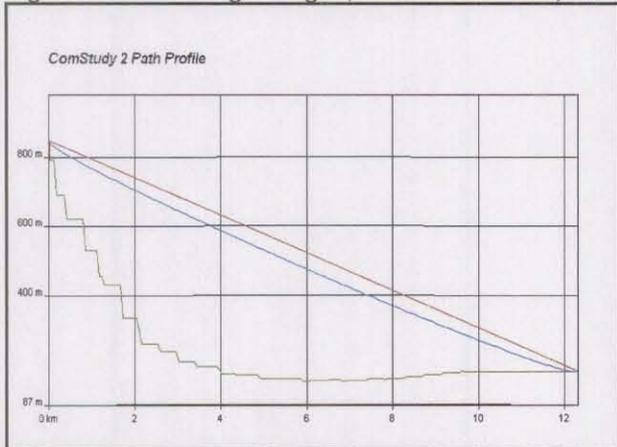
Figure 5 - #9 Parking Garage (Terrain to Tx)

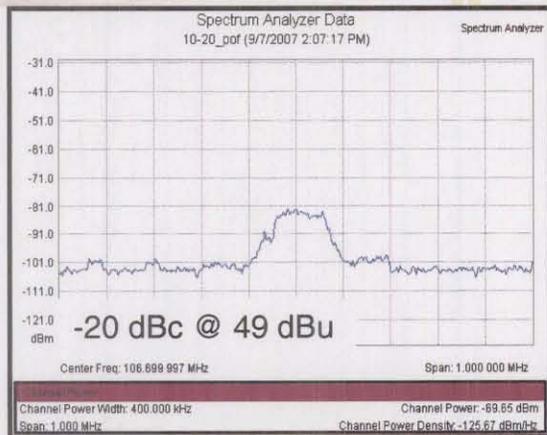
Figure 1- #10 Parking Garage (-20 dBc POF)

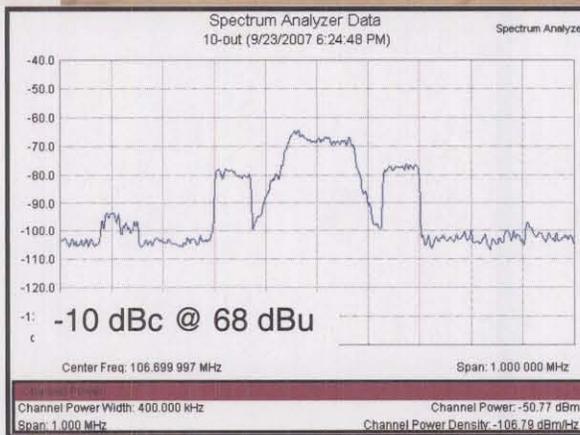
Figure 2- #10 Parking Garage (-10 dBc Outside)

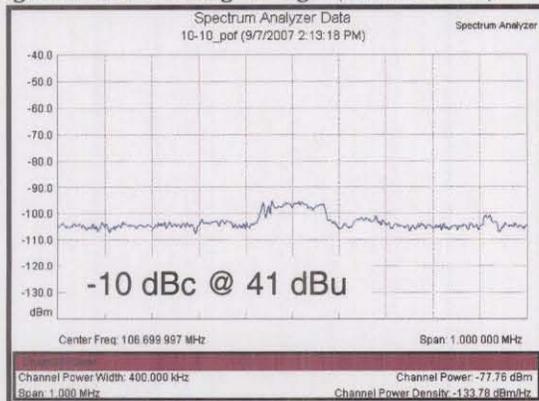
Figure 2- #10 Parking Garage (-10 dBc POF)

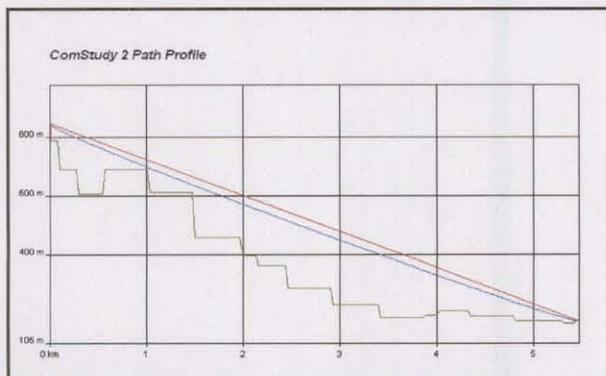
Figure 4 - #10 Parking Garage (Terrain to Tx)
