**ATTACHMENT FOUR
VERIZON MANHATTAN TEST REPORT**

**Network Services Technology Department
Wireless Access Technologies**

**Location Accuracy Testing
of TruePosition in Manhattan, New York**

**September 5, 2000
to
September 8, 2000**

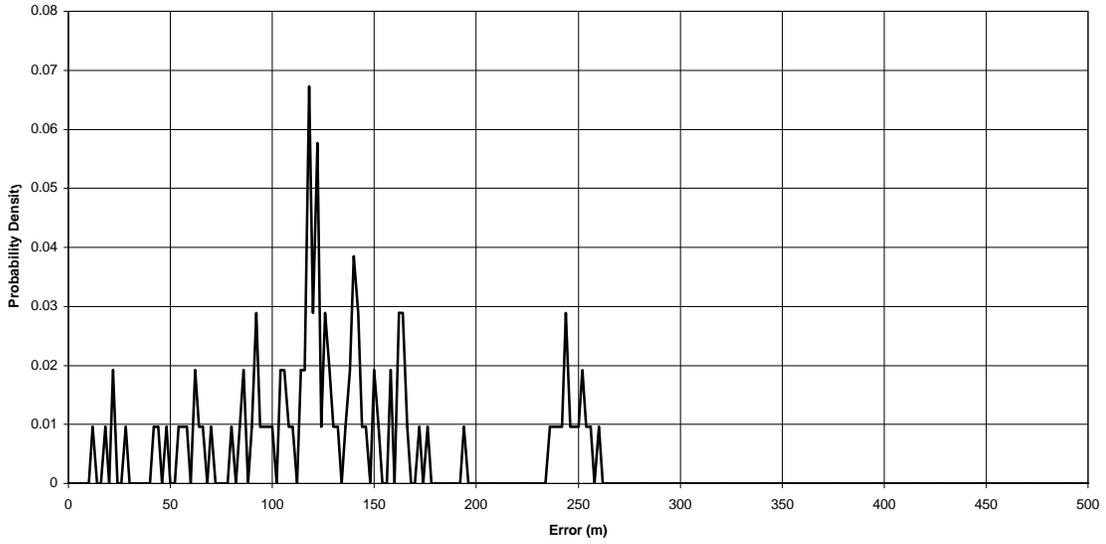
FIGURE U2D: PROBABILTIIY DENSITY FUNCTION FOR LOCATION ERROR

# Test Locations:	3
Location 1:	1040 N 6th Ave between 39th and 40th, Roses Only (Fashion District Display and map on pole)
Location 2:	787 7th Ave between 52th and 51st St (Fire hydrant)
Location 3:	Treasure Chest, 3rd Ave, between 47th and 48th (Gray light pole with sign Local Truck Route)
Total # Fixes:	104
67% Error:	142
95% Error:	250

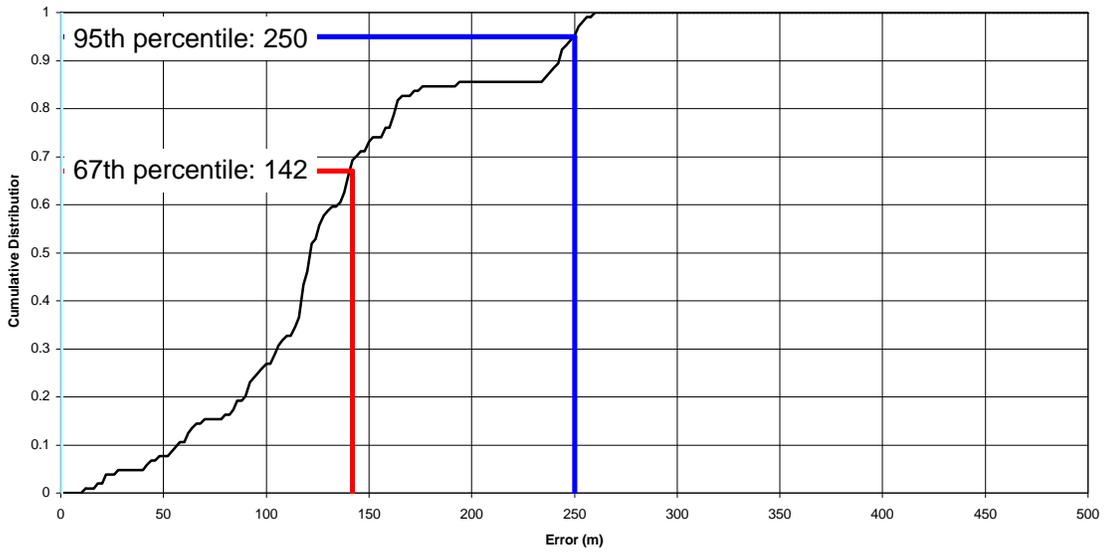
FIGURE U2E: CUMULATIVE DISTRIBUTION FUNCTION FOR LOCATION ERROR

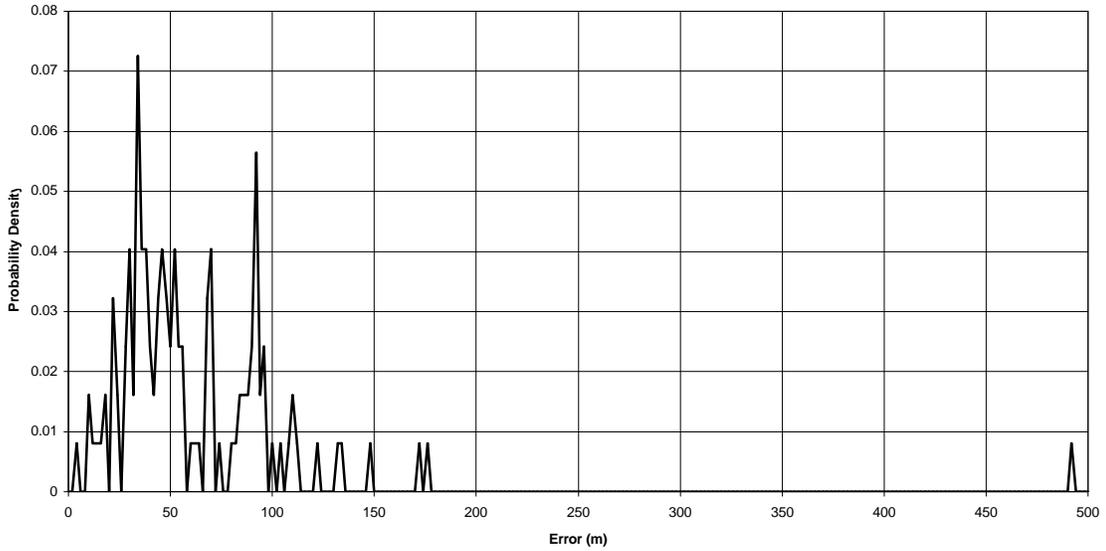
FIGURE U1D: PROBABILTIIY DENSITY FUNCTION FOR LOCATION ERROR

# Test Locations:	3
Location 1:	Andrew's Coffee Shop, Intersection Broadway and 39th (Traffic light pole at corner)
Location 2:	Intersection- NE corner of 49th St and 7th Ave (Traffic light pole)
Location 3:	CitiBank on the SW corner of 46th & 3rd (Traffic light pole)
Total # Fixes:	124
67% Error:	70
95% Error:	122

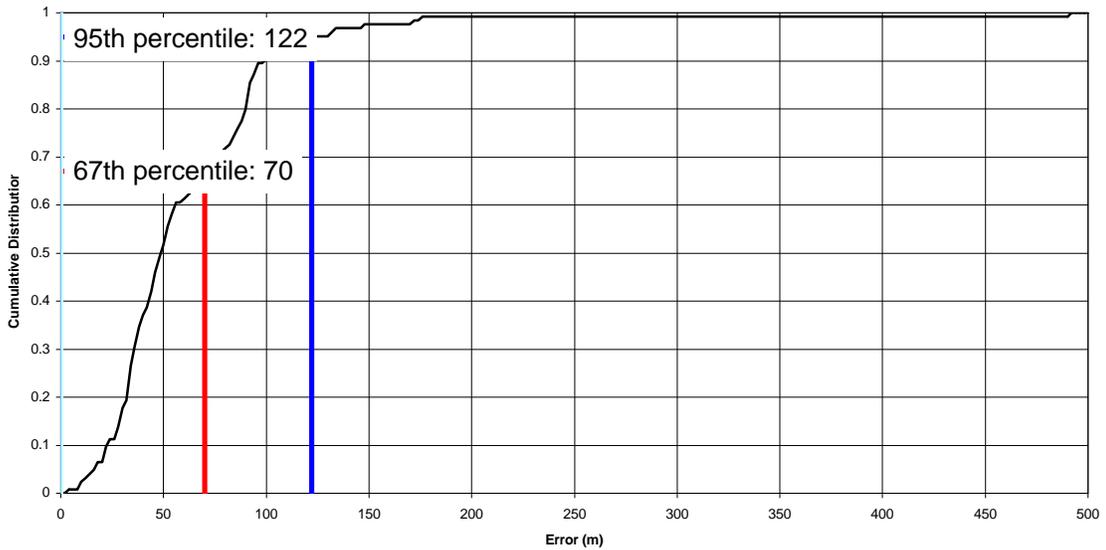
FIGURE U1E: CUMULATIVE DISTRIBUTION FUNCTION FOR LOCATION ERROR

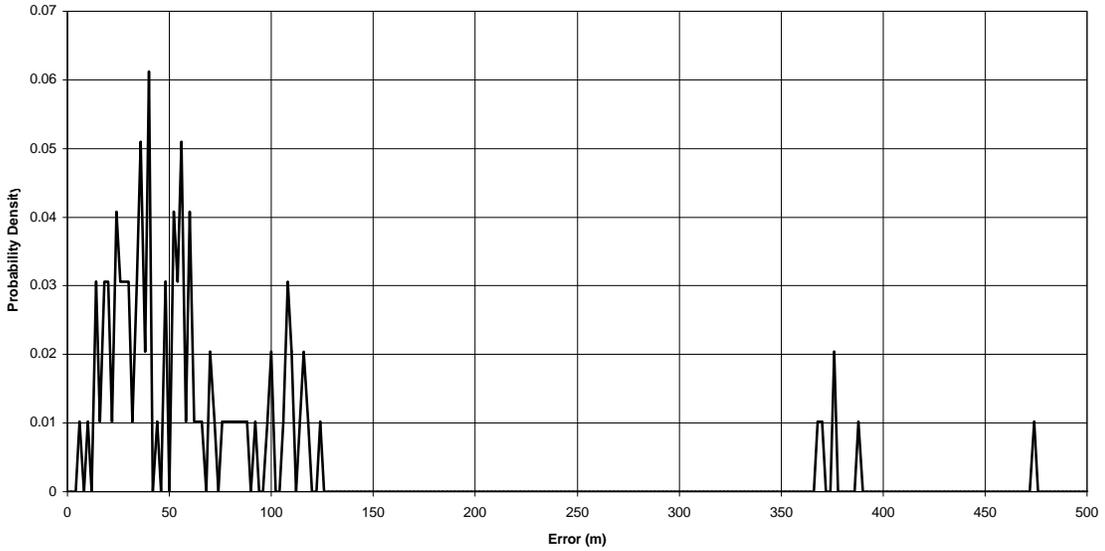
FIGURE U4D: PROBABILITY DENSITY FUNCTION FOR LOCATION ERROR

# Test Locations:	3
Location 1:	Associated store, between 48 & 49 street, 2nd Ave (Tree with grade just before Stationary store)
Location 2:	Belvedere Hotel, 319 48th St, between 9 & 8 Ave (Fire hydrant)
Location 3:	Parking garage on 36th St between 9 and 8 (Phone on wall)
Total # Fixes:	98
67% Error:	64
95% Error:	370

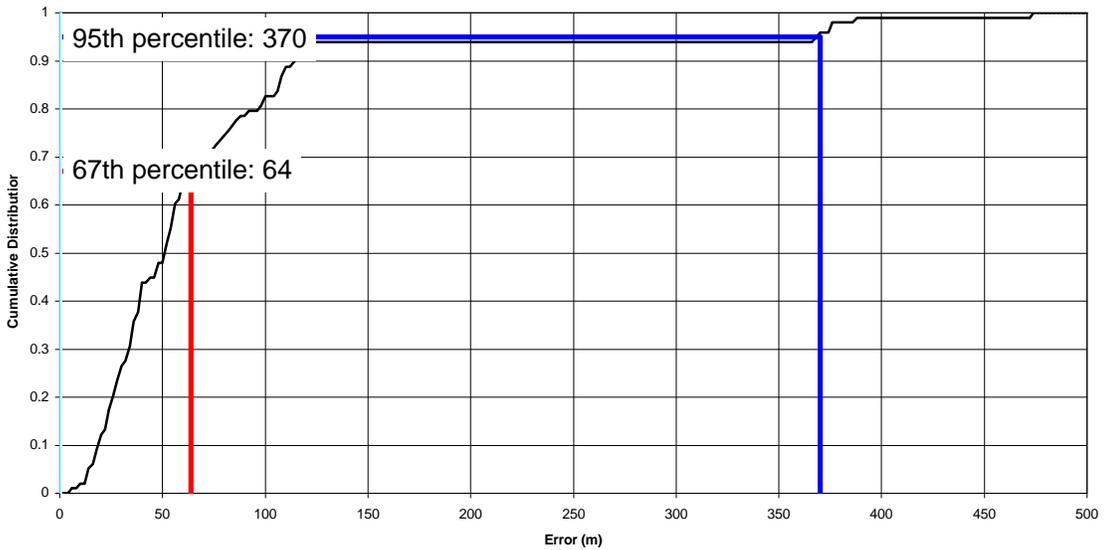
FIGURE U4E: CUMULATIVE DISTRIBUTION FUNCTION FOR LOCATION ERROR

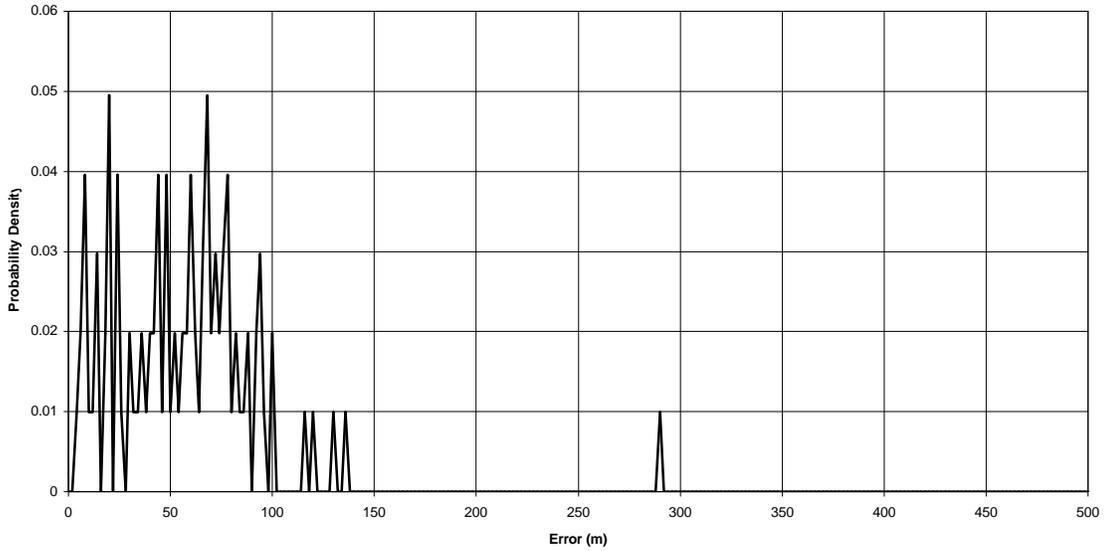
FIGURE U3D: PROBABILITY DENSITY FUNCTION FOR LOCATION ERROR

# Test Locations:	3
Location 1:	NE corner of 52nd & 2nd Ave (Traffic light pole in front of Mimi's restaurant-984 2nd Ave)
Location 2:	SE corner, 51st St and 9th Ave, St Claire Yue Wah restaurant (Traffic light pole)
Location 3:	NW corner of 34th and 8th (Traffic light pole)
Total # Fixes:	101
67% Error:	70
95% Error:	100

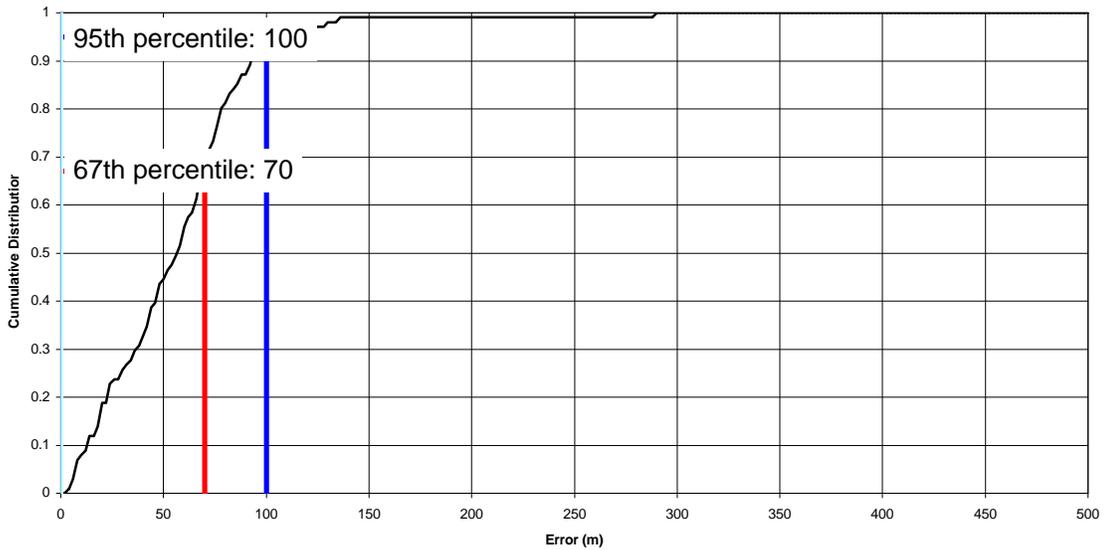
FIGURE U3E: CUMULATIVE DISTRIBUTION FUNCTION FOR LOCATION ERROR

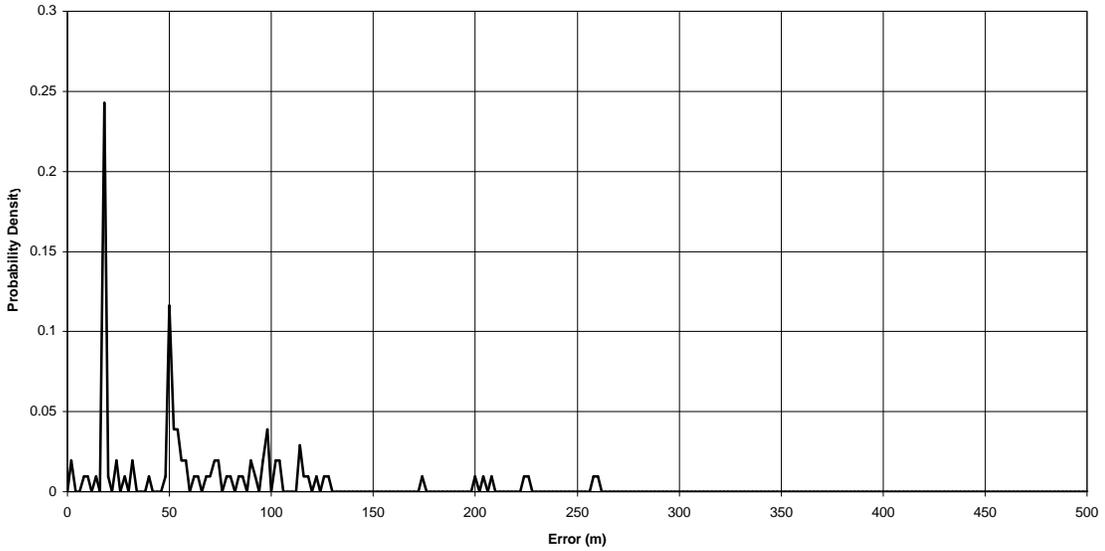
FIGURE U7B: PROBABILITY DENSITY FUNCTION FOR LOCATION ERROR

# Test Locations:	3
Location 1:	Fashion Center Bldg on Madison at #30 West 39th St (Phone booth to your left in line with entrance of 30 W 39th)
Location 2:	7th Ave between 54th and 53rd Streets, Lindy's Griddle and Breakfast (No standing sign)
Location 3:	3rd Ave between 50th and 51st, Starbucks Coffee (Caution recessed crosswalk on 3rd Ave sign)
Total # Fixes:	103
67% Error:	74
95% Error:	204

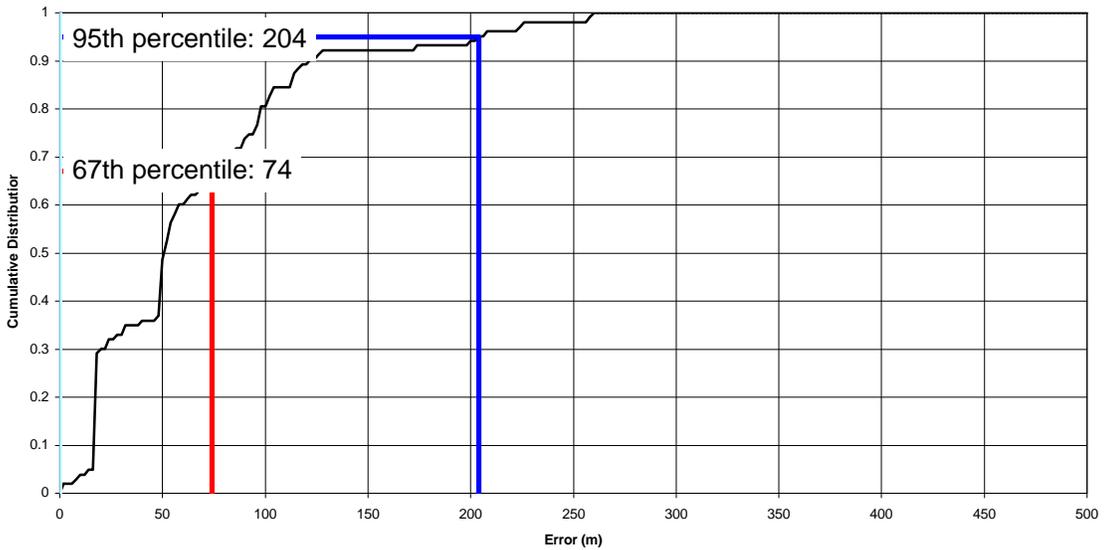
FIGURE U7C: CUMULATIVE DISTRIBUTION FUNCTION FOR LOCATION ERROR

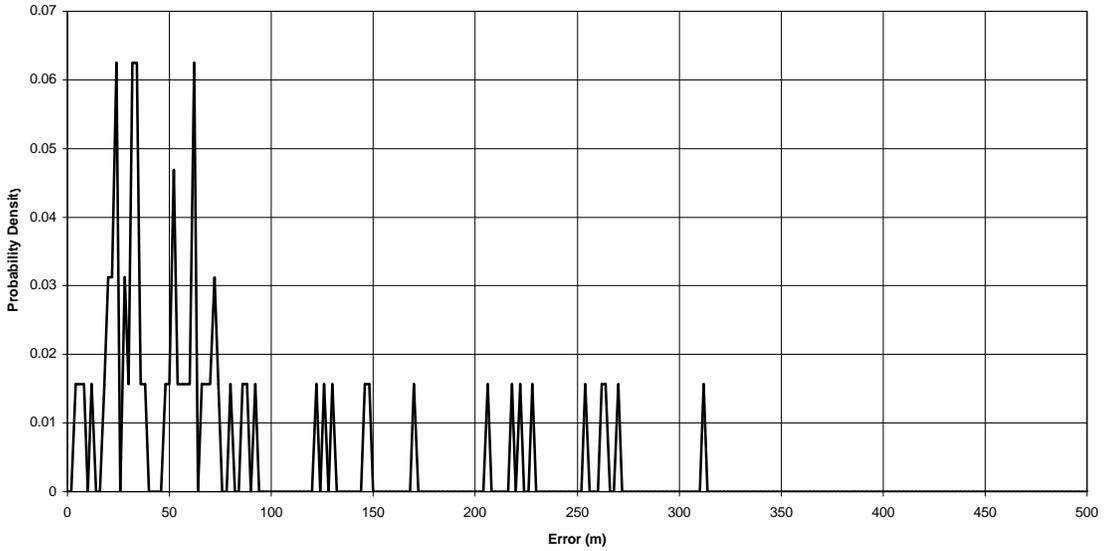
FIGURE U8B: PROBABILTIIY DENSITY FUNCTION FOR LOCATION ERROR

# Test Locations:	5 w/3 traveling routes
Location 1:	Route of 2nd Avenue locating at "Night Owls", "Blockheads", "Duane Read Pharmacy", "Savin Building", "Queens Midtown tunnel" between 34th and 57th
Location 2:	Route of 3rd Ave locating at "Au Bon Pain", "Muldoons Irish Pub", "TheTreasure Chest", "CitiGroup Center", "SW corner of 57th"
Location 3:	Route of 57th Street locating at "Rainbow Store", "Lee's Art Shop", "Hotel Parker Meridian", "Turnbull & Asser" and #950 3rd at 57th St
Total # Fixes:	64
67% Error:	72
95% Error:	262

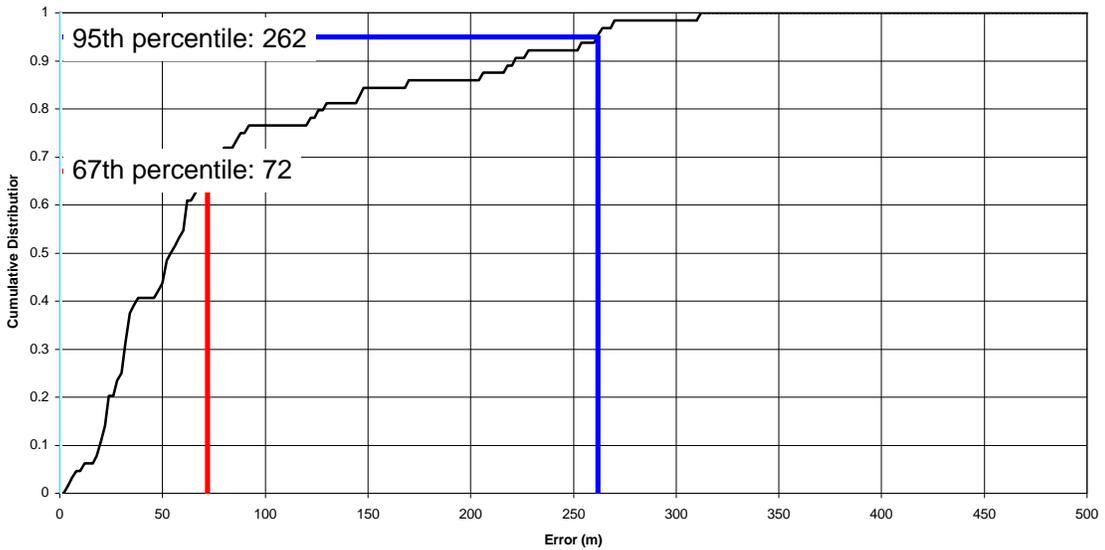
FIGURE U8C: CUMULATIVE DISTRIBUTION FUNCTION FOR LOCATION ERROR

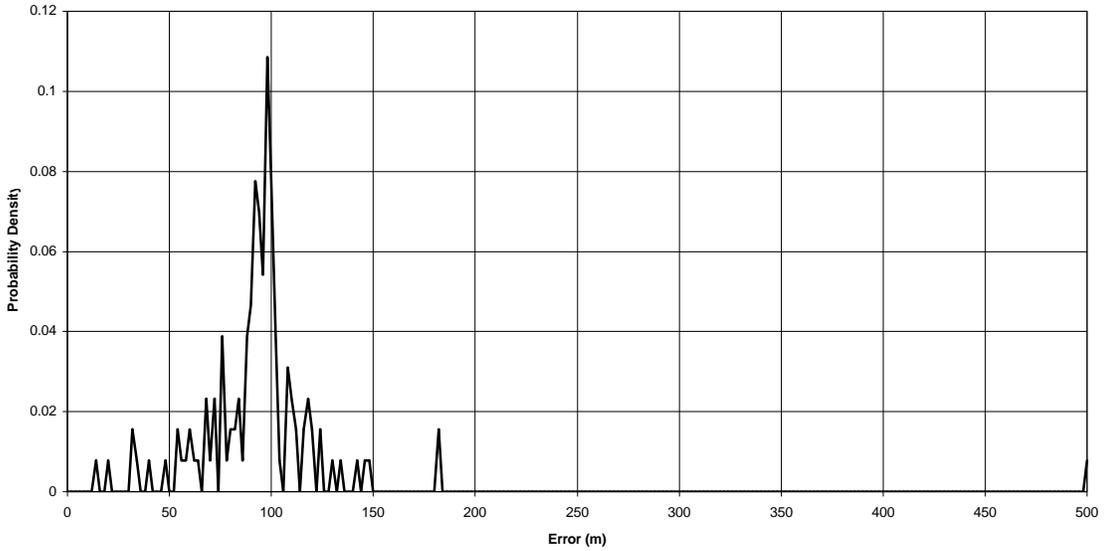
FIGURE U10D: PROBABILITY DENSITY FUNCTION FOR LOCATION ERROR

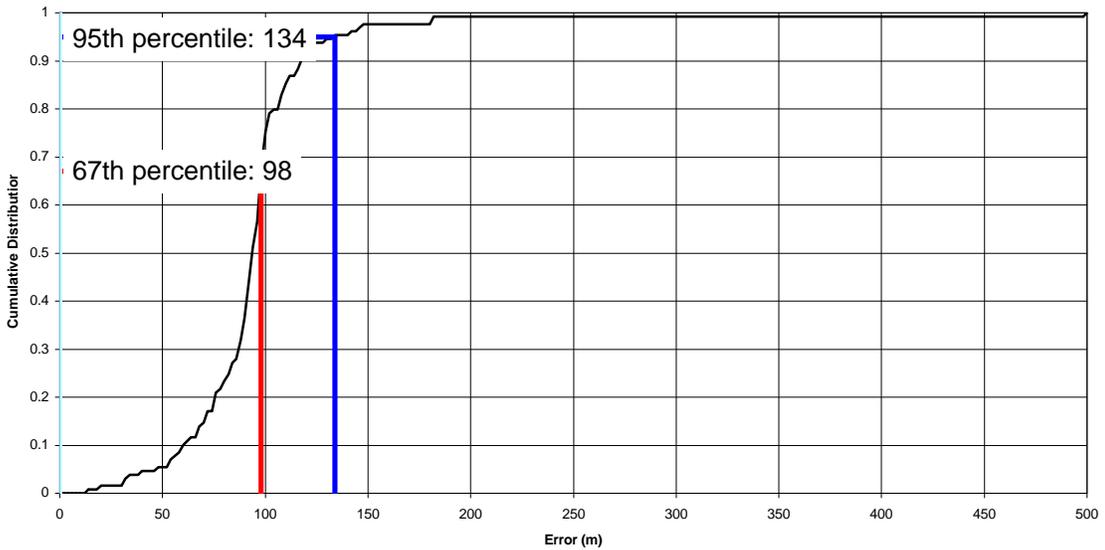
FIGURE U10E: CUMULATIVE DISTRIBUTION FUNCTION FOR LOCATION ERROR

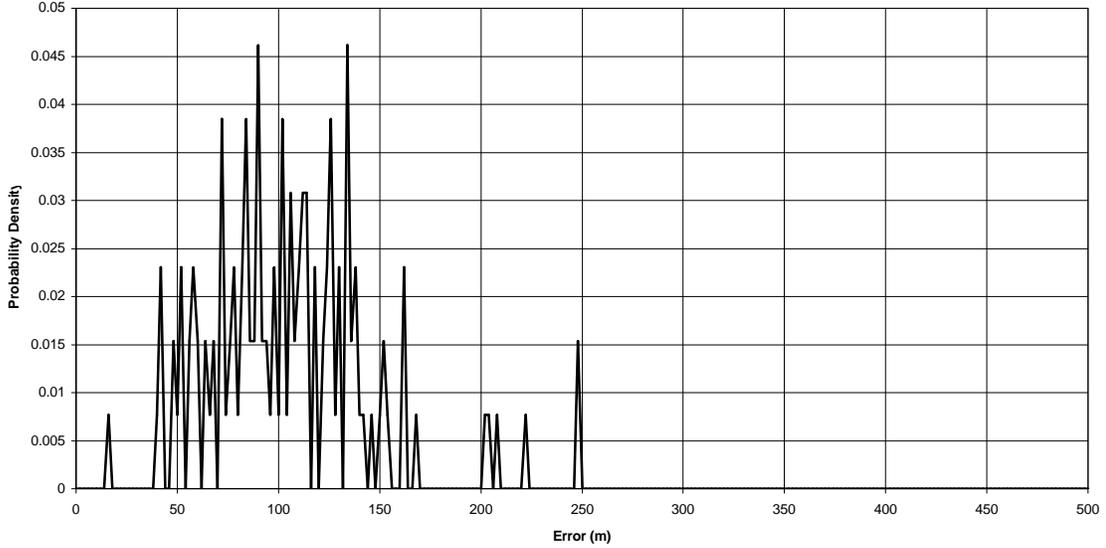
FIGURE U16D: PROBABILITY DENSITY FUNCTION FOR LOCATION ERROR

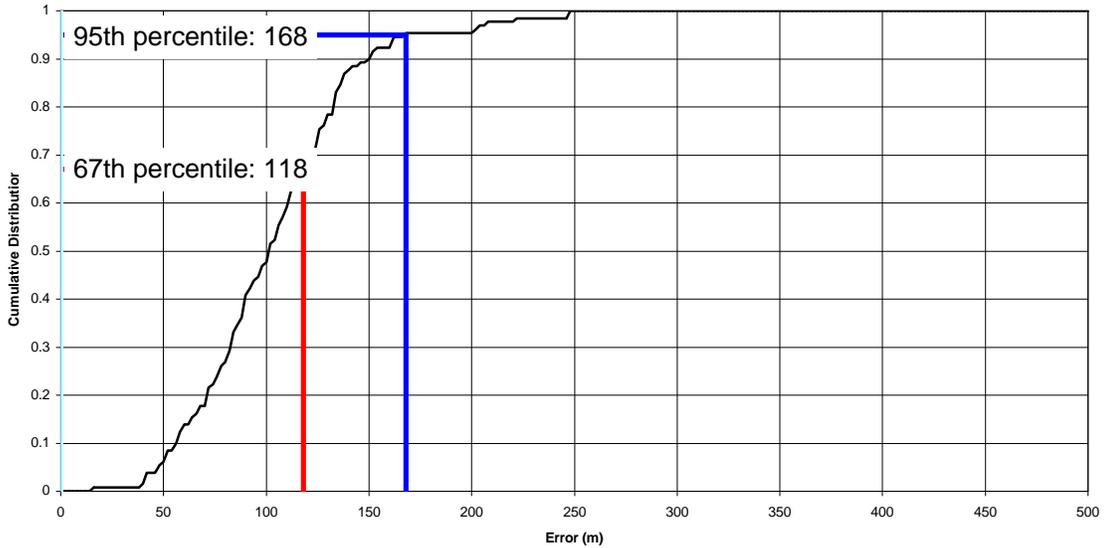
FIGURE U16E: CUMULATIVE DISTRIBUTION FUNCTION FOR LOCATION ERROR

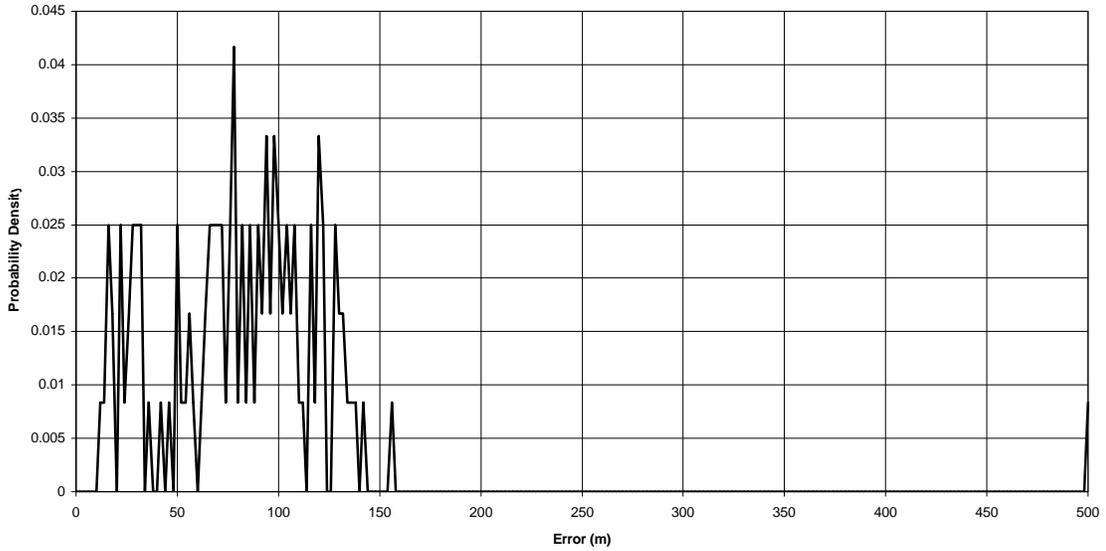
FIGURE U13D: PROBABILITY DENSITY FUNCTION FOR LOCATION ERROR

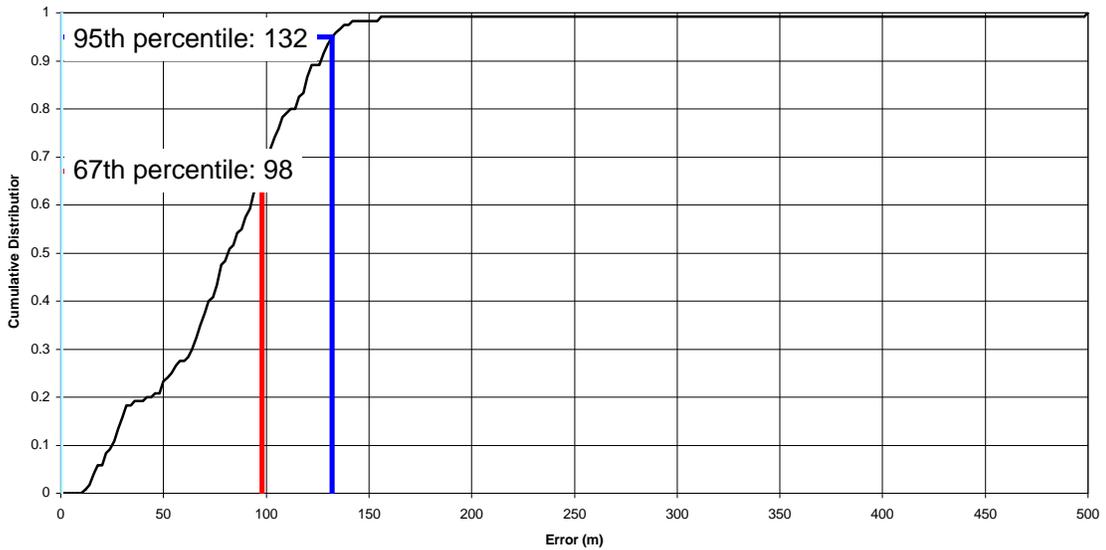
FIGURE U13E: CUMULATIVE DISTRIBUTION FUNCTION FOR LOCATION ERROR

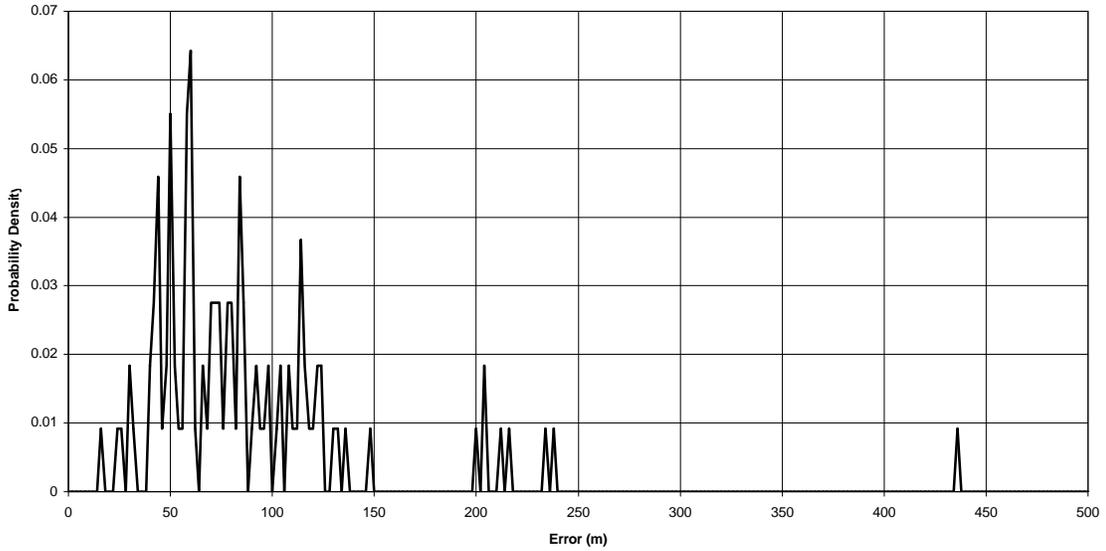
FIGURE U12D: PROBABILITY DENSITY FUNCTION FOR LOCATION ERROR

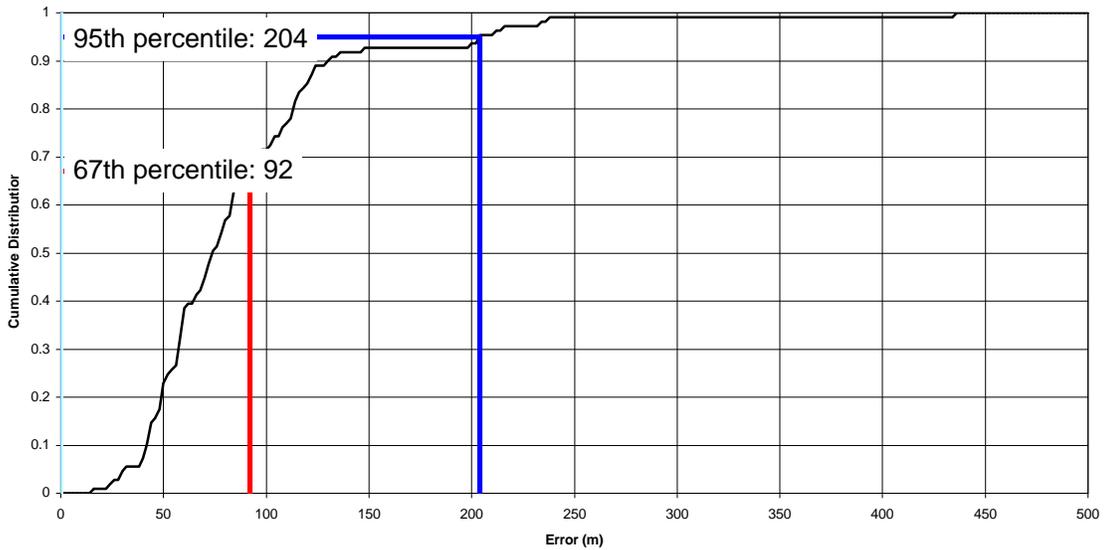
FIGURE U12E: CUMULATIVE DISTRIBUTION FUNCTION FOR LOCATION ERROR

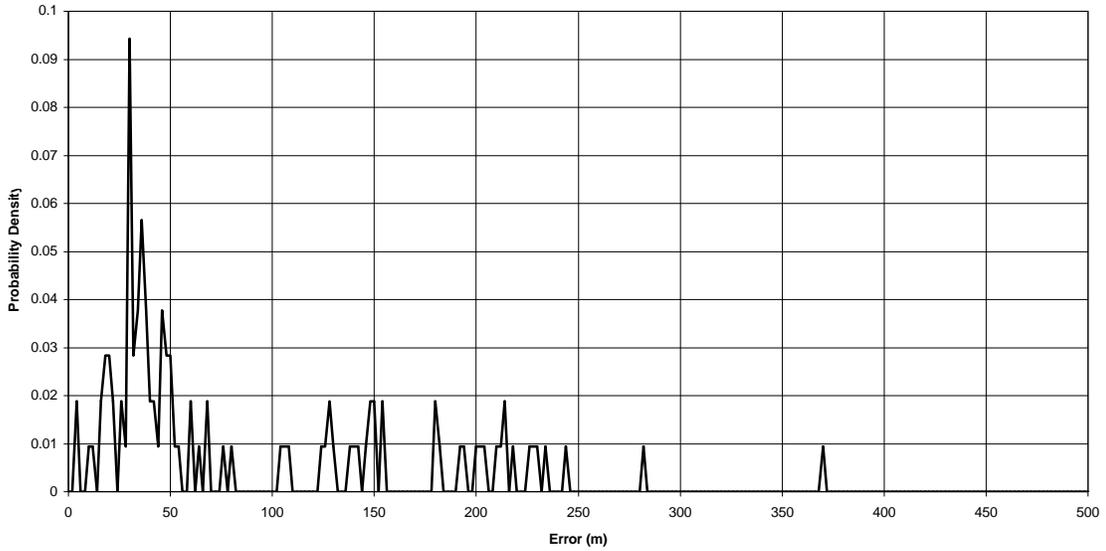
FIGURE U18D: PROBABILITY DENSITY FUNCTION FOR LOCATION ERROR

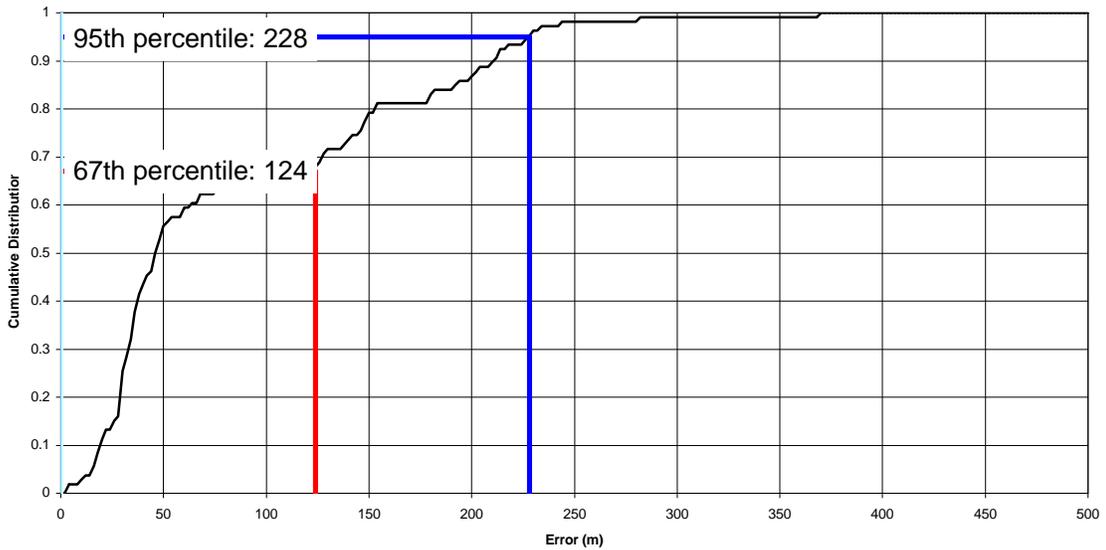
FIGURE U18E: CUMULATIVE DISTRIBUTION FUNCTION FOR LOCATION ERROR

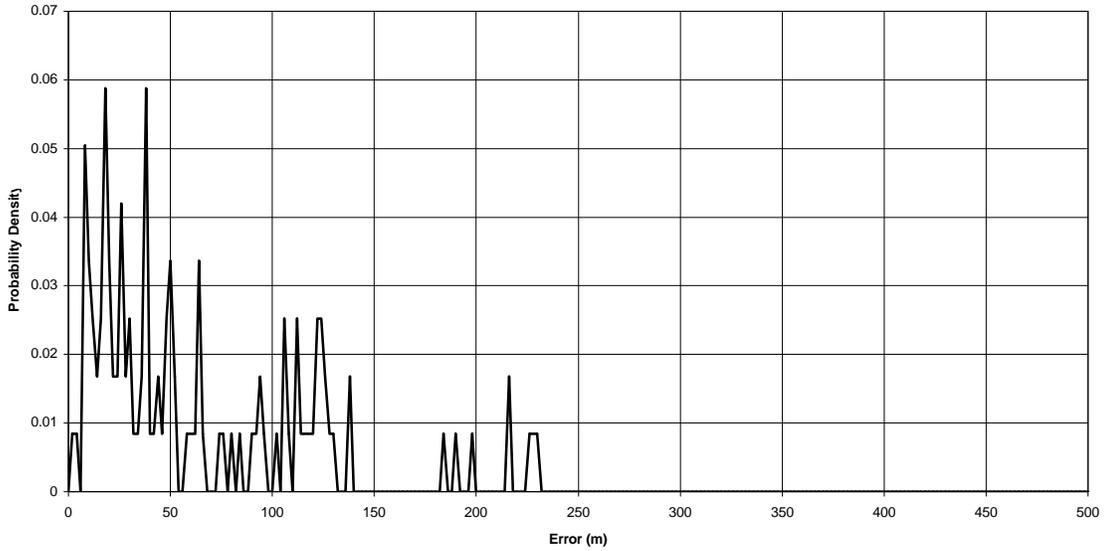
FIGURE U15D: PROBABILITY DENSITY FUNCTION FOR LOCATION ERROR

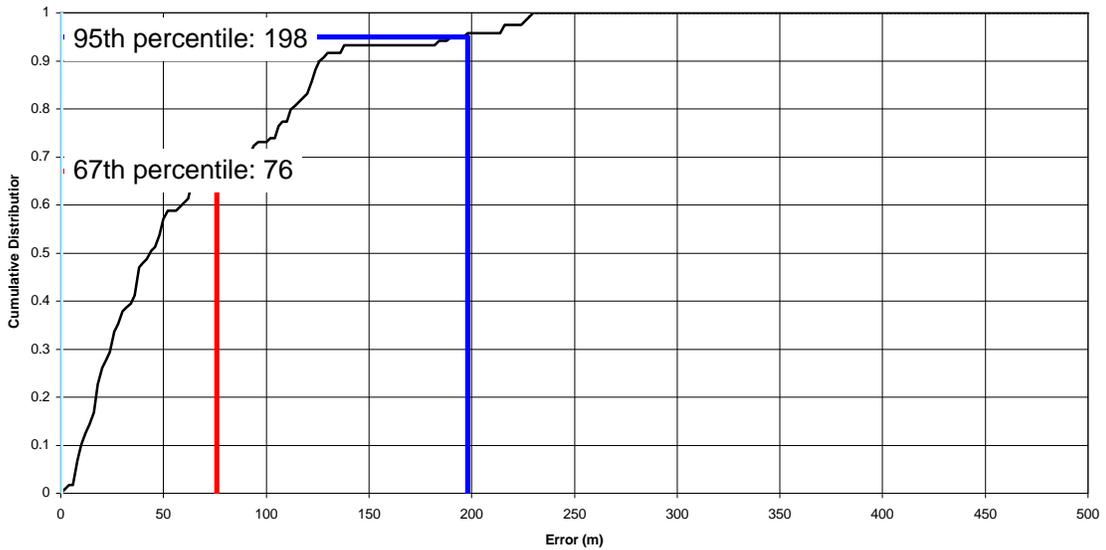
FIGURE U15E: CUMULATIVE DISTRIBUTION FUNCTION FOR LOCATION ERROR

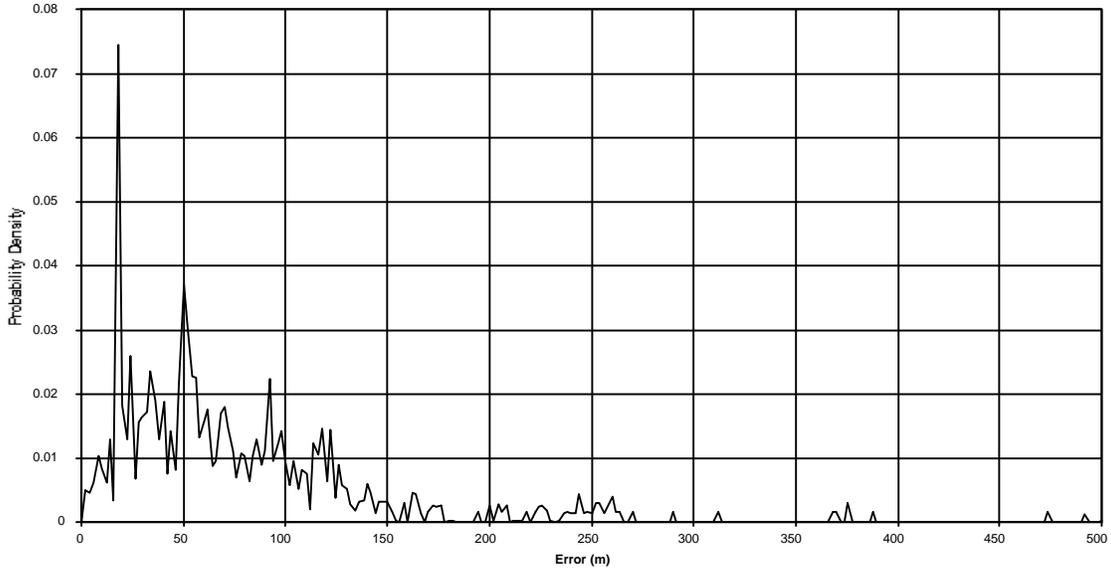
In the first profile it was assumed that the majority of calls are made outdoors (60%+25%+10% = 95%), as opposed to indoor (5%). This is based on the assumption that most 911 callers indoor would use a wireline phone. It was also assumed that in a dense urban environment almost twice as many 911 calls are made by pedestrians (60%) versus in-vehicle calls (25% +10% = 35%). It was further assumed that in a dense urban environment most in-vehicle calls are made from stationary vehicles, as opposed to moving vehicles. For this weighting profile the error is 88 meters 67% of the time and 226 meters 95% of the time, and is compliant with the FCC requirements. Figures 3.1 and 3.2 provide the weighted pdf and CDF for this profile.

FIGURE 3.1: PROBABILITY DENSITY FUNCTION (PROFILE 1)

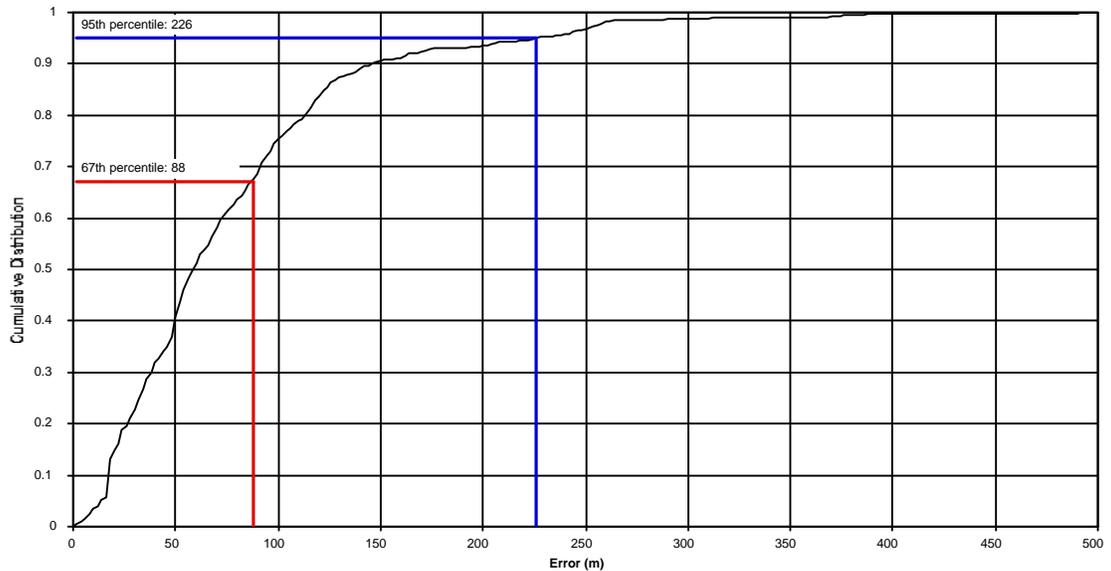
FIGURE 3.2: CUMULATIVE DISTRIBUTION FUNCTION

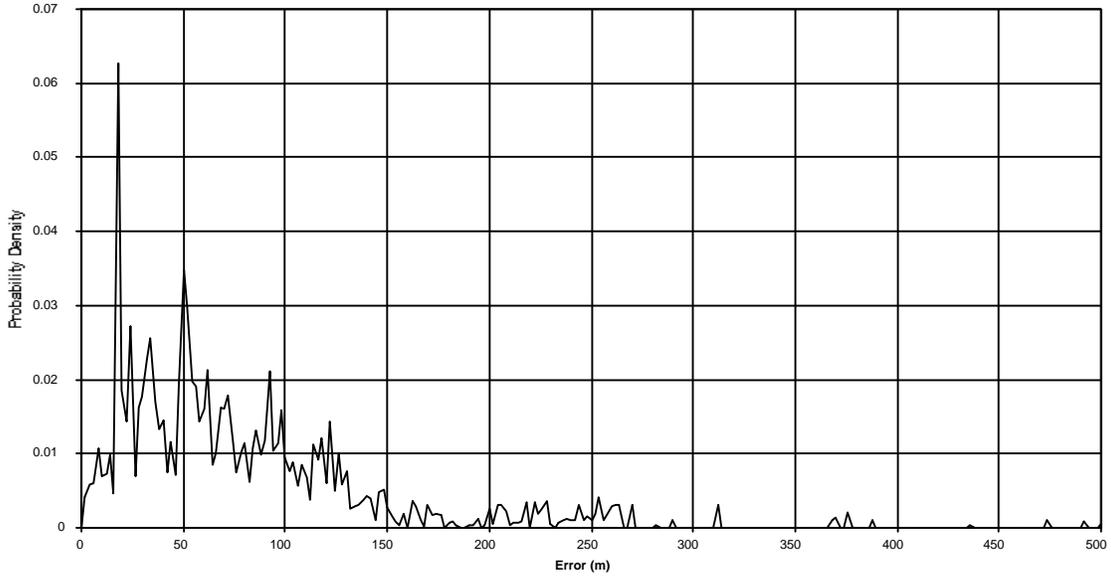
In the second profile it was assumed that a higher and more significant percentage of calls are made indoor (20%) compared to the first profile (only 5 % indoor). It was also assumed that pedestrians make a comparable number of 911 calls (40%) compared to in-vehicle calls (20% + 20%). It is also assumed that the number of calls from moving vehicles is comparable to the number of calls from stationary vehicles. For this weighting profile the error is 90 meters 67% of the time and 226 meters 95% of the time, and is also compliant with the FCC requirements. Figures 3.3 and 3.4 provide the weighted pdf and CDF for this profile.

FIGURE 3.3: PROBABILITY DENSITY FUNCTION (PROFILE 2)

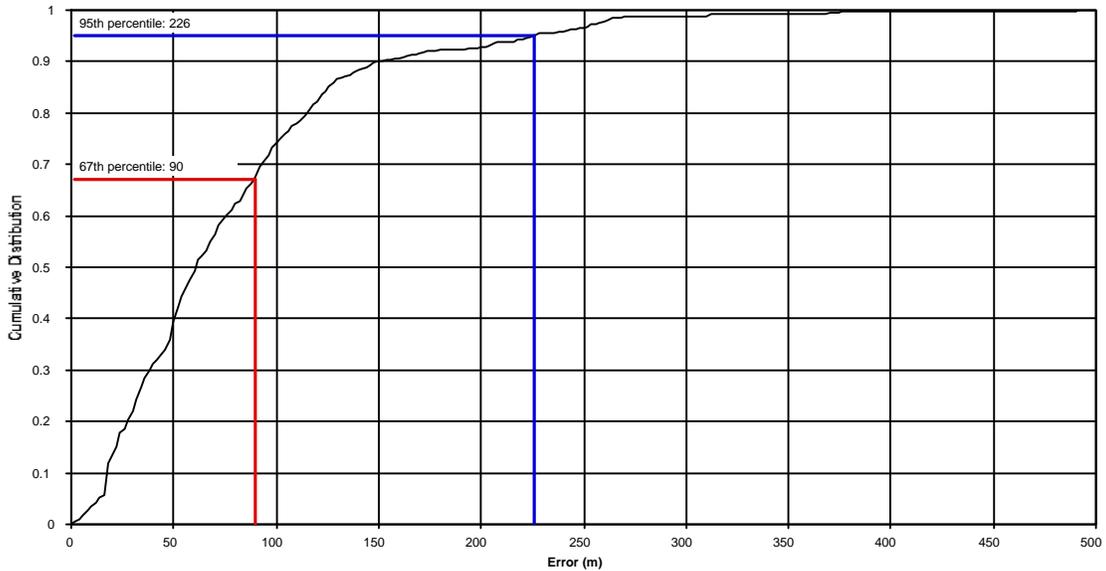
FIGURE 3.4: CUMULATIVE DISTRIBUTION FUNCTION (PROFILE 2)

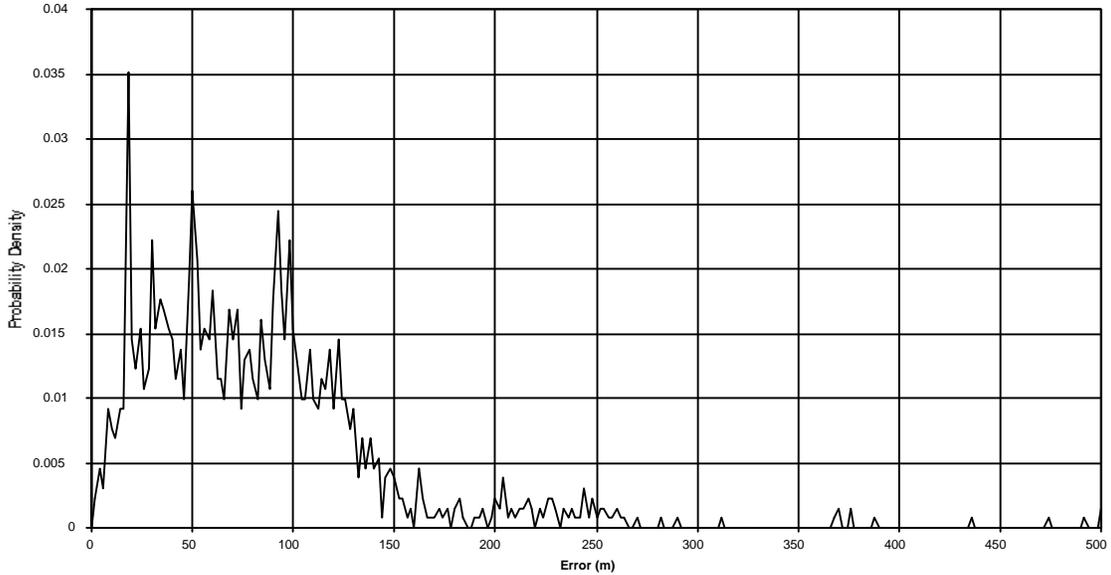
In the third profile it is assumed that the 12 tested scenario have equal weighting (i.e. $1/12 * 100\%$). For this weighting profile the error is 96 meters 67% of the time and 204 meters 95% of the time, and is compliant with the FCC requirement. Figures 3.5 and 3.6 provide the pdf and CDF for this profile.

FIGURE 3.5: PROBABILITY DENSITY FUNCTION (PROFILE 3)

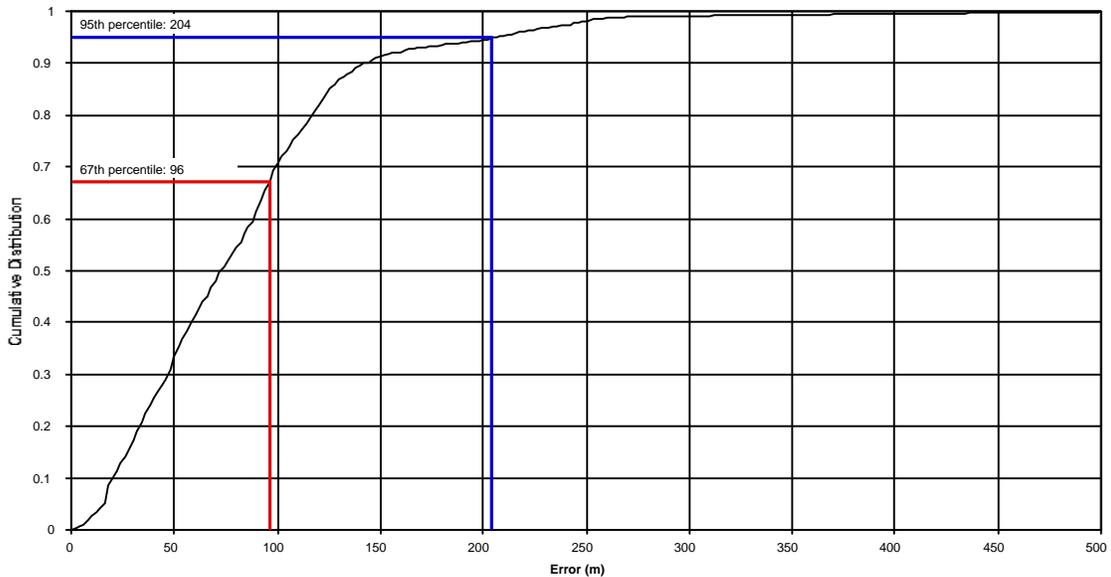
FIGURE 3.6: CUMULATIVE DISTRIBUTION FUNCTION (PROFILE 3)
