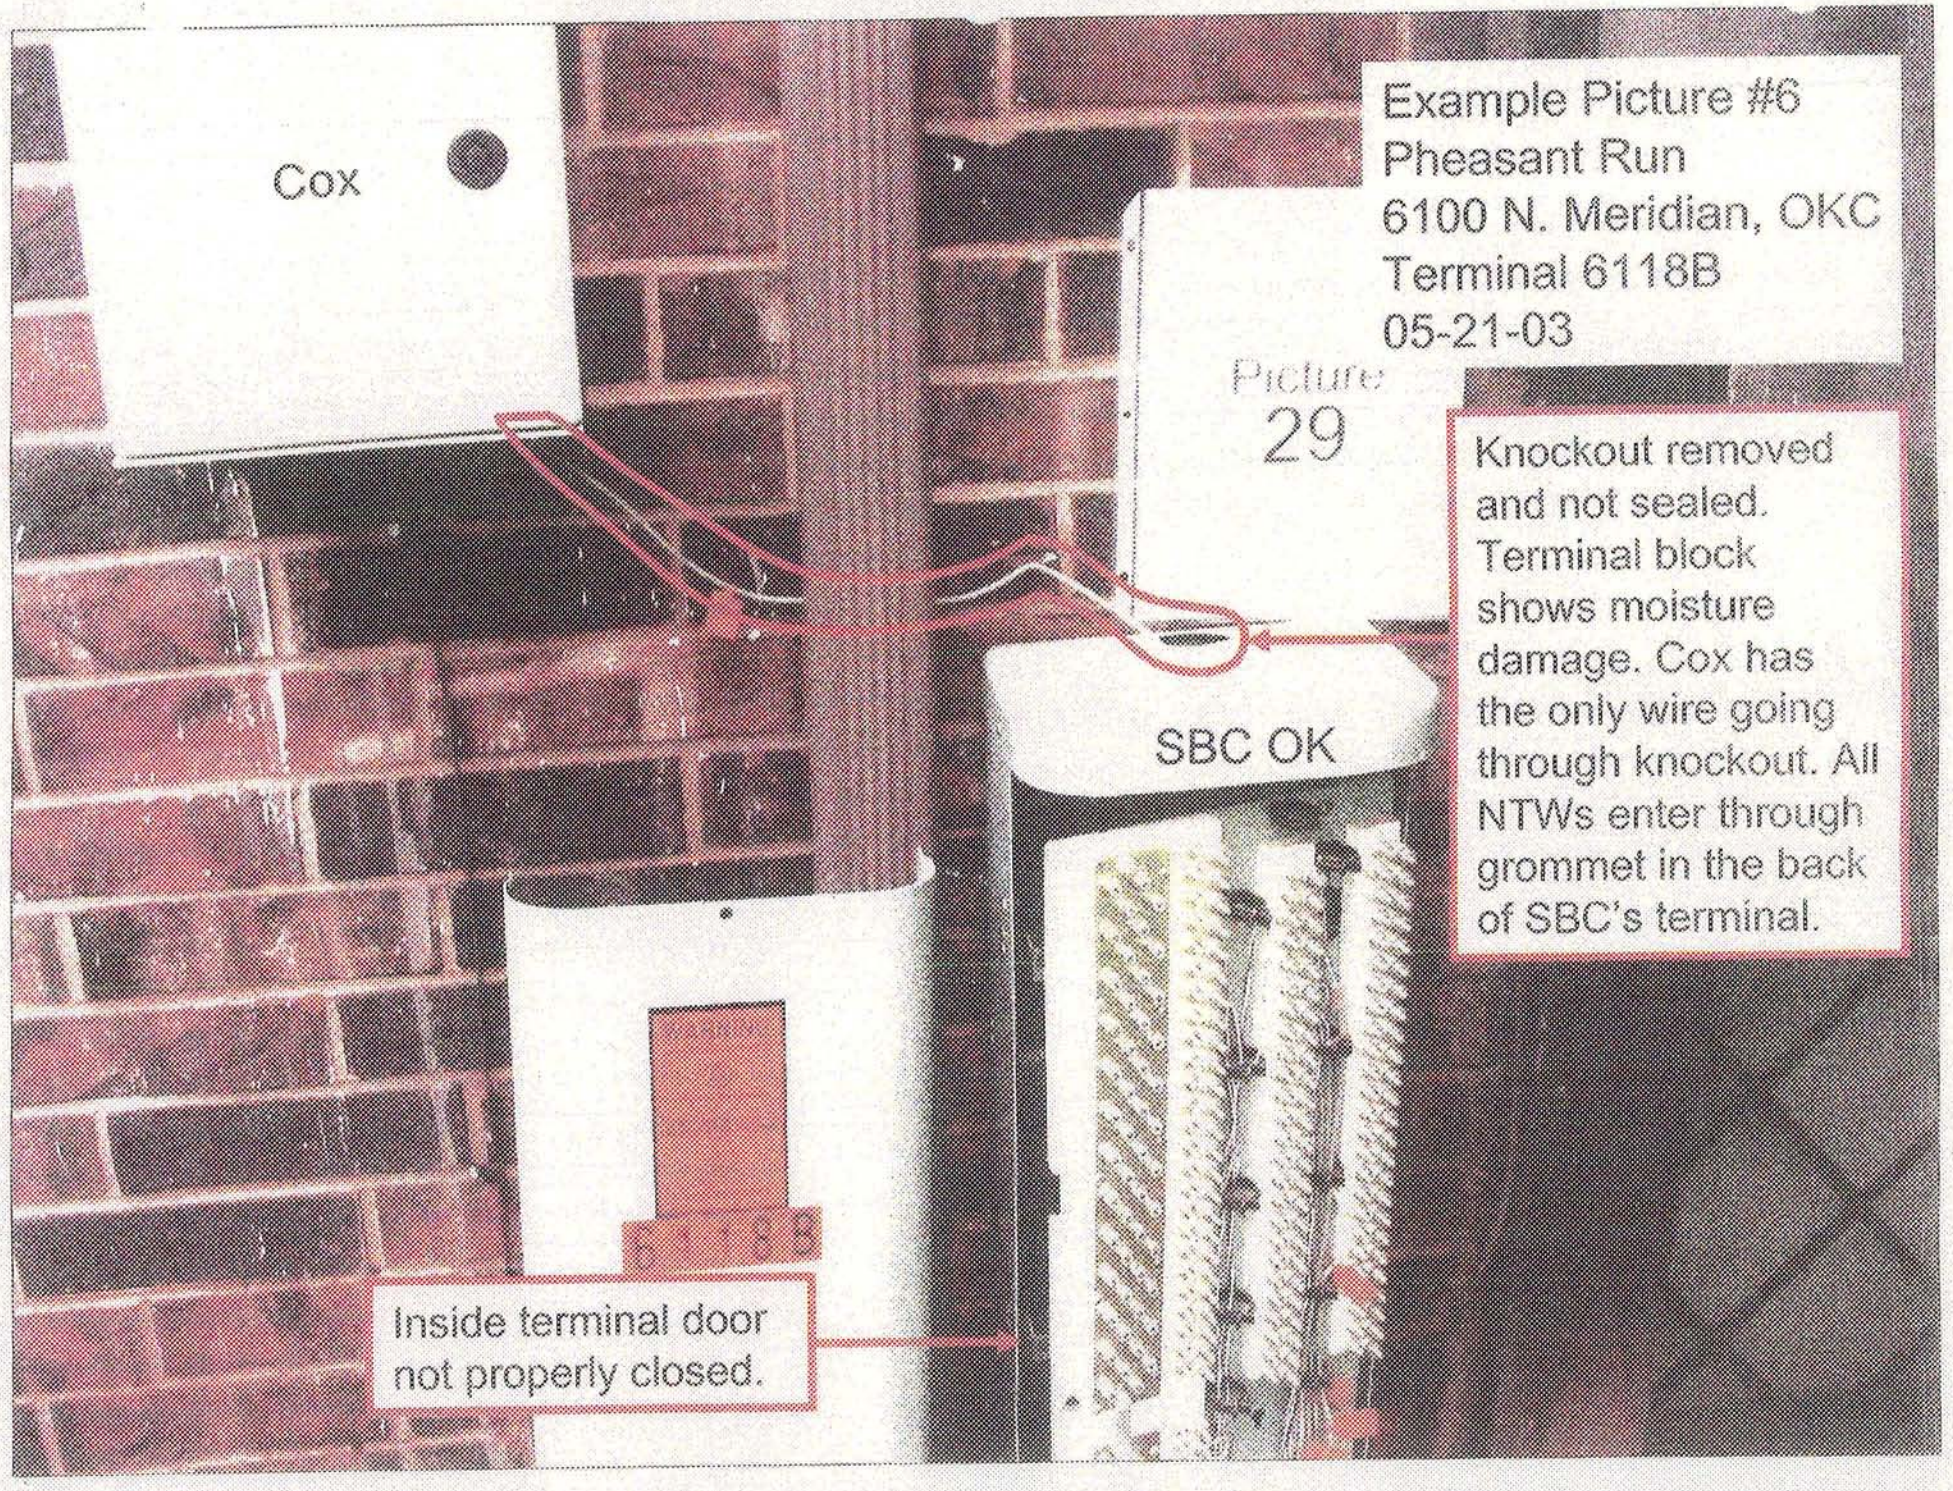
Cox
Example Picture #6
Pheasant Run
6100 N. Meridian, OKC
Terminal 6118B
05-21-03
Picture
29
Knockout removed and not sealed. Terminal block shows moisture damage. Cox has the only wire going through knockout. All NTWs enter through grommet in the back of SBC's terminal.
SBC OK
Inside terminal door not properly closed.

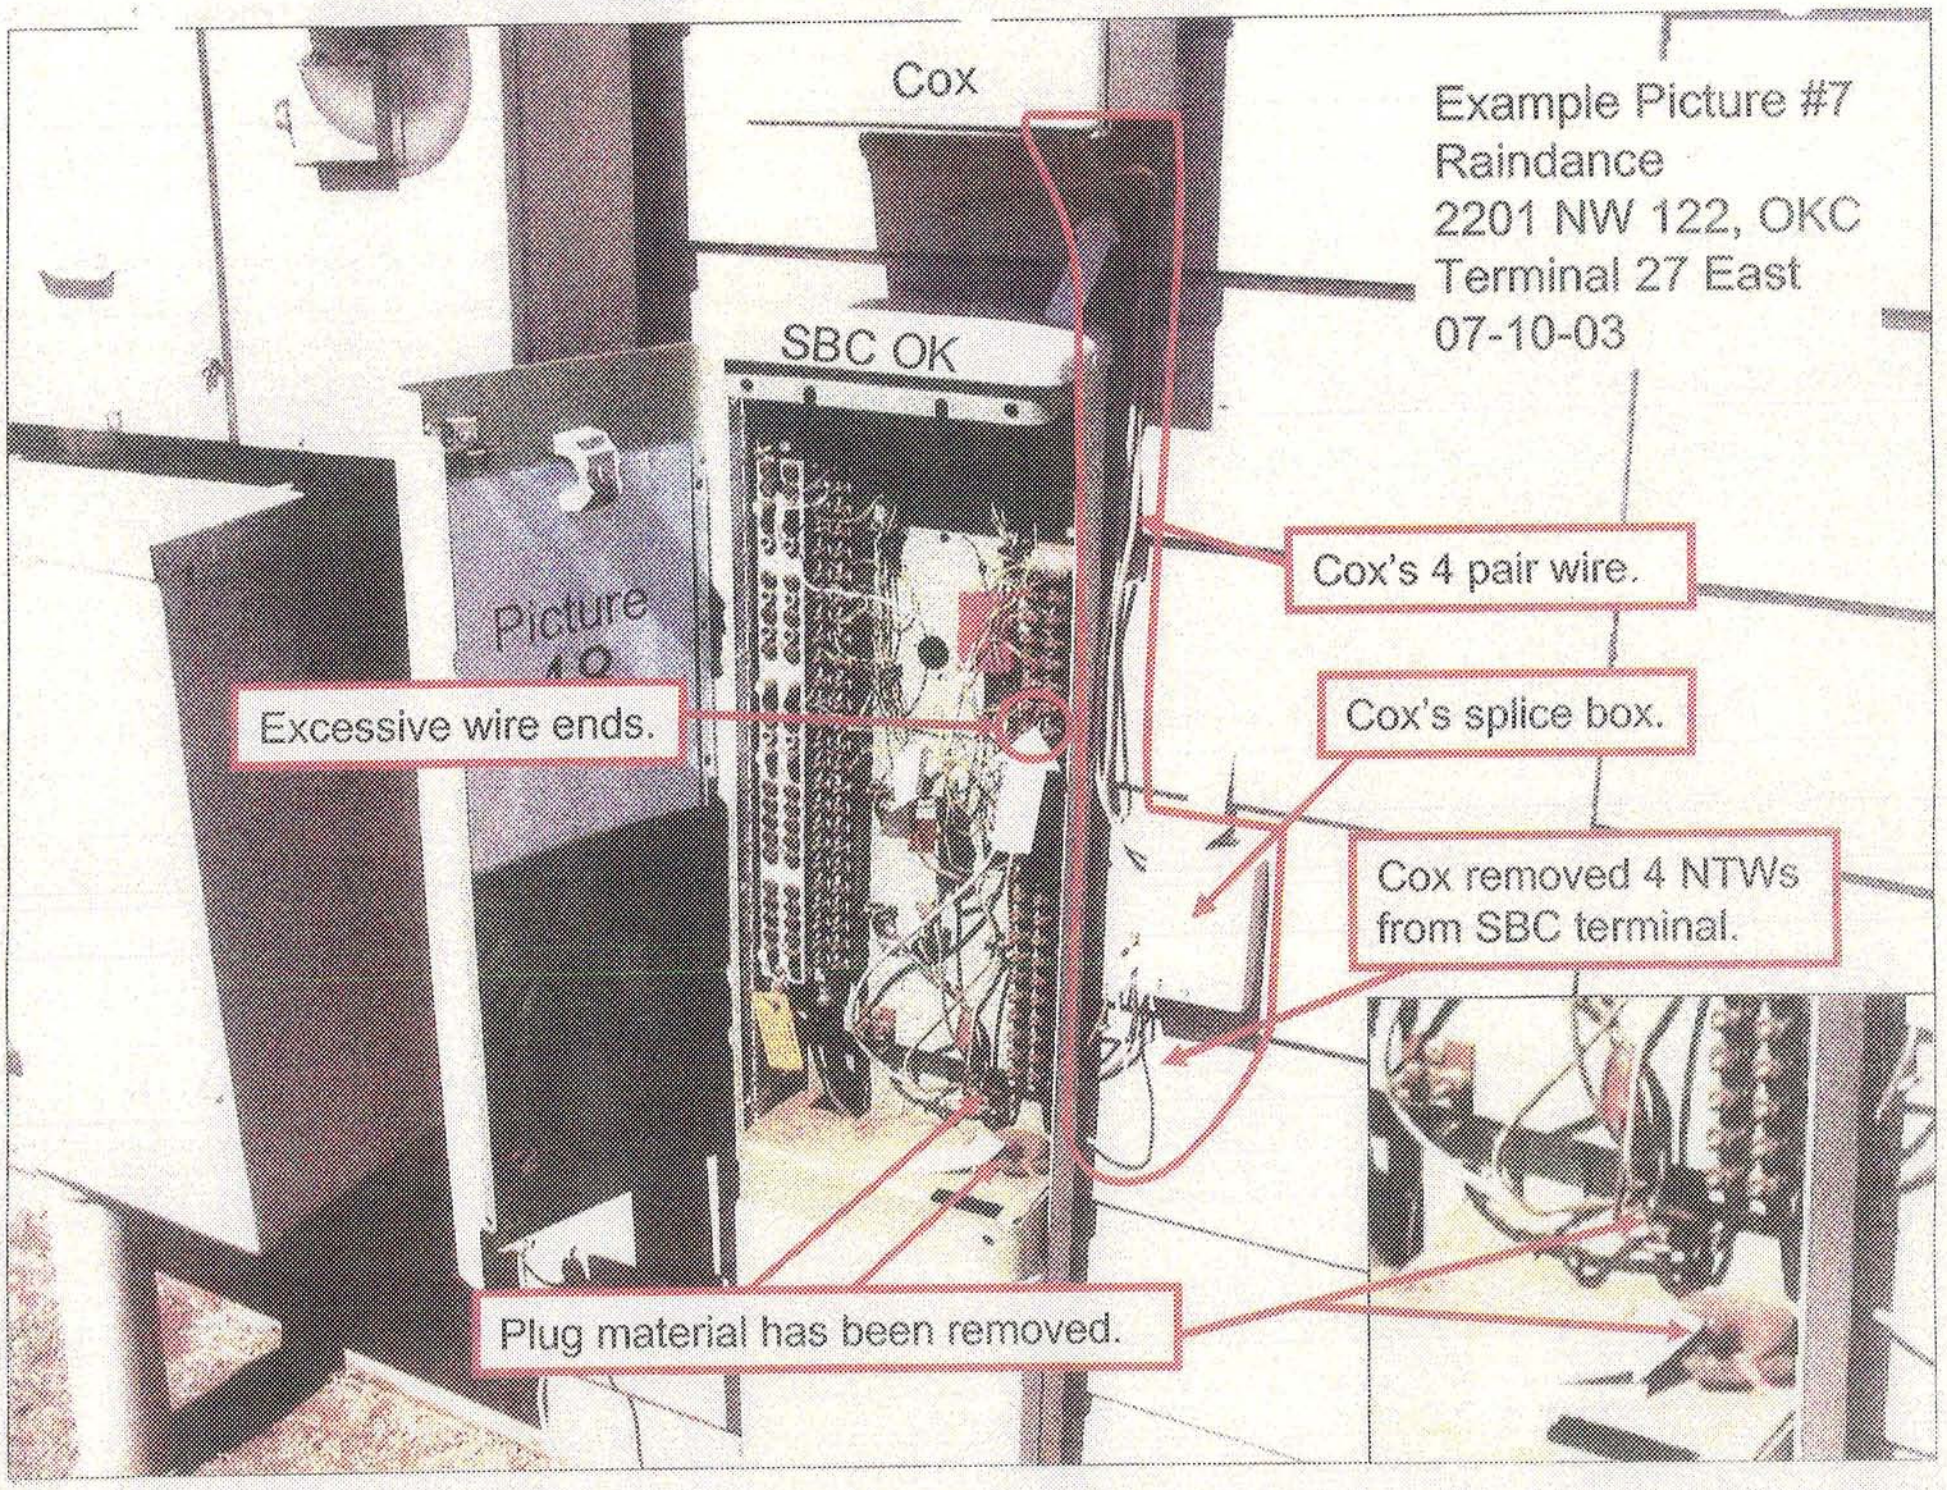
Cox
Example Picture #7
Raindance
2201 NW 122, OKC
Terminal 27 East
07-10-03
SBC OK
Picture
Excessive wire ends.
Cox's 4 pair wire.
Cox's splice box.
Cox removed 4 NTWs
from SBC terminal.
Plug material has been removed.

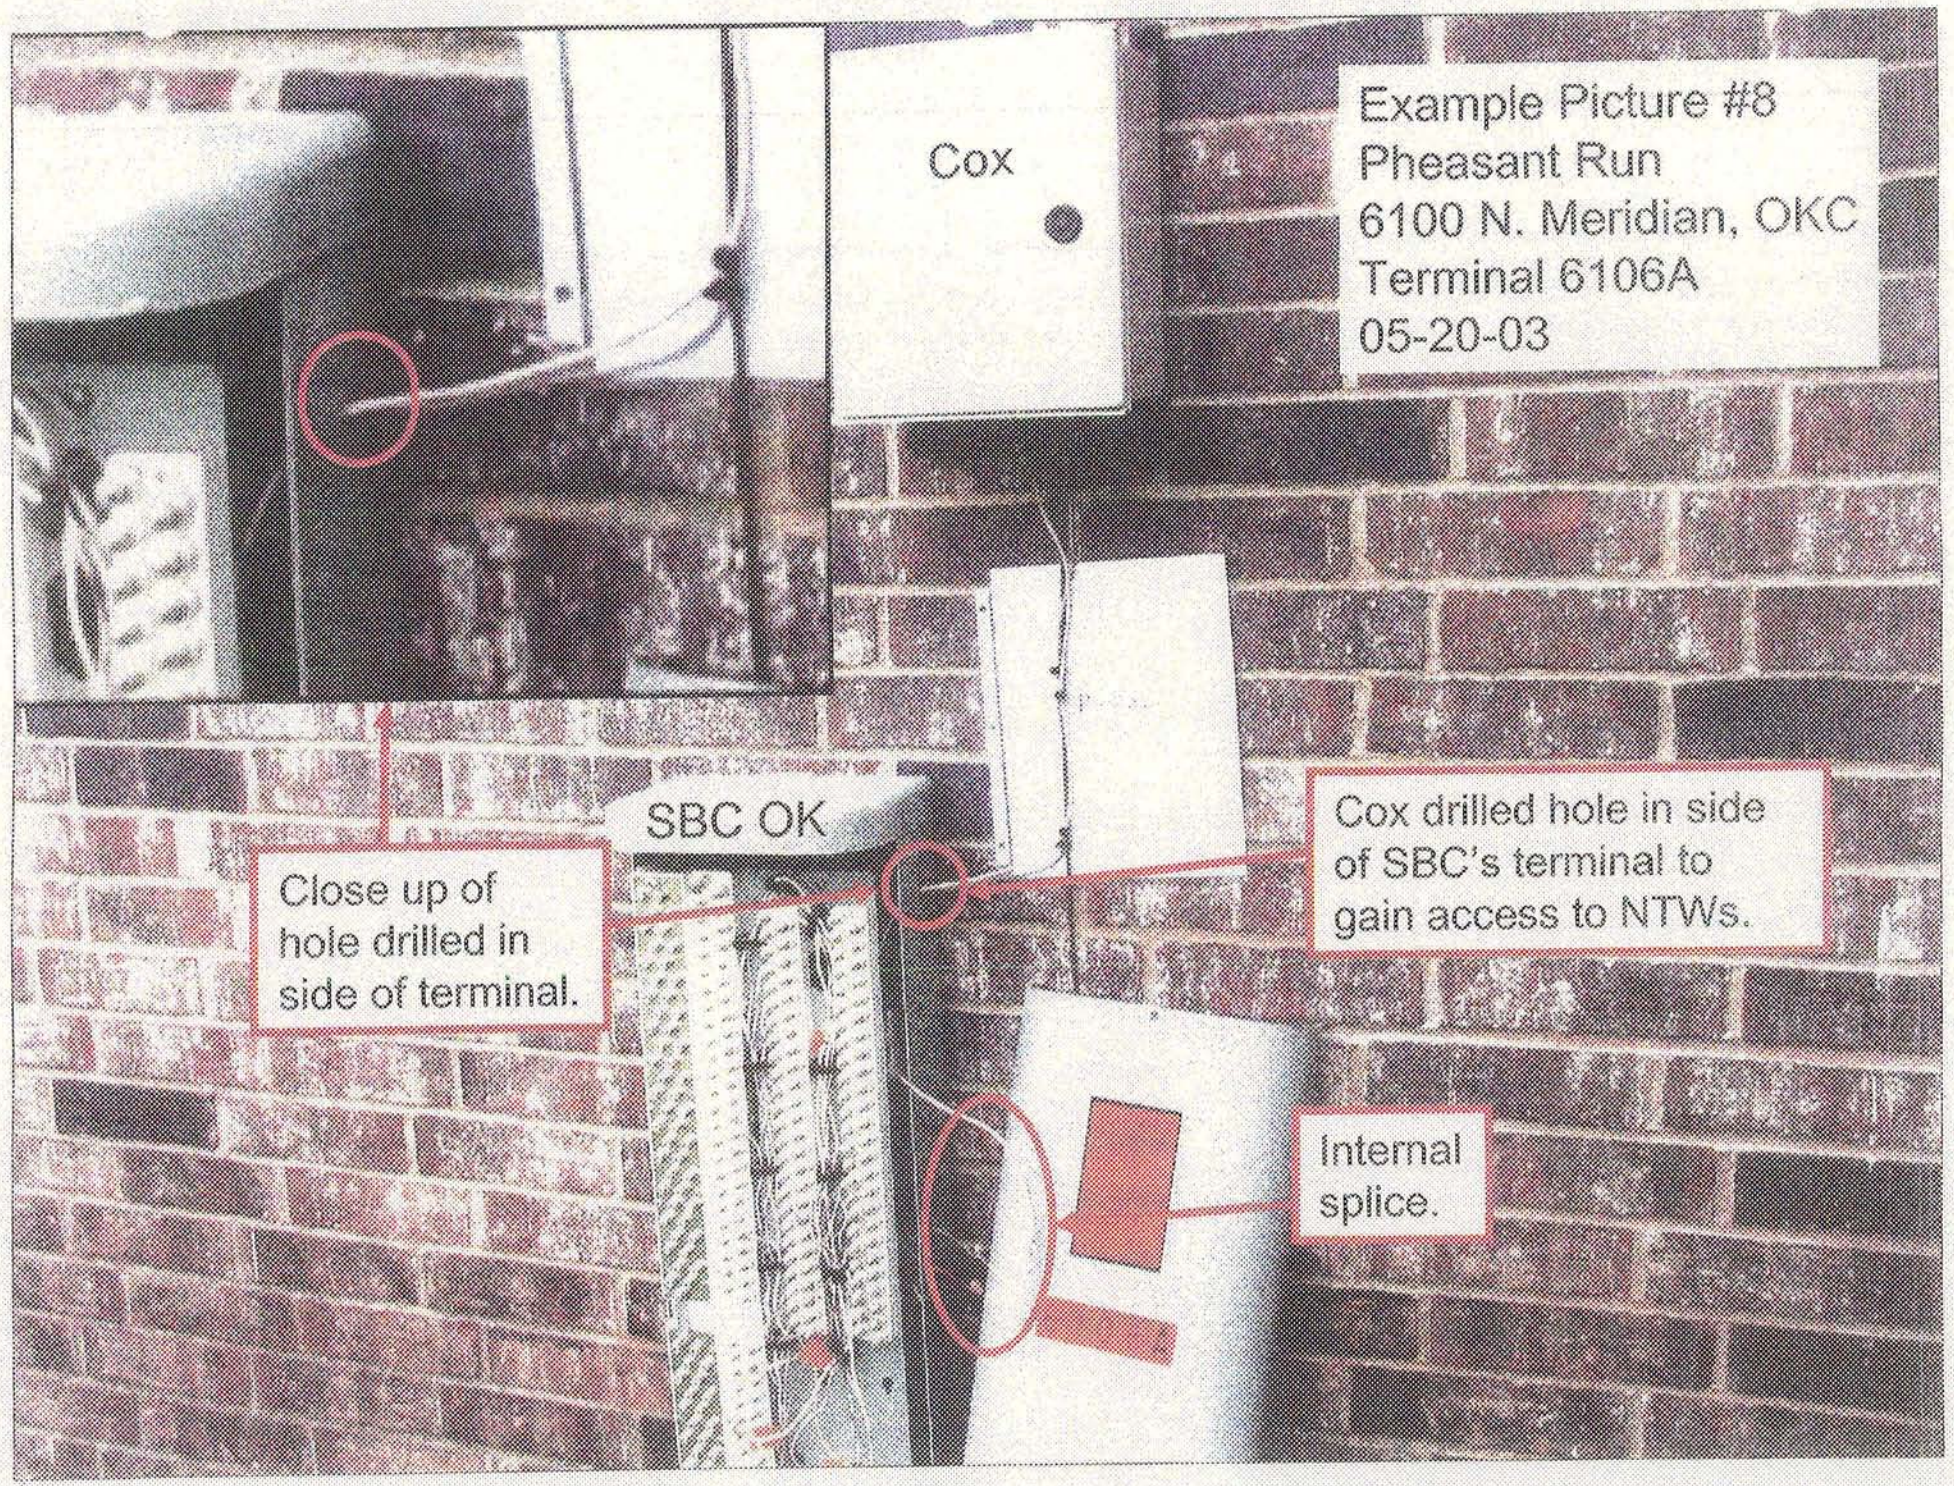
Cox
Example Picture #8
Pheasant Run
6100 N. Meridian, OKC
Terminal 6106A
05-20-03
SBC OK
Close up of hole drilled in side of terminal.
Cox drilled hole in side of SBC's terminal to gain access to NTWs.
Internal splice.

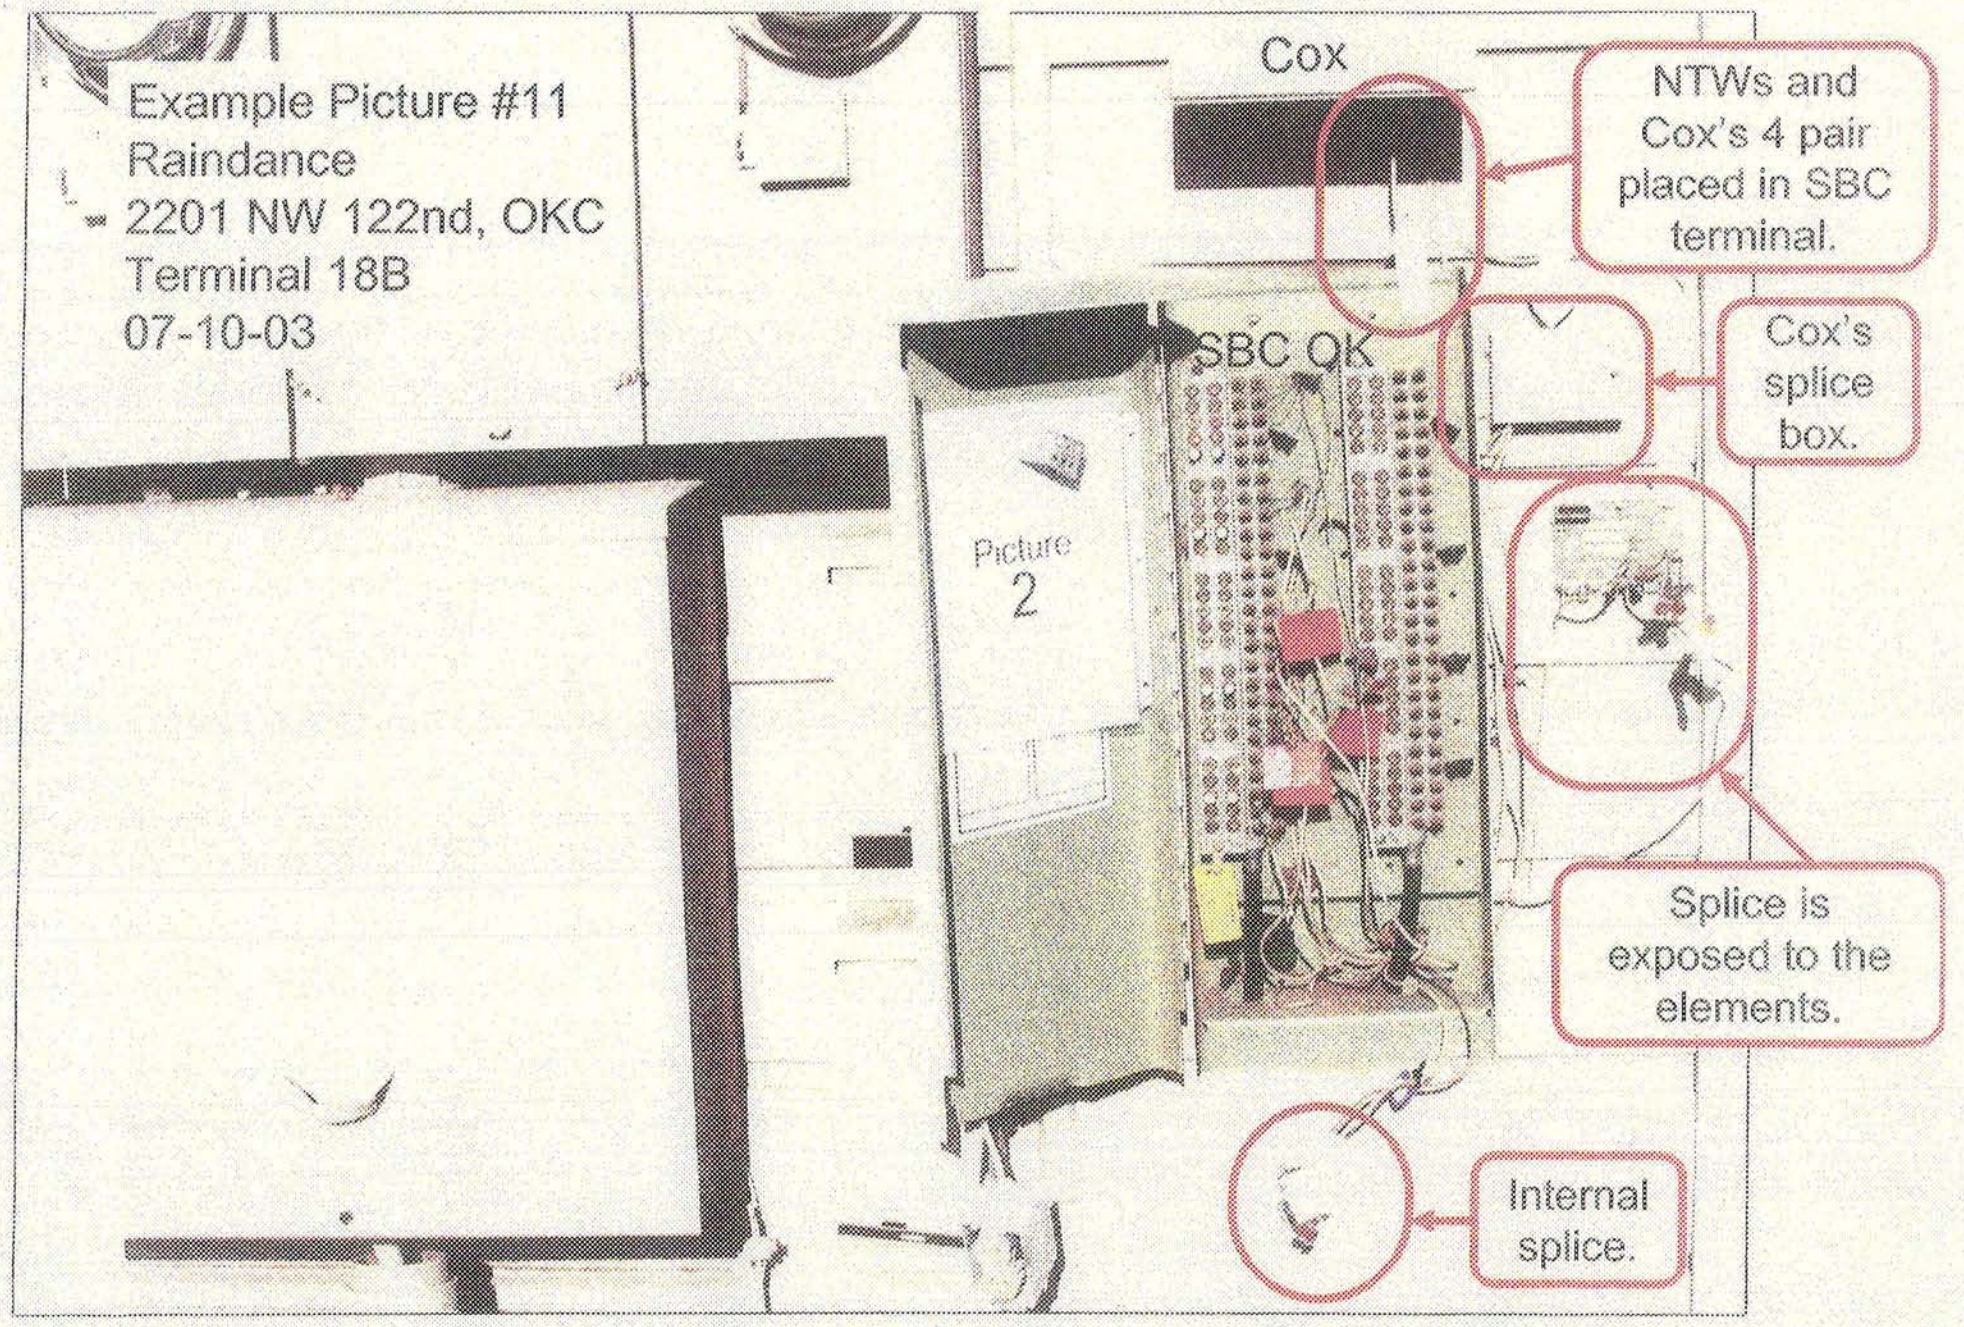
Example Picture #11
Raindance
2201 NW 122nd, OKC
Terminal 18B
07-10-03
Cox
NTWs and Cox's 4 pair placed in SBC terminal.
SBC OK
Cox's splice box.
Picture 2
Splice is exposed to the elements.
Internal splice.
