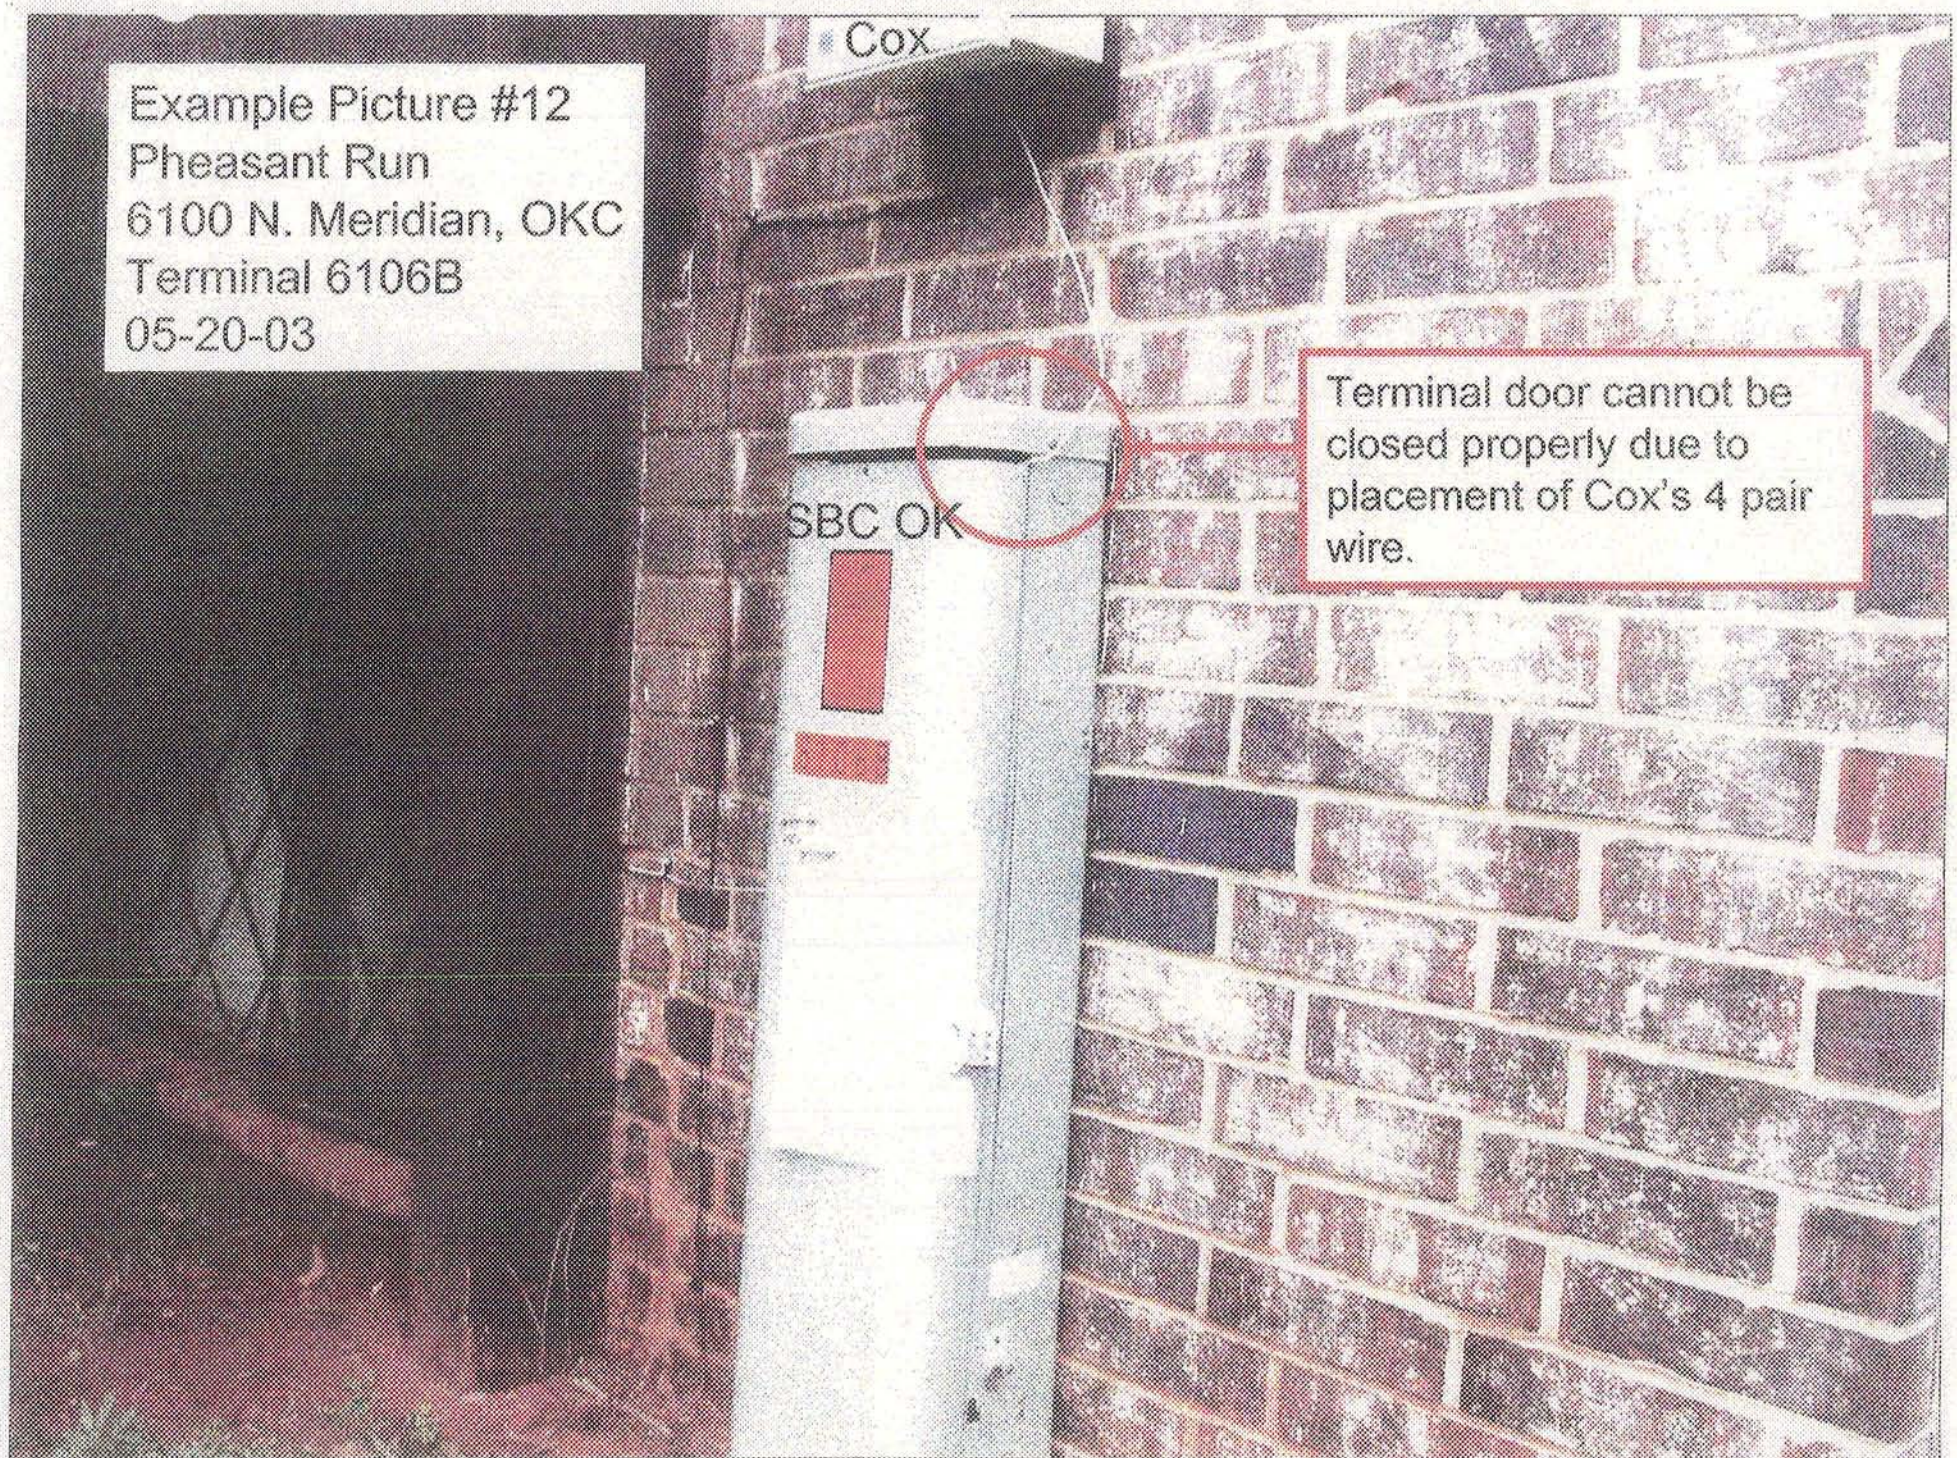
Example Picture #12
Pheasant Run
6100 N. Meridian, OKC
Terminal 6106B
05-20-03
Cox
SBC OK
Terminal door cannot be closed properly due to placement of Cox's 4 pair wire.

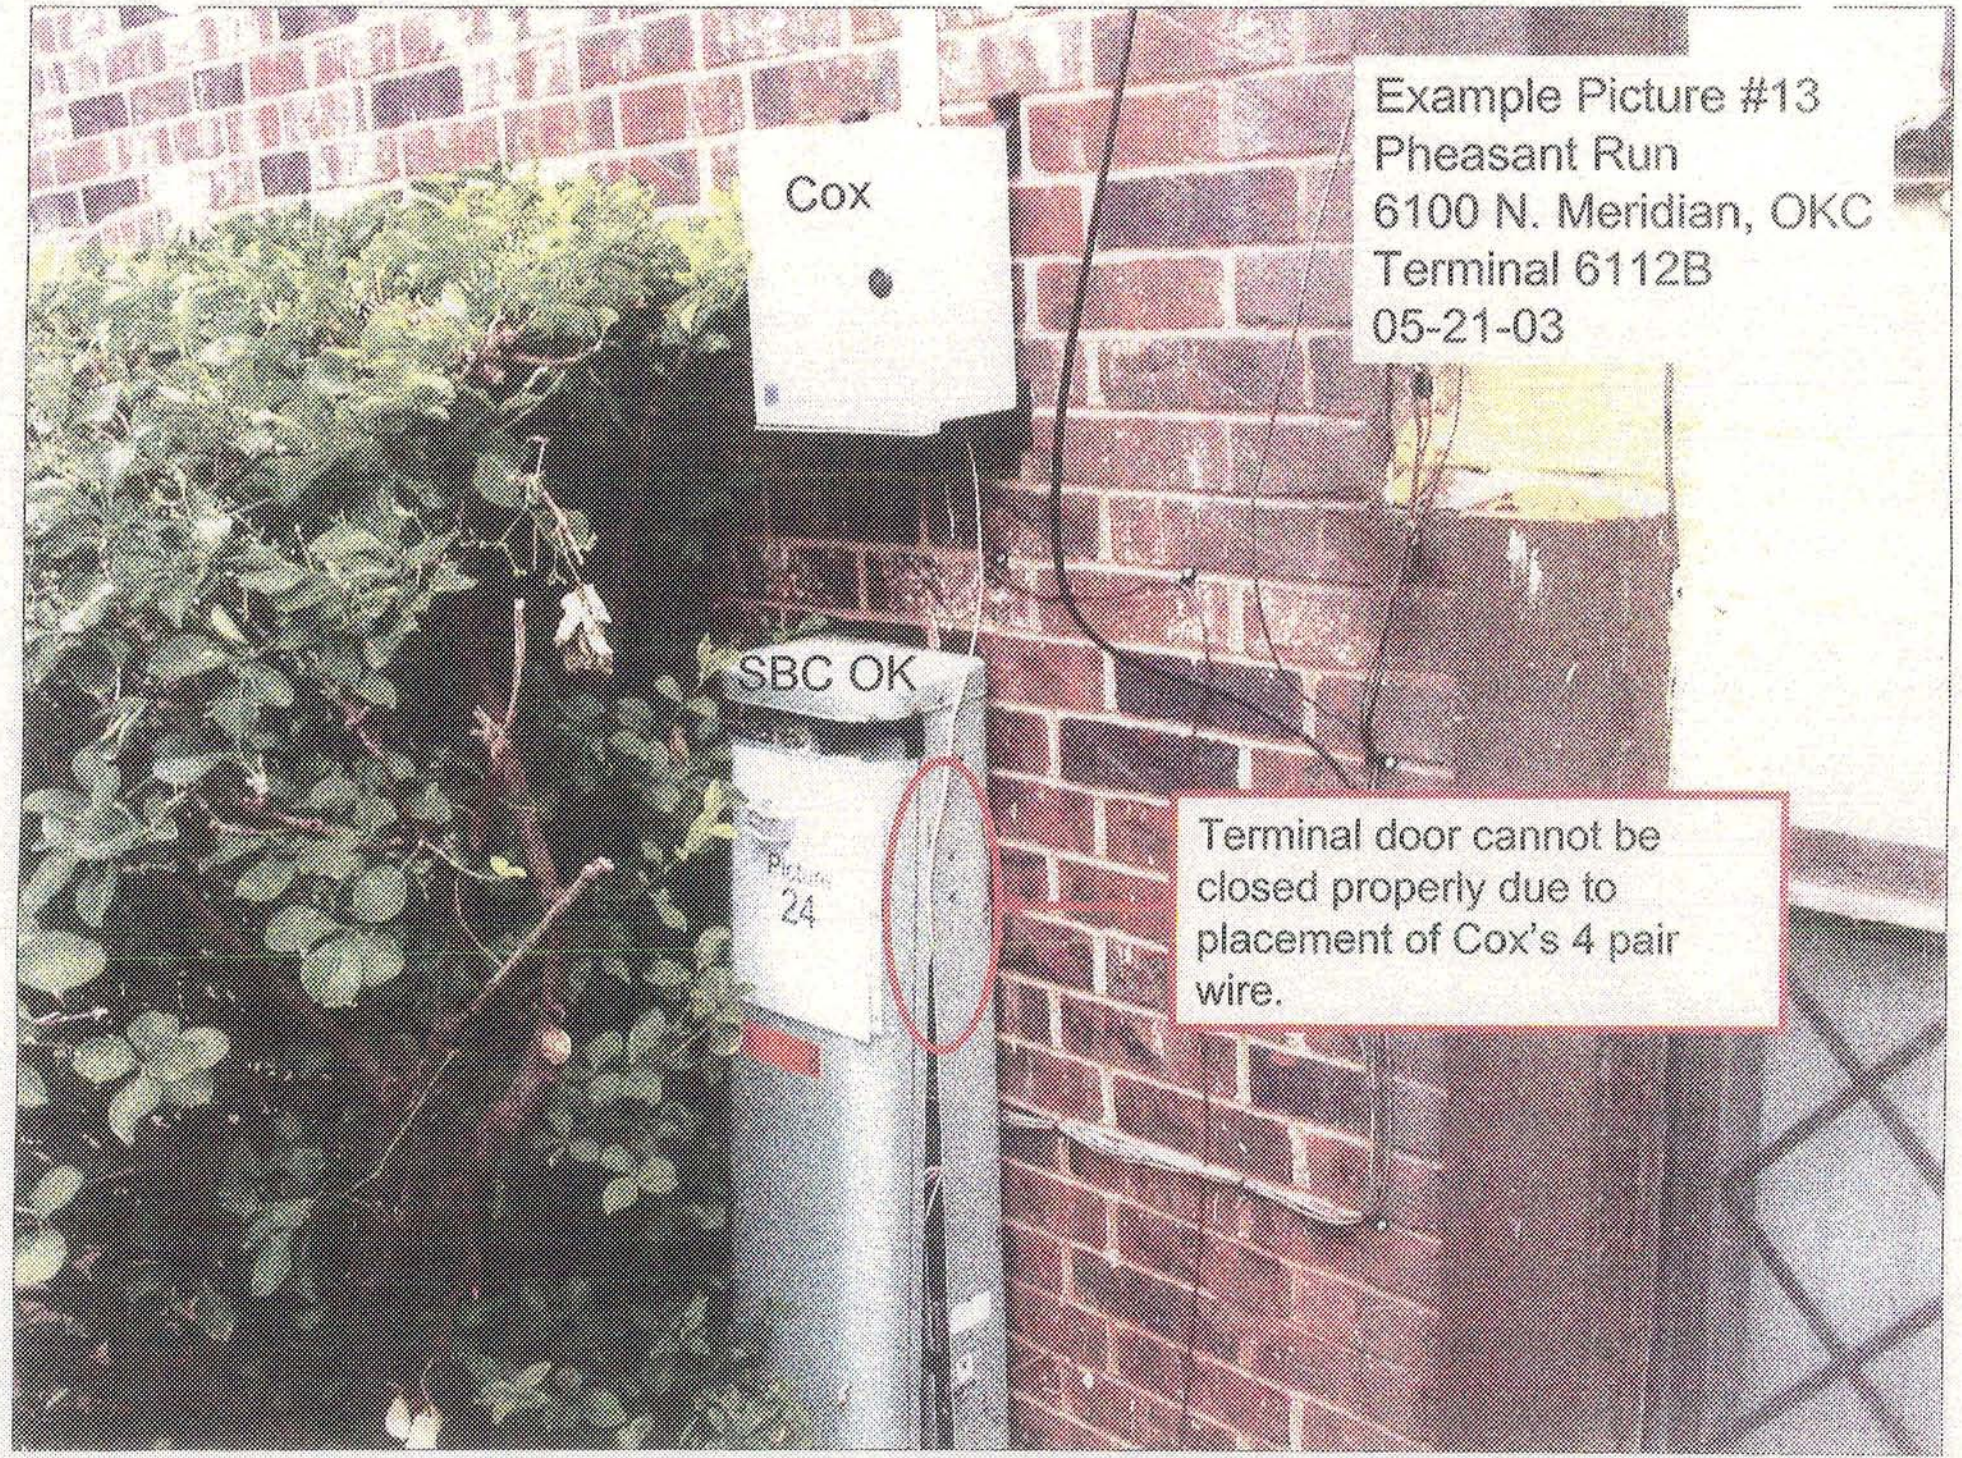
Example Picture #13
Pheasant Run
6100 N. Meridian, OKC
Terminal 6112B
05-21-03
Cox
SBC OK
24
Terminal door cannot be closed properly due to placement of Cox's 4 pair wire.

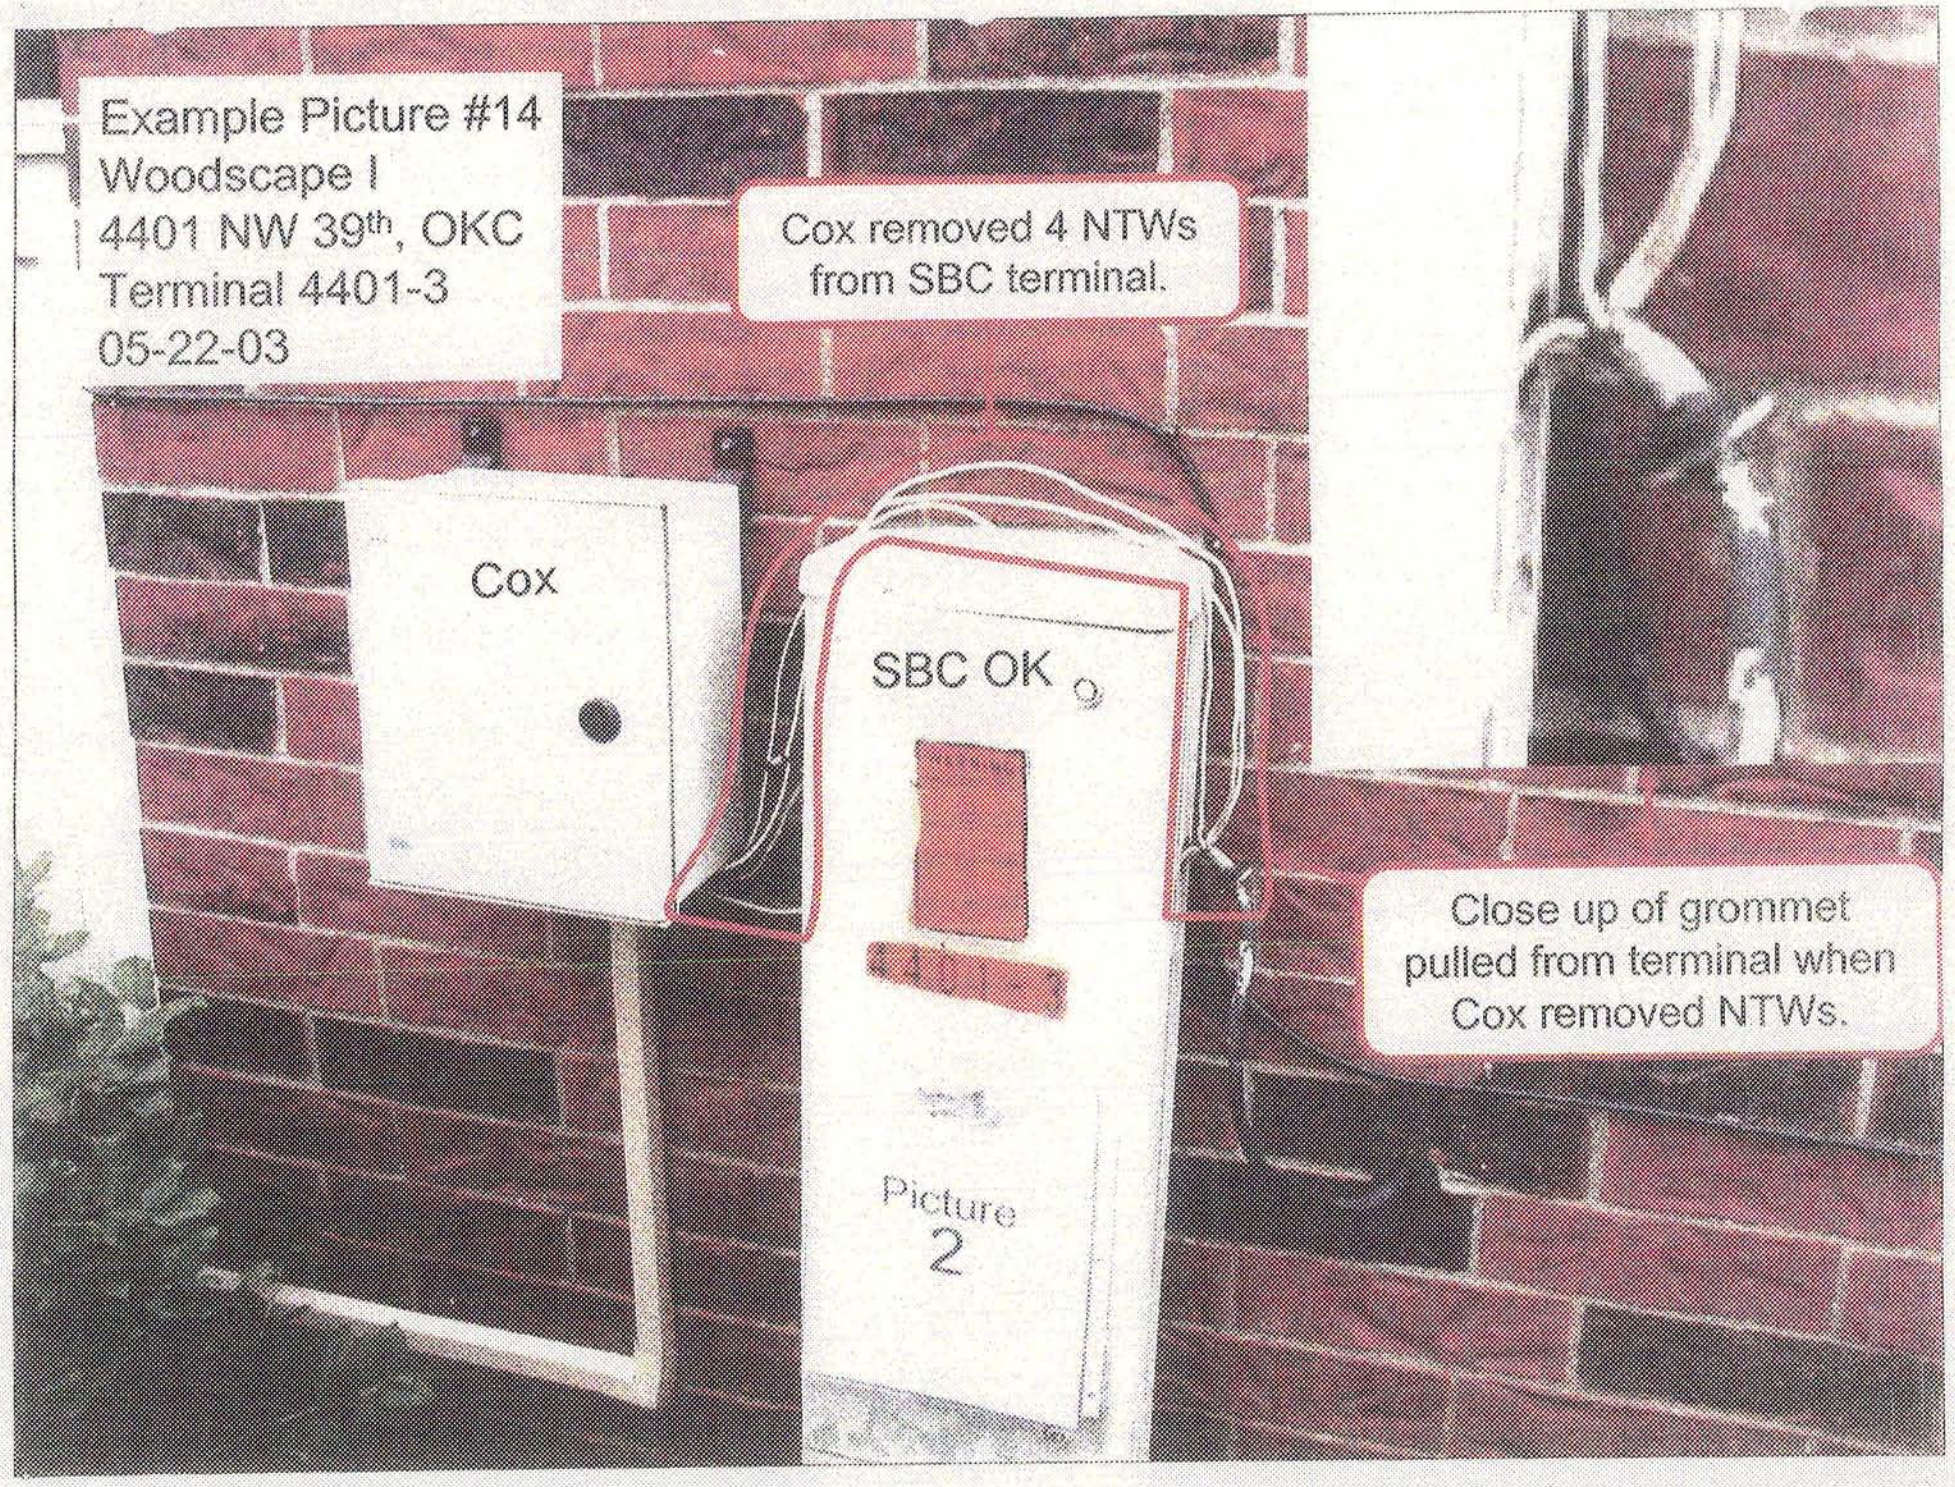
Example Picture #14
Woodscape I
4401 NW 39th, OKC
Terminal 4401-3
05-22-03
Cox removed 4 NTWs from SBC terminal.
Cox
SBC OK
Close up of grommet pulled from terminal when Cox removed NTWs.
Picture 2

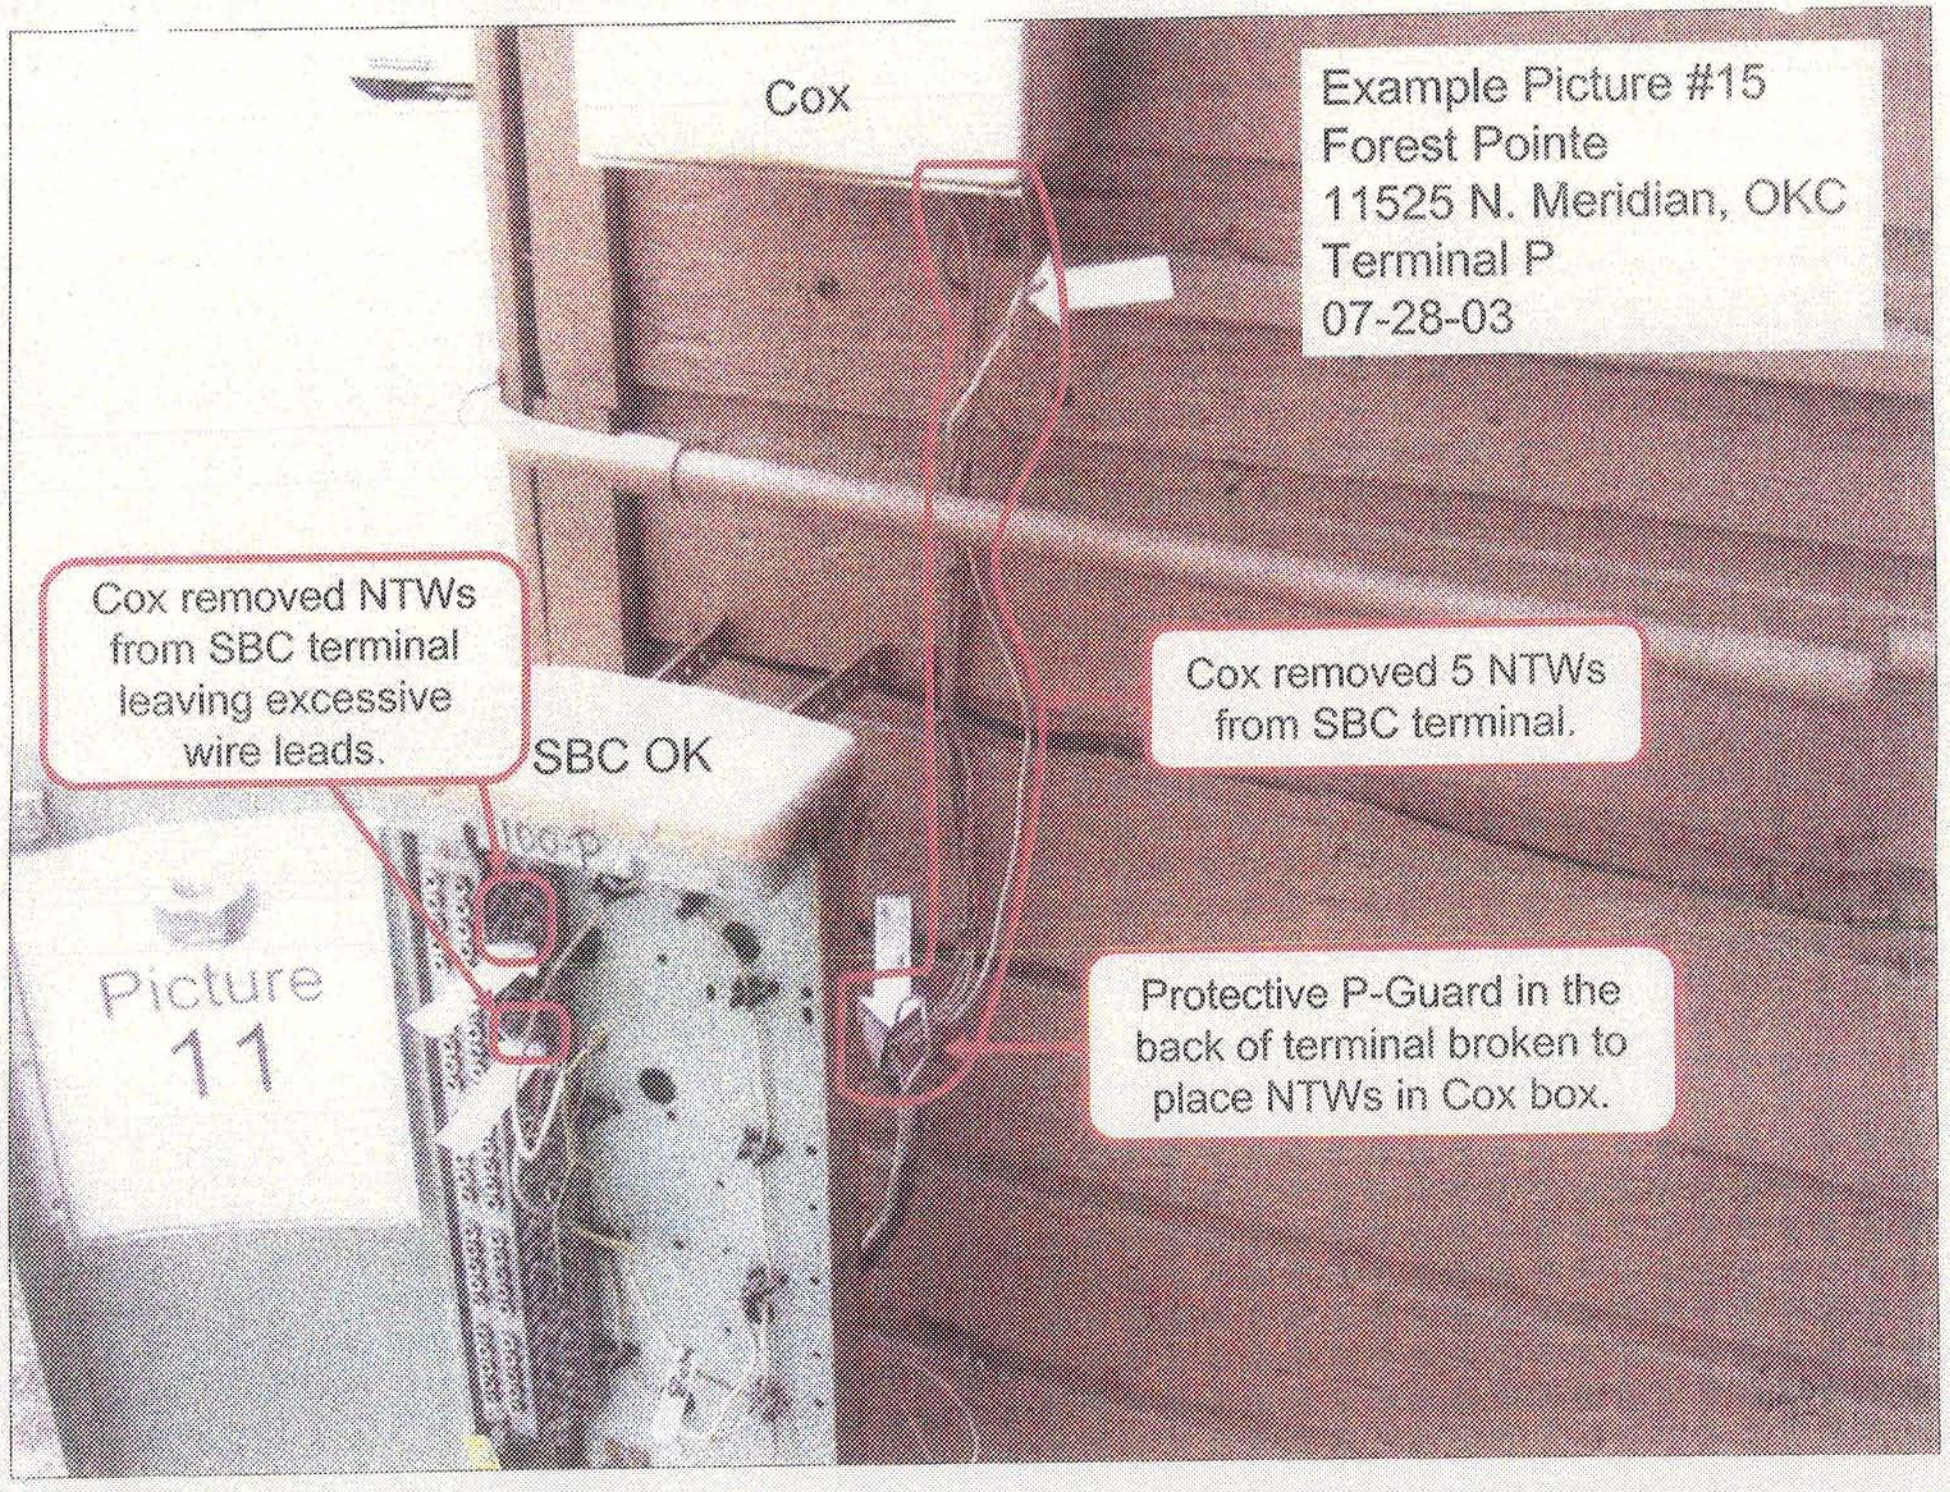
Cox
Example Picture #15
Forest Pointe
11525 N. Meridian, OKC
Terminal P
07-28-03
Cox removed NTWs from SBC terminal leaving excessive wire leads.
SBC OK
Cox removed 5 NTWs from SBC terminal.
Protective P-Guard in the back of terminal broken to place NTWs in Cox box.
Picture 11

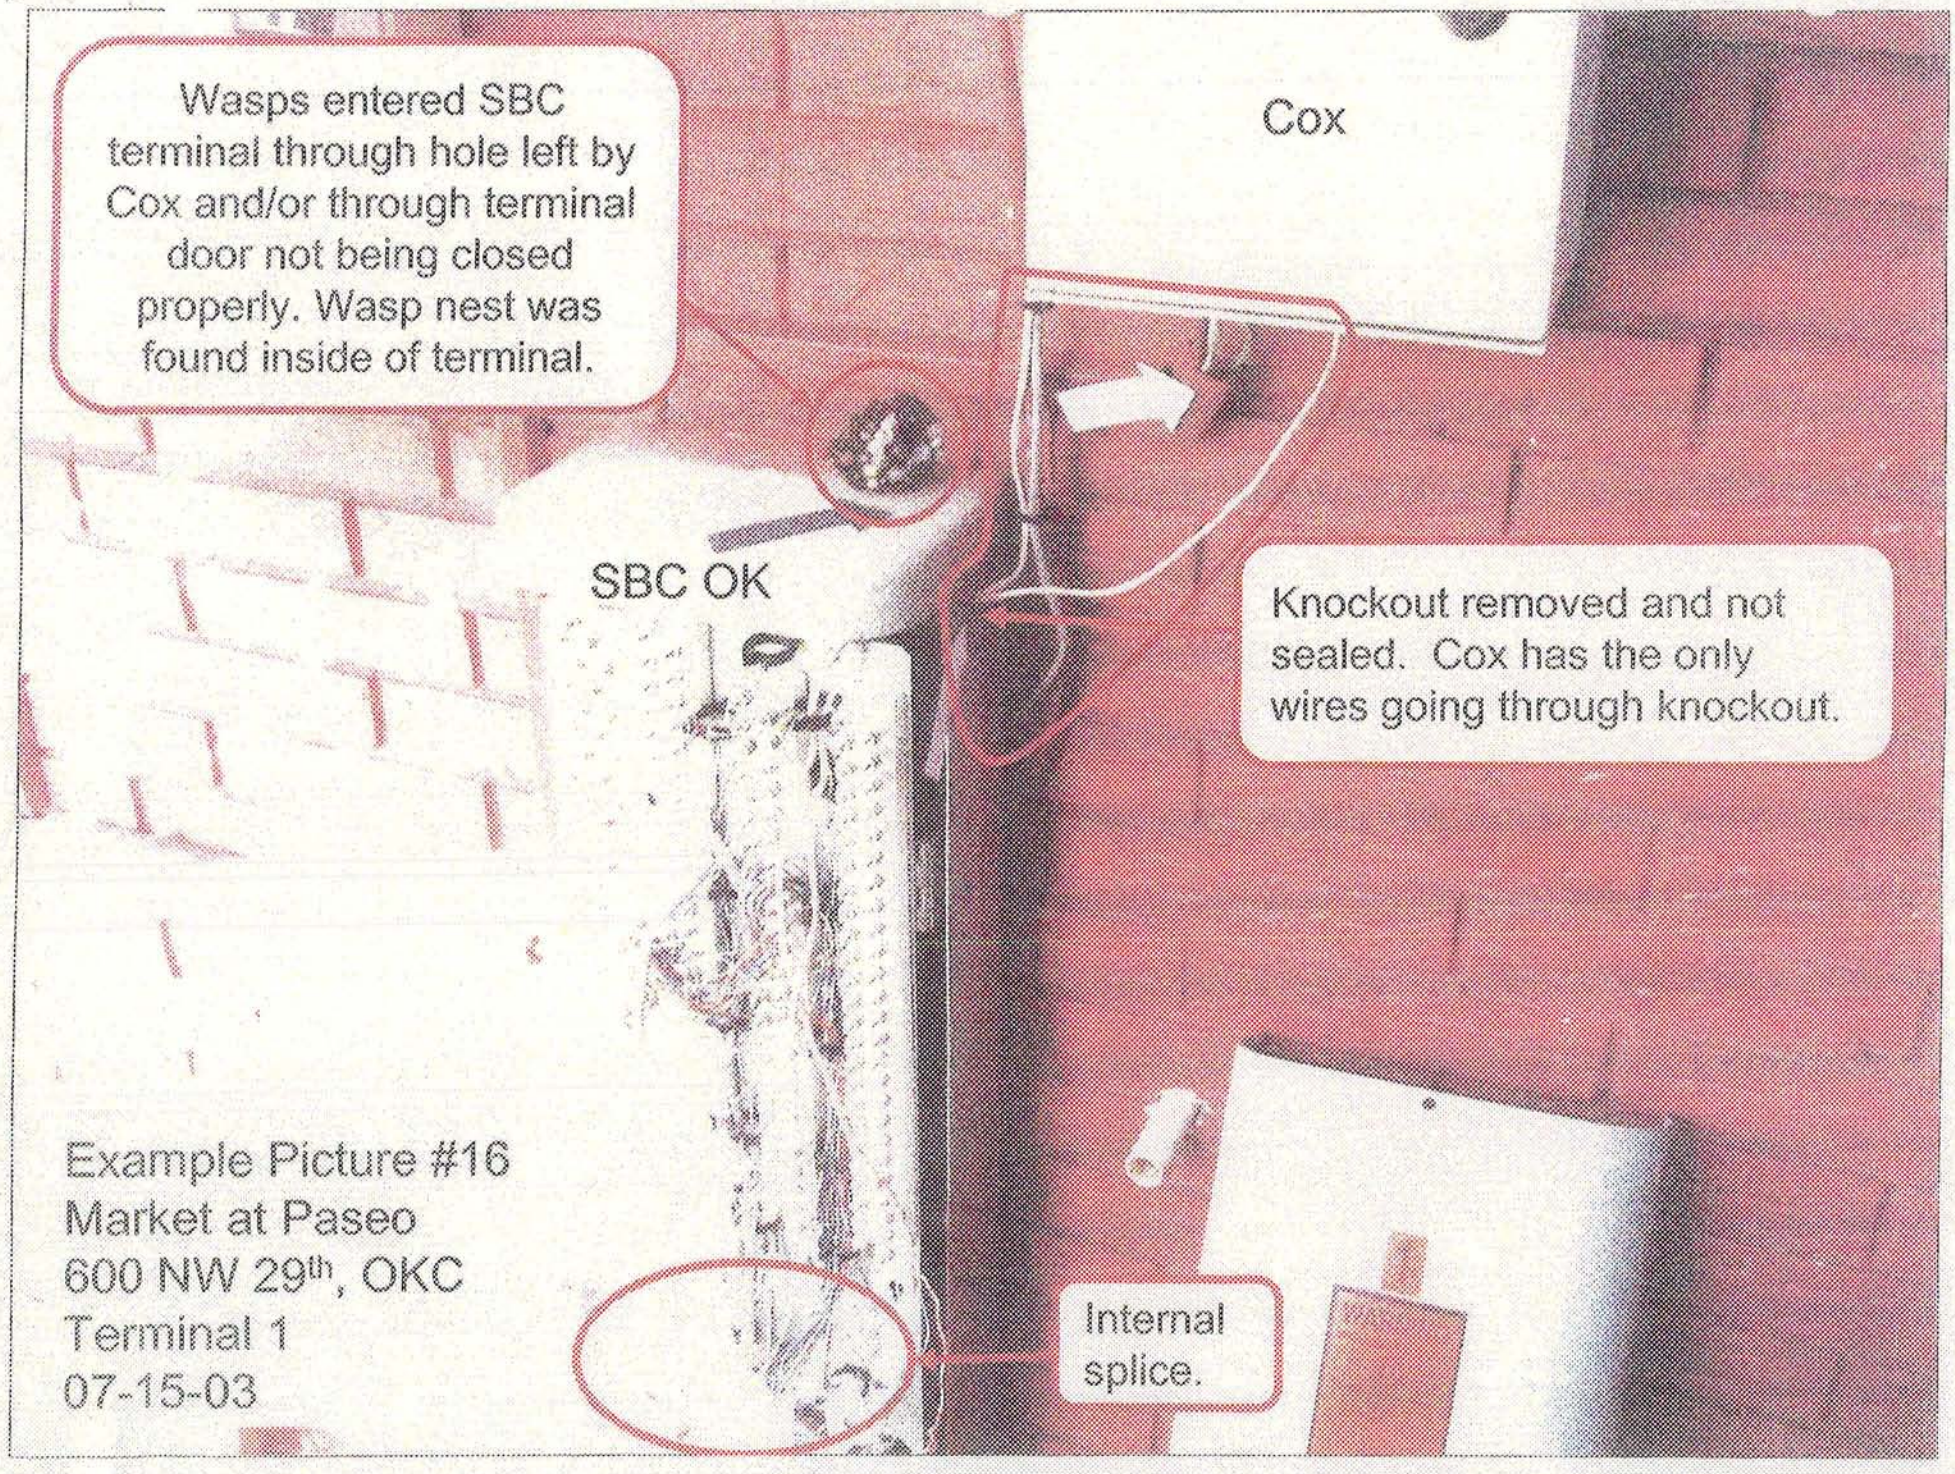
Wasps entered SBC terminal through hole left by Cox and/or through terminal door not being closed properly. Wasp nest was found inside of terminal.
Cox
SBC OK
Knockout removed and not sealed. Cox has the only wires going through knockout.
Internal splice.
Example Picture #16
Market at Paseo
600 NW 29th, OKC
Terminal 1
07-15-03

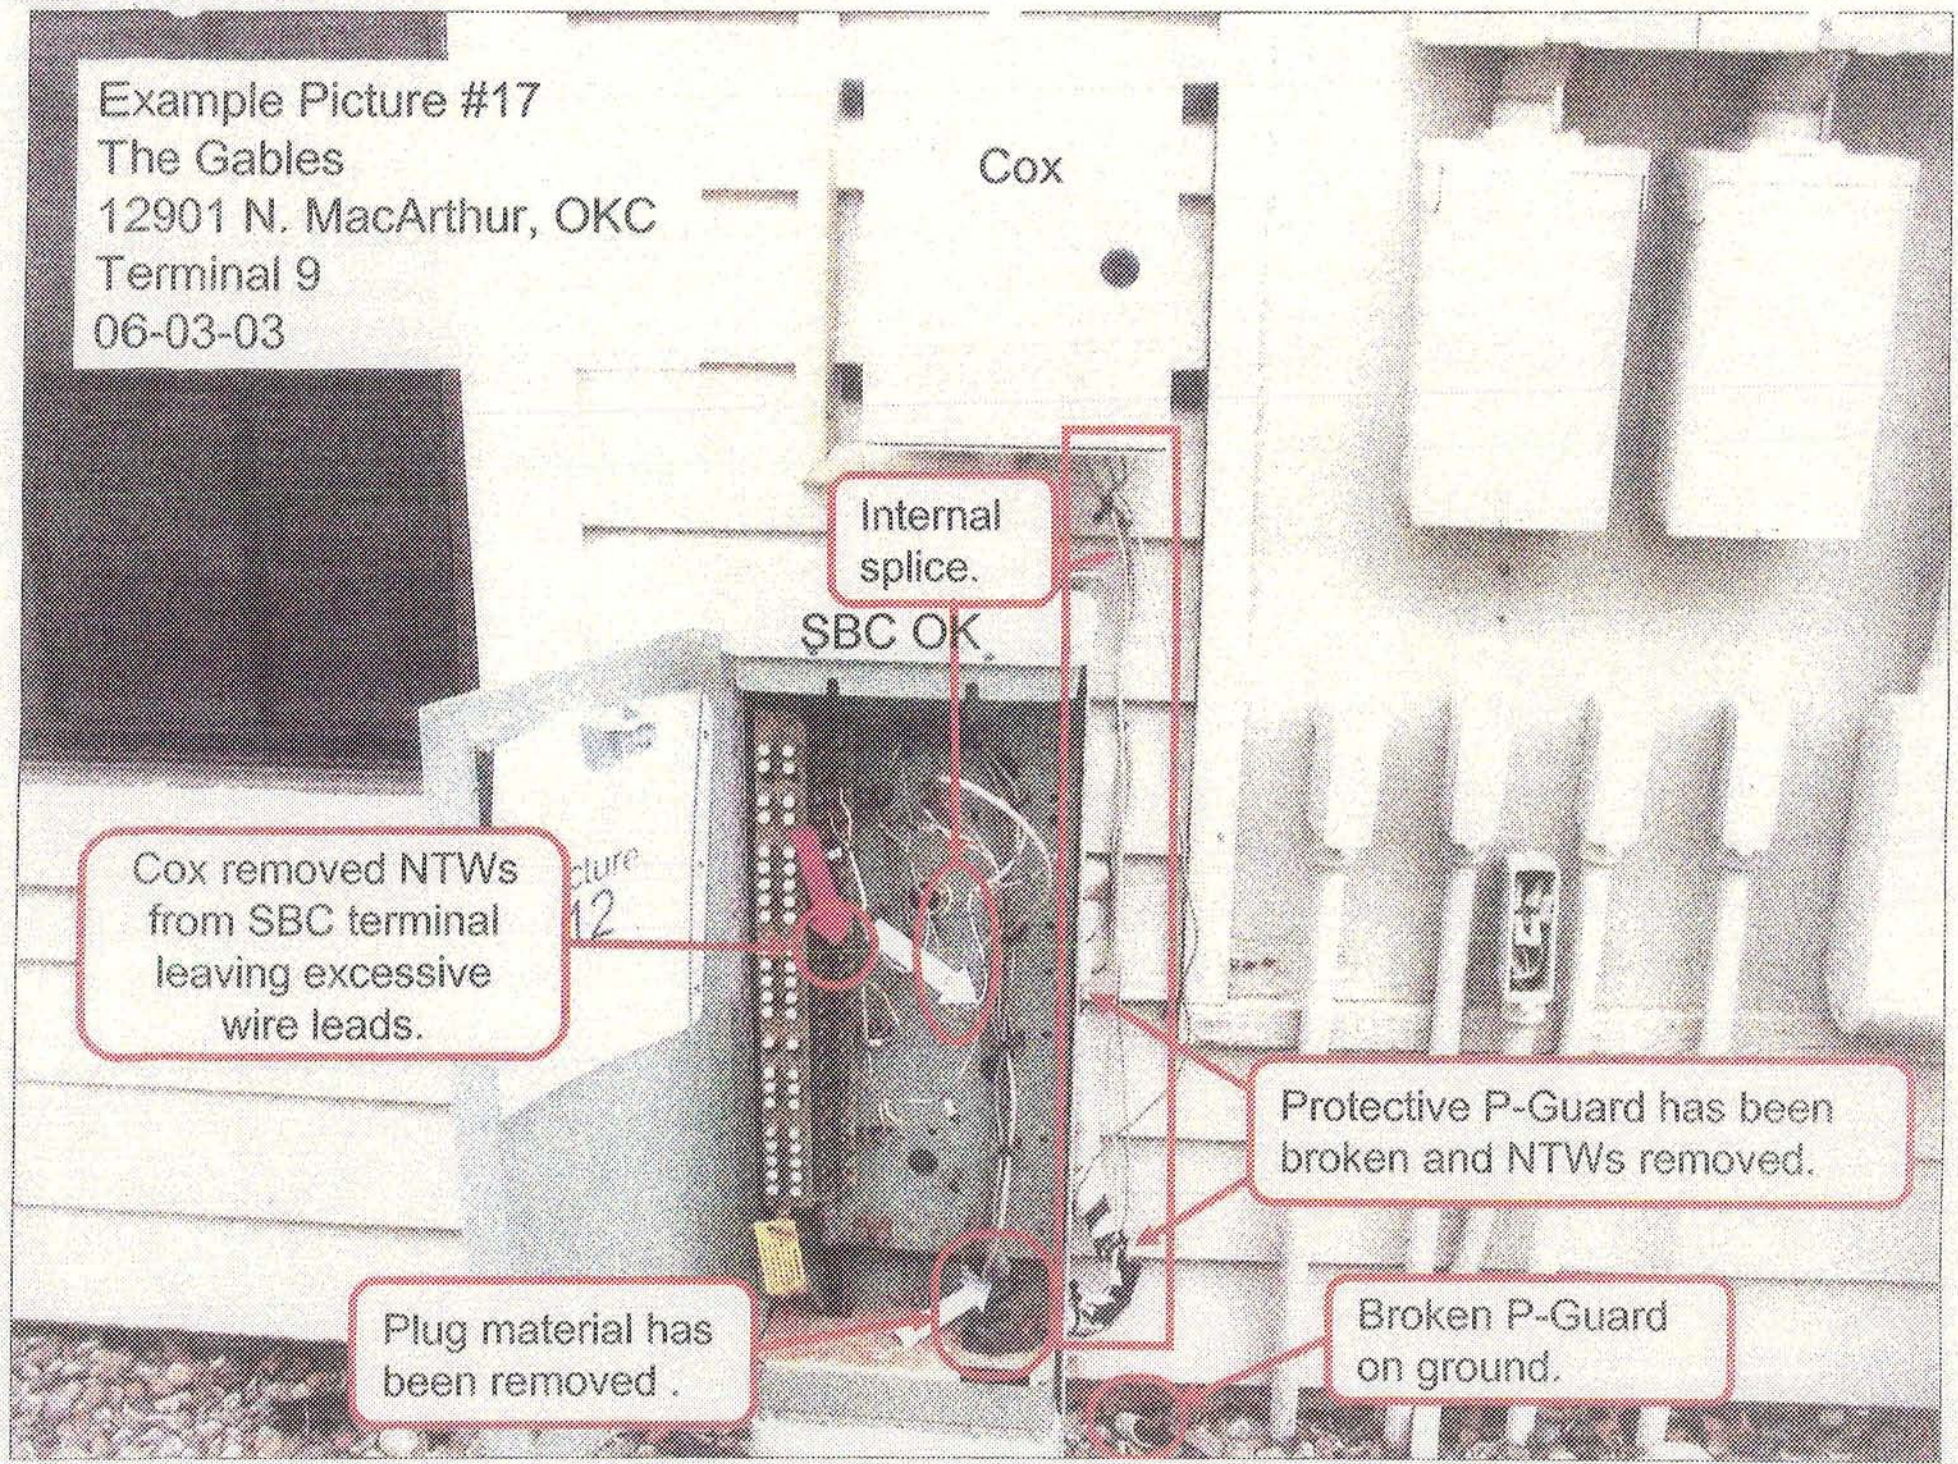
Example Picture #17
The Gables
12901 N. MacArthur, OKC
Terminal 9
06-03-03
Cox
Internal splice.
SBC OK
Cox removed NTWs from SBC terminal leaving excessive wire leads.
Protective P-Guard has been broken and NTWs removed.
Plug material has been removed .
Broken P-Guard on ground.
