Tab 1
Pole Reports for Richard Blake Pendley Declaration

Make Ready Work Report

USS TrackingNo
07-25004A

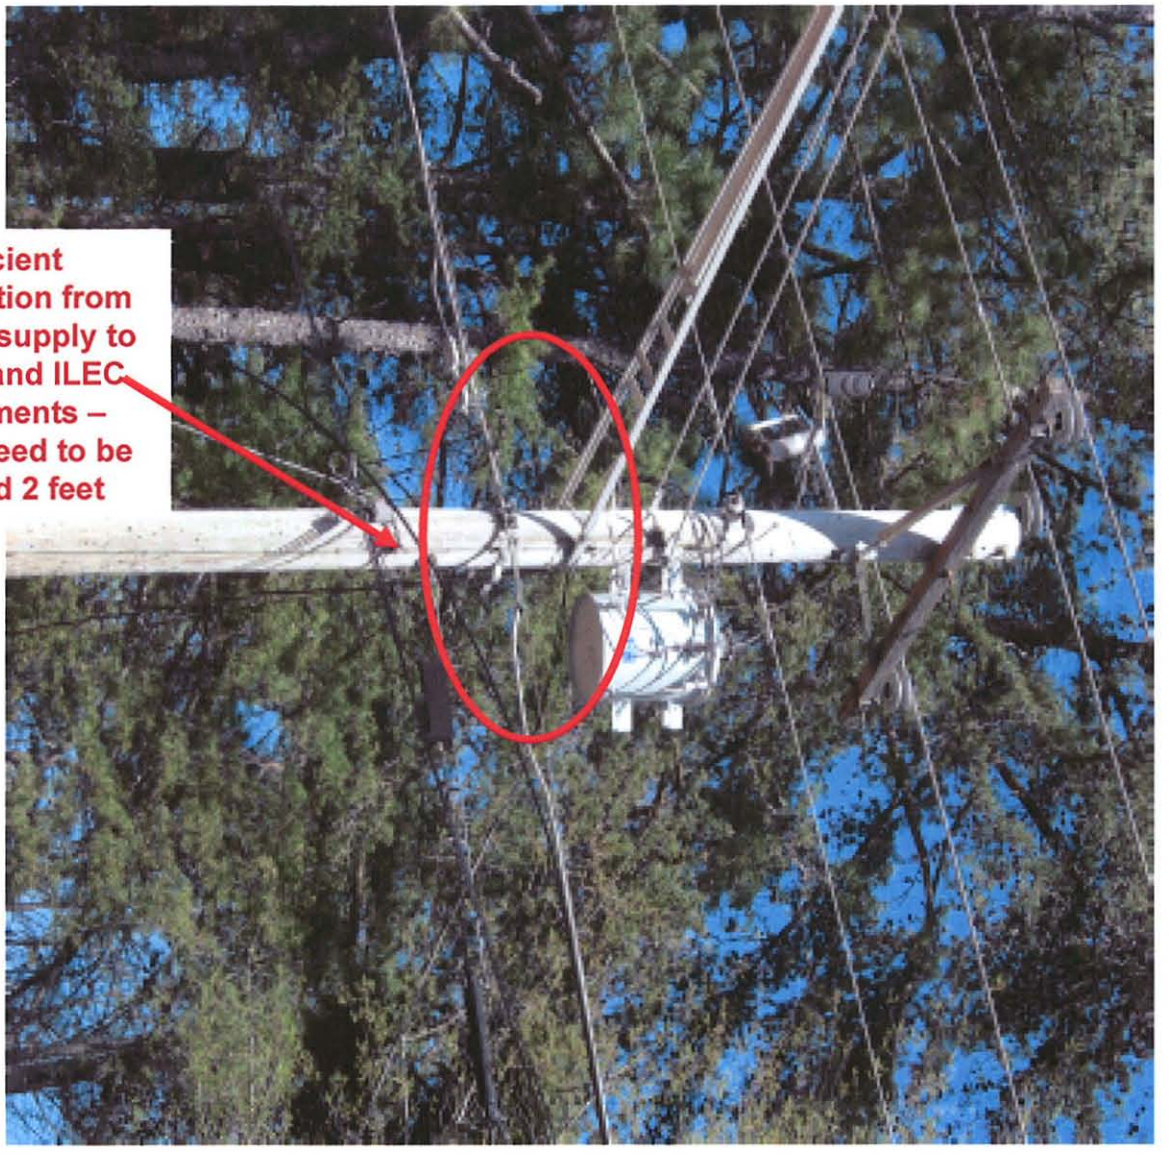
Pole Sequence Number:	Pole Height:	Pole Class:	Pole Date:	Picture Number:	Longitude:	Latitude:
74	40	4	79	DSCN0031.JPG	-84.6860496599	33.72005594899

Insufficient separation from power supply to CATV and ILEC attachments – Both need to be lowered 2 feet

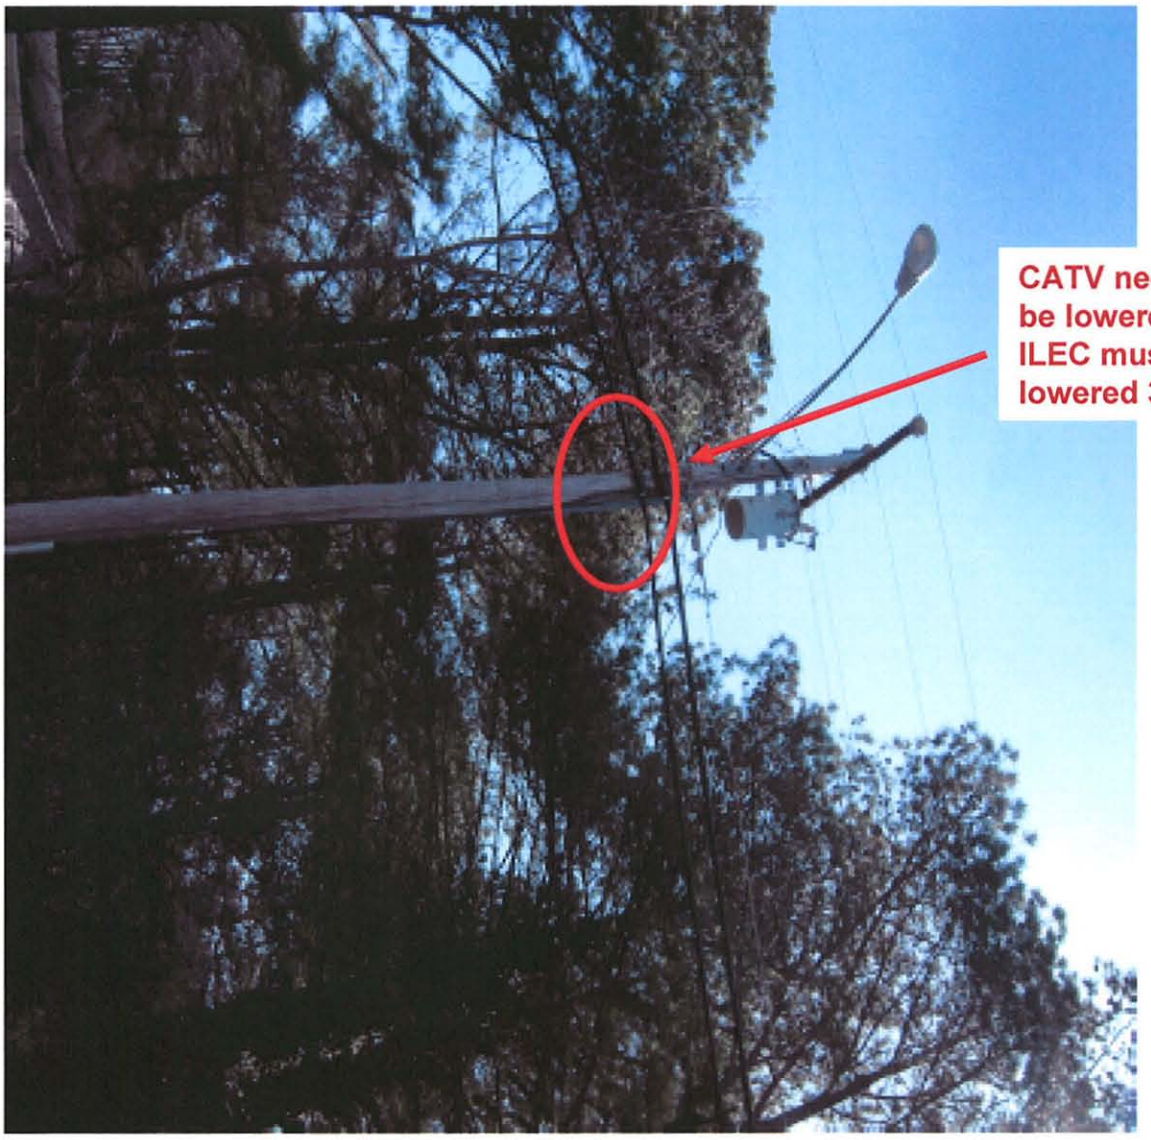
Pole Sequence Number:	Pole Height:	Pole Class:	Pole Date:	Picture Number:	Longitude:	Latitude:
49	40	5	0	DSCN0025.JPG	-84.6834423094	33.71869578081

CHANGING OUT POLE TO THE SOUTH

Company	Type Attachment	Measure Location	Feet	Inches	New POA	Install Anch/ Guy	Add Guy Mkr	Trim Tree	Attach	Bond	Transfer Cable	Violation	Responsible Party	Work Req'd	M/R Seq #
GREYSTONE															
	Transformer	@ Pole	31	11		☐	☐	☐		☐	☐	☐	☐	☐	
GREYSTONE		Clearance: 22													
	Riser-Secondary	@ Pole	30	1		☐	☐	☐		☐	☐	☐	☐	☐	
COMCAST(N)		Clearance: 8													
	Coax	@ Pole	29	5	26'9"	☐	☐	☐	M	☐	☐	☑	☐	☑	2
LOWER COMCAST(N) COAX 32" TO 40" BELOW GREYSTONE RISERSEC															
BELLSOUTH		Clearance: 2													
	Service Drop	@ Pole	29	3	26'3"	☐	☐	☐	M	☐	☐	☑	☐	☑	1
LOWER BELLSOUTH SERVICE DROP 36" TO 46" BELOW GREYSTONE RISERSEC															
BELLSOUTH		Clearance: 8													
	Multipair Cable	@ Pole	28	7	25'9"	☐	☐	☐	M	☐	☐	☑	☐	☑	1
LOWER BELLSOUTH MPC 34" TO 52" BELOW GREYSTONE RISERSEC															
BELLSOUTH		Clearance: 12													
	Multipair Cable	@ Pole	27	7	24'9"	☐	☐	☐	M	☐	☐	☑	☐	☑	1
LOWER BELLSOUTH MPC 34" TO 64" BELOW GREYSTONE RISERSEC

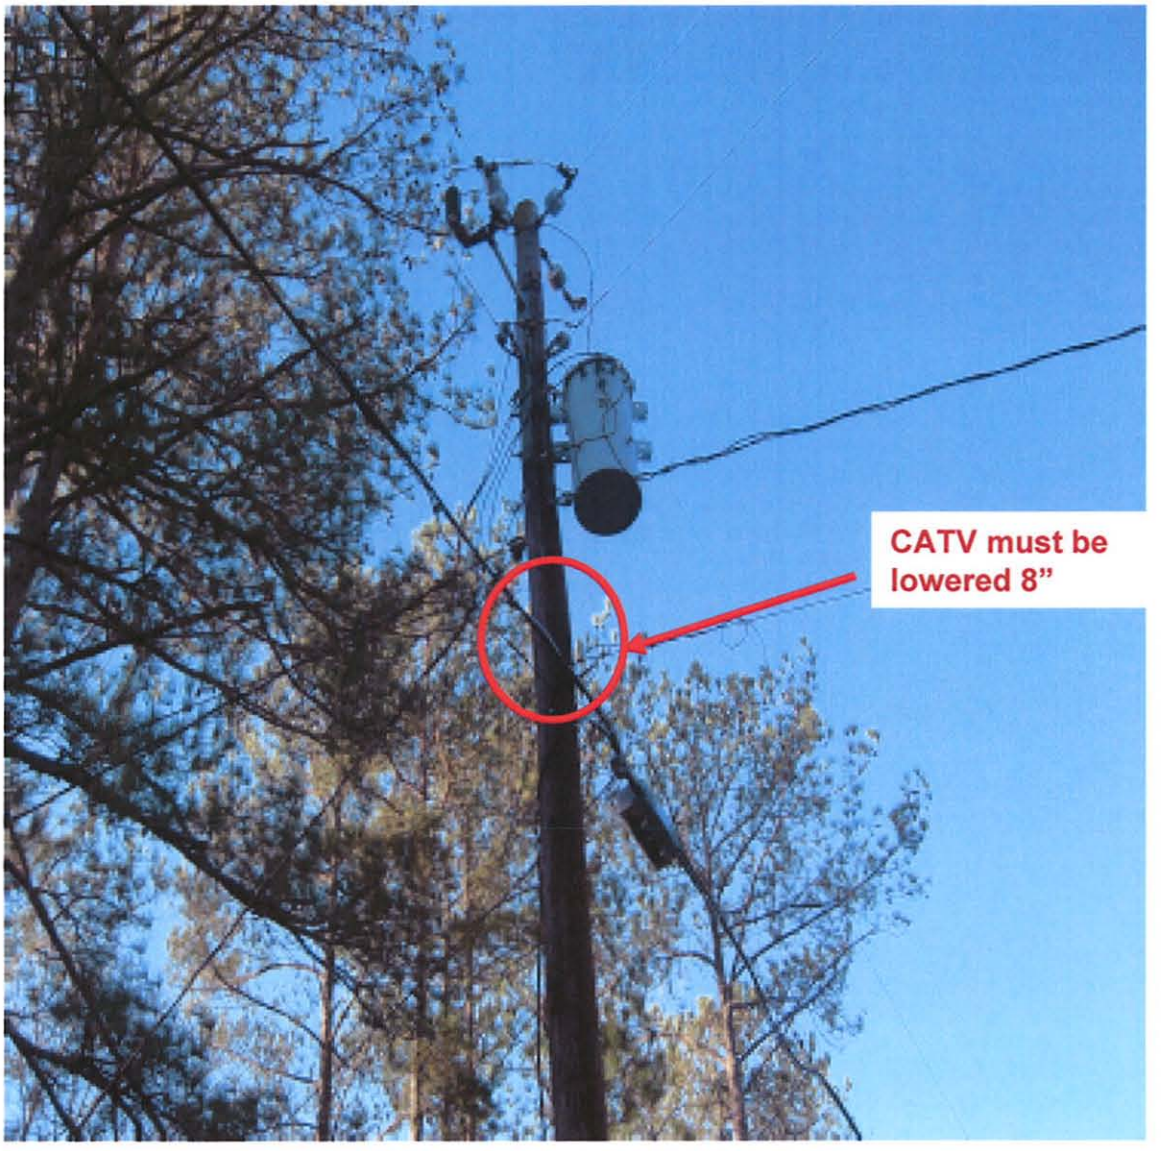
Pole Sequence Number:	Pole Height:	Pole Class:	Pole Date:	Picture Number:	Longitude:	Latitude:
59	0	0	0	DSCN0063.JPG	-84.6460461387	33.74580226170

Company	Type Attachment	Measure Location	Feet	Inches	New POA	Install Anch/ Guy	Add Guy Mkr	Trim Tree	Attach	Bond	Transfer Cable	Violation	Responsible Party	Work Req'd	M/R Seq #
GREYSTONE	Triplex Secondary	@ Pole	24	8		☐	☐	☐		☐	☐	☐	☐	☐	
GREYSTONE	Transformer Drip Loop	Clearance: 8 @ Pole	24	2		☐	☐	☐		☐	☐	☐	☐	☐	
COMCAST(N)	Coax	Clearance: 32 @ Pole	21	6	20'10"	☑	☑	☐	M	☐	☐	☑	☐	☑	1
COMCAST(N)	Coax	Midspan E DW	18	0		☐	☐	☐		☐	☐	☐	☐	☐

LOWER COMCAST(N) COAX 8" TO 46" BELOW GREYSTONE SECTPX. RESET ANCHOR AND DOWN GUY, CURRENTLY 3' OUT OF GROUND
