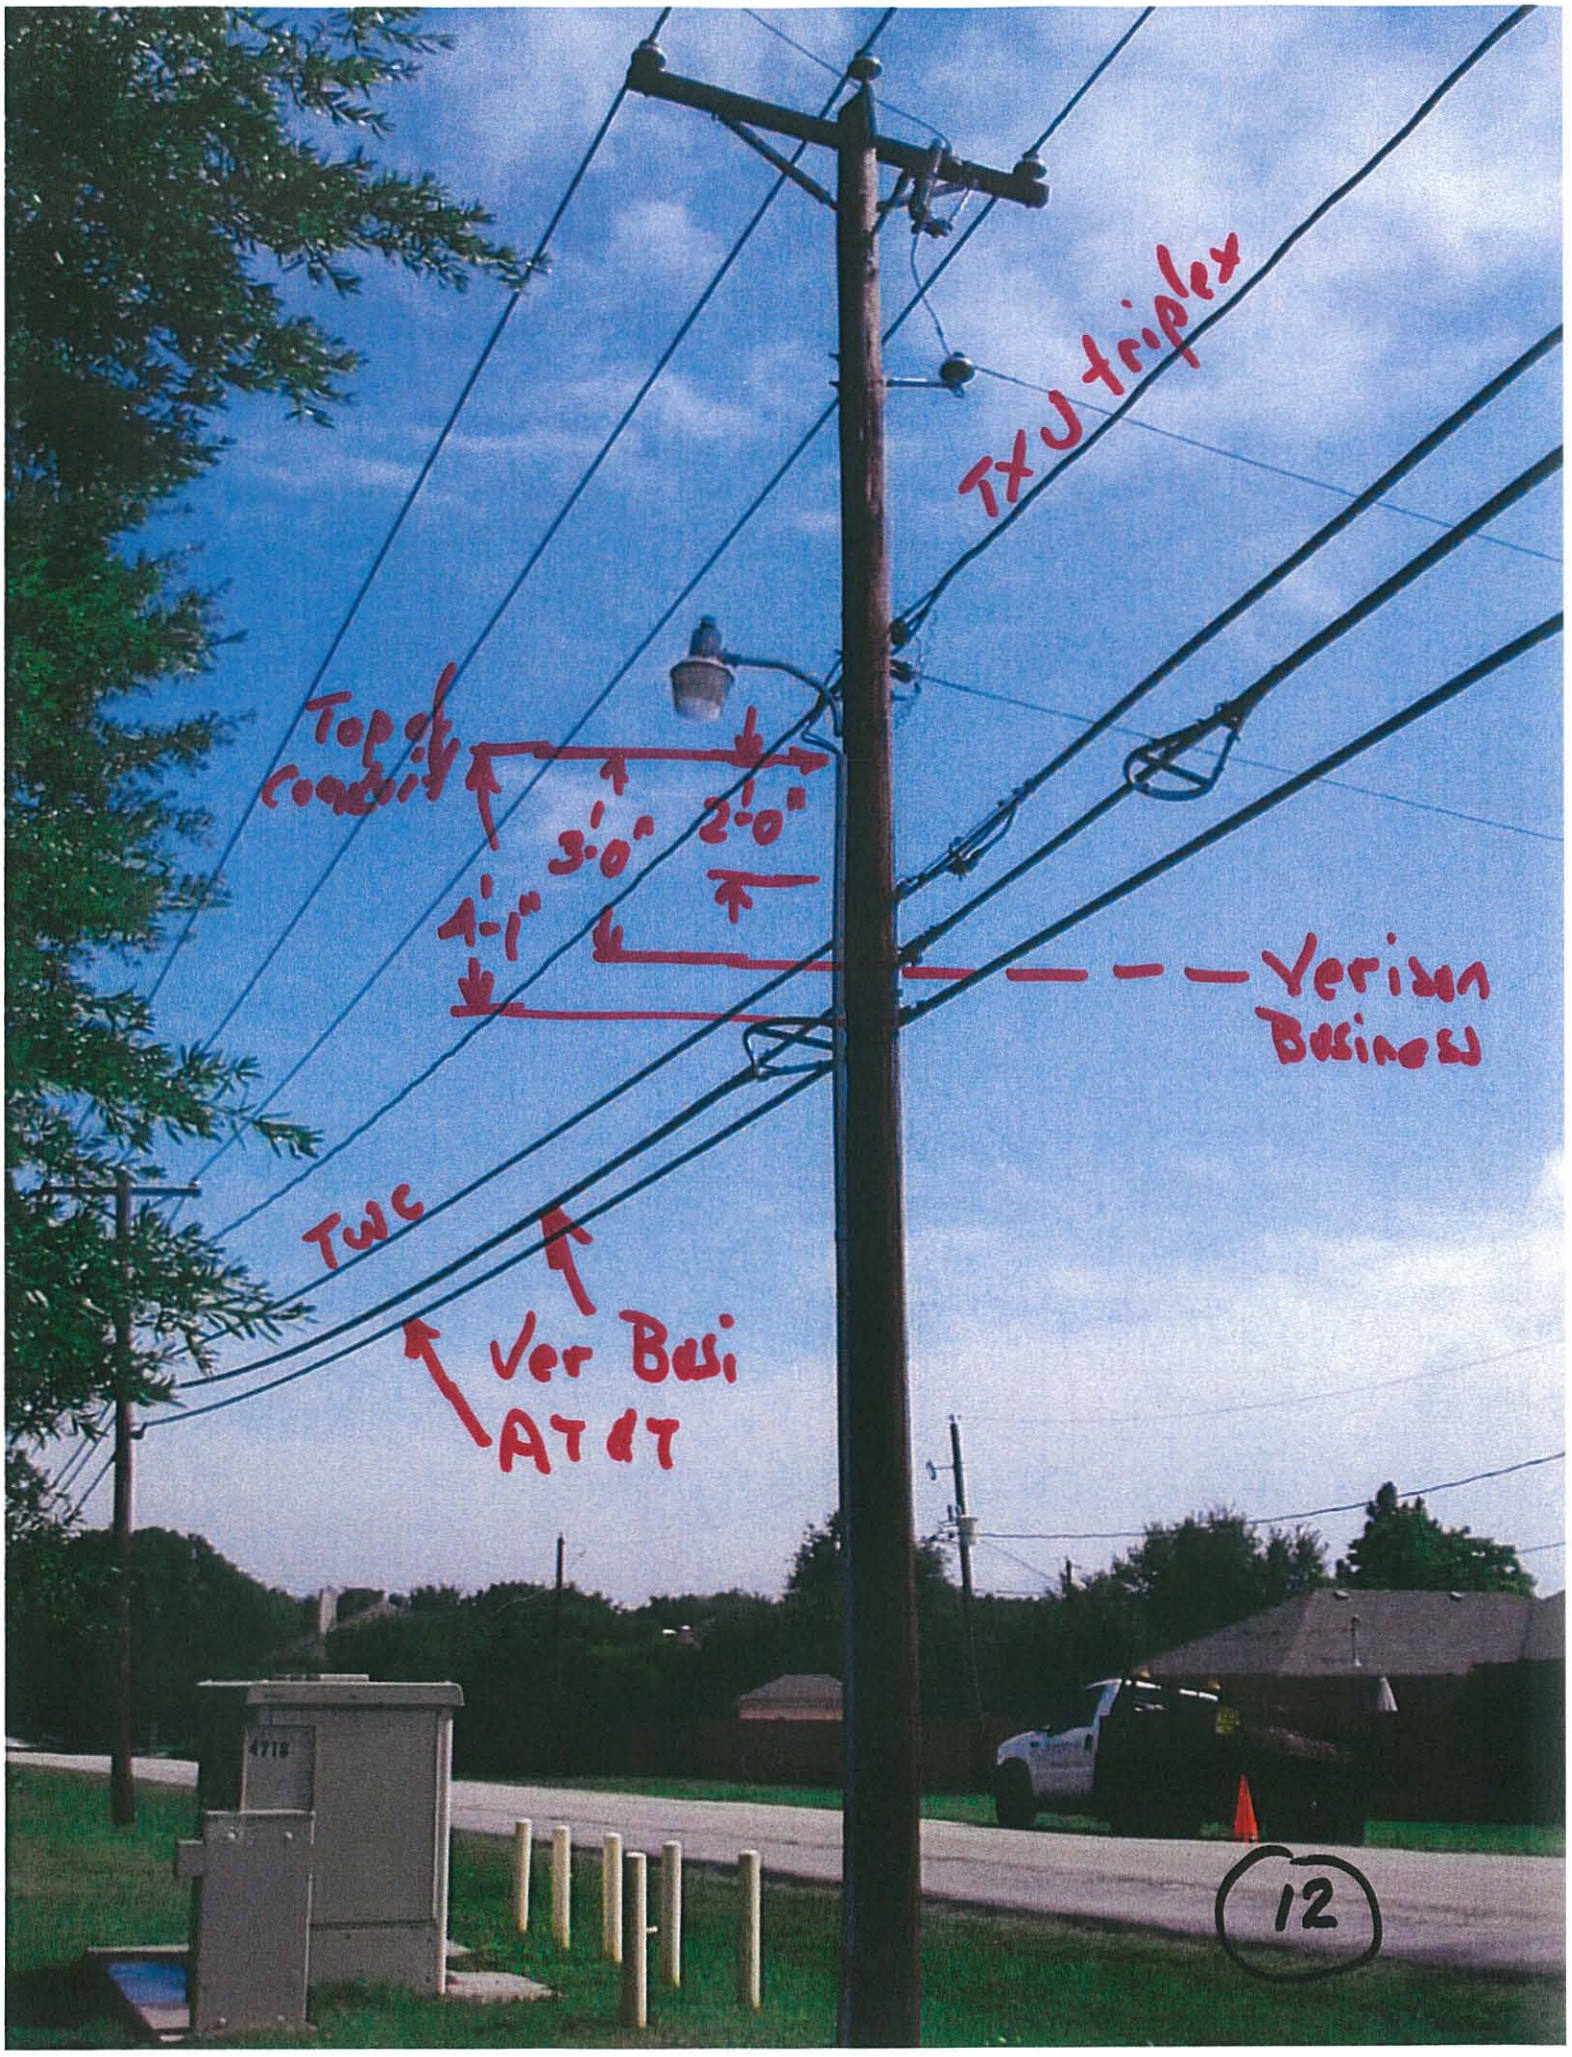
TXU triplex
Top of conduit
3'-0"
2'-0"
4'-1"
Verizon Business
TWC
Ver Busi
AT&T
12

Top of Conduit
TWC
Ver Boss
AT&T

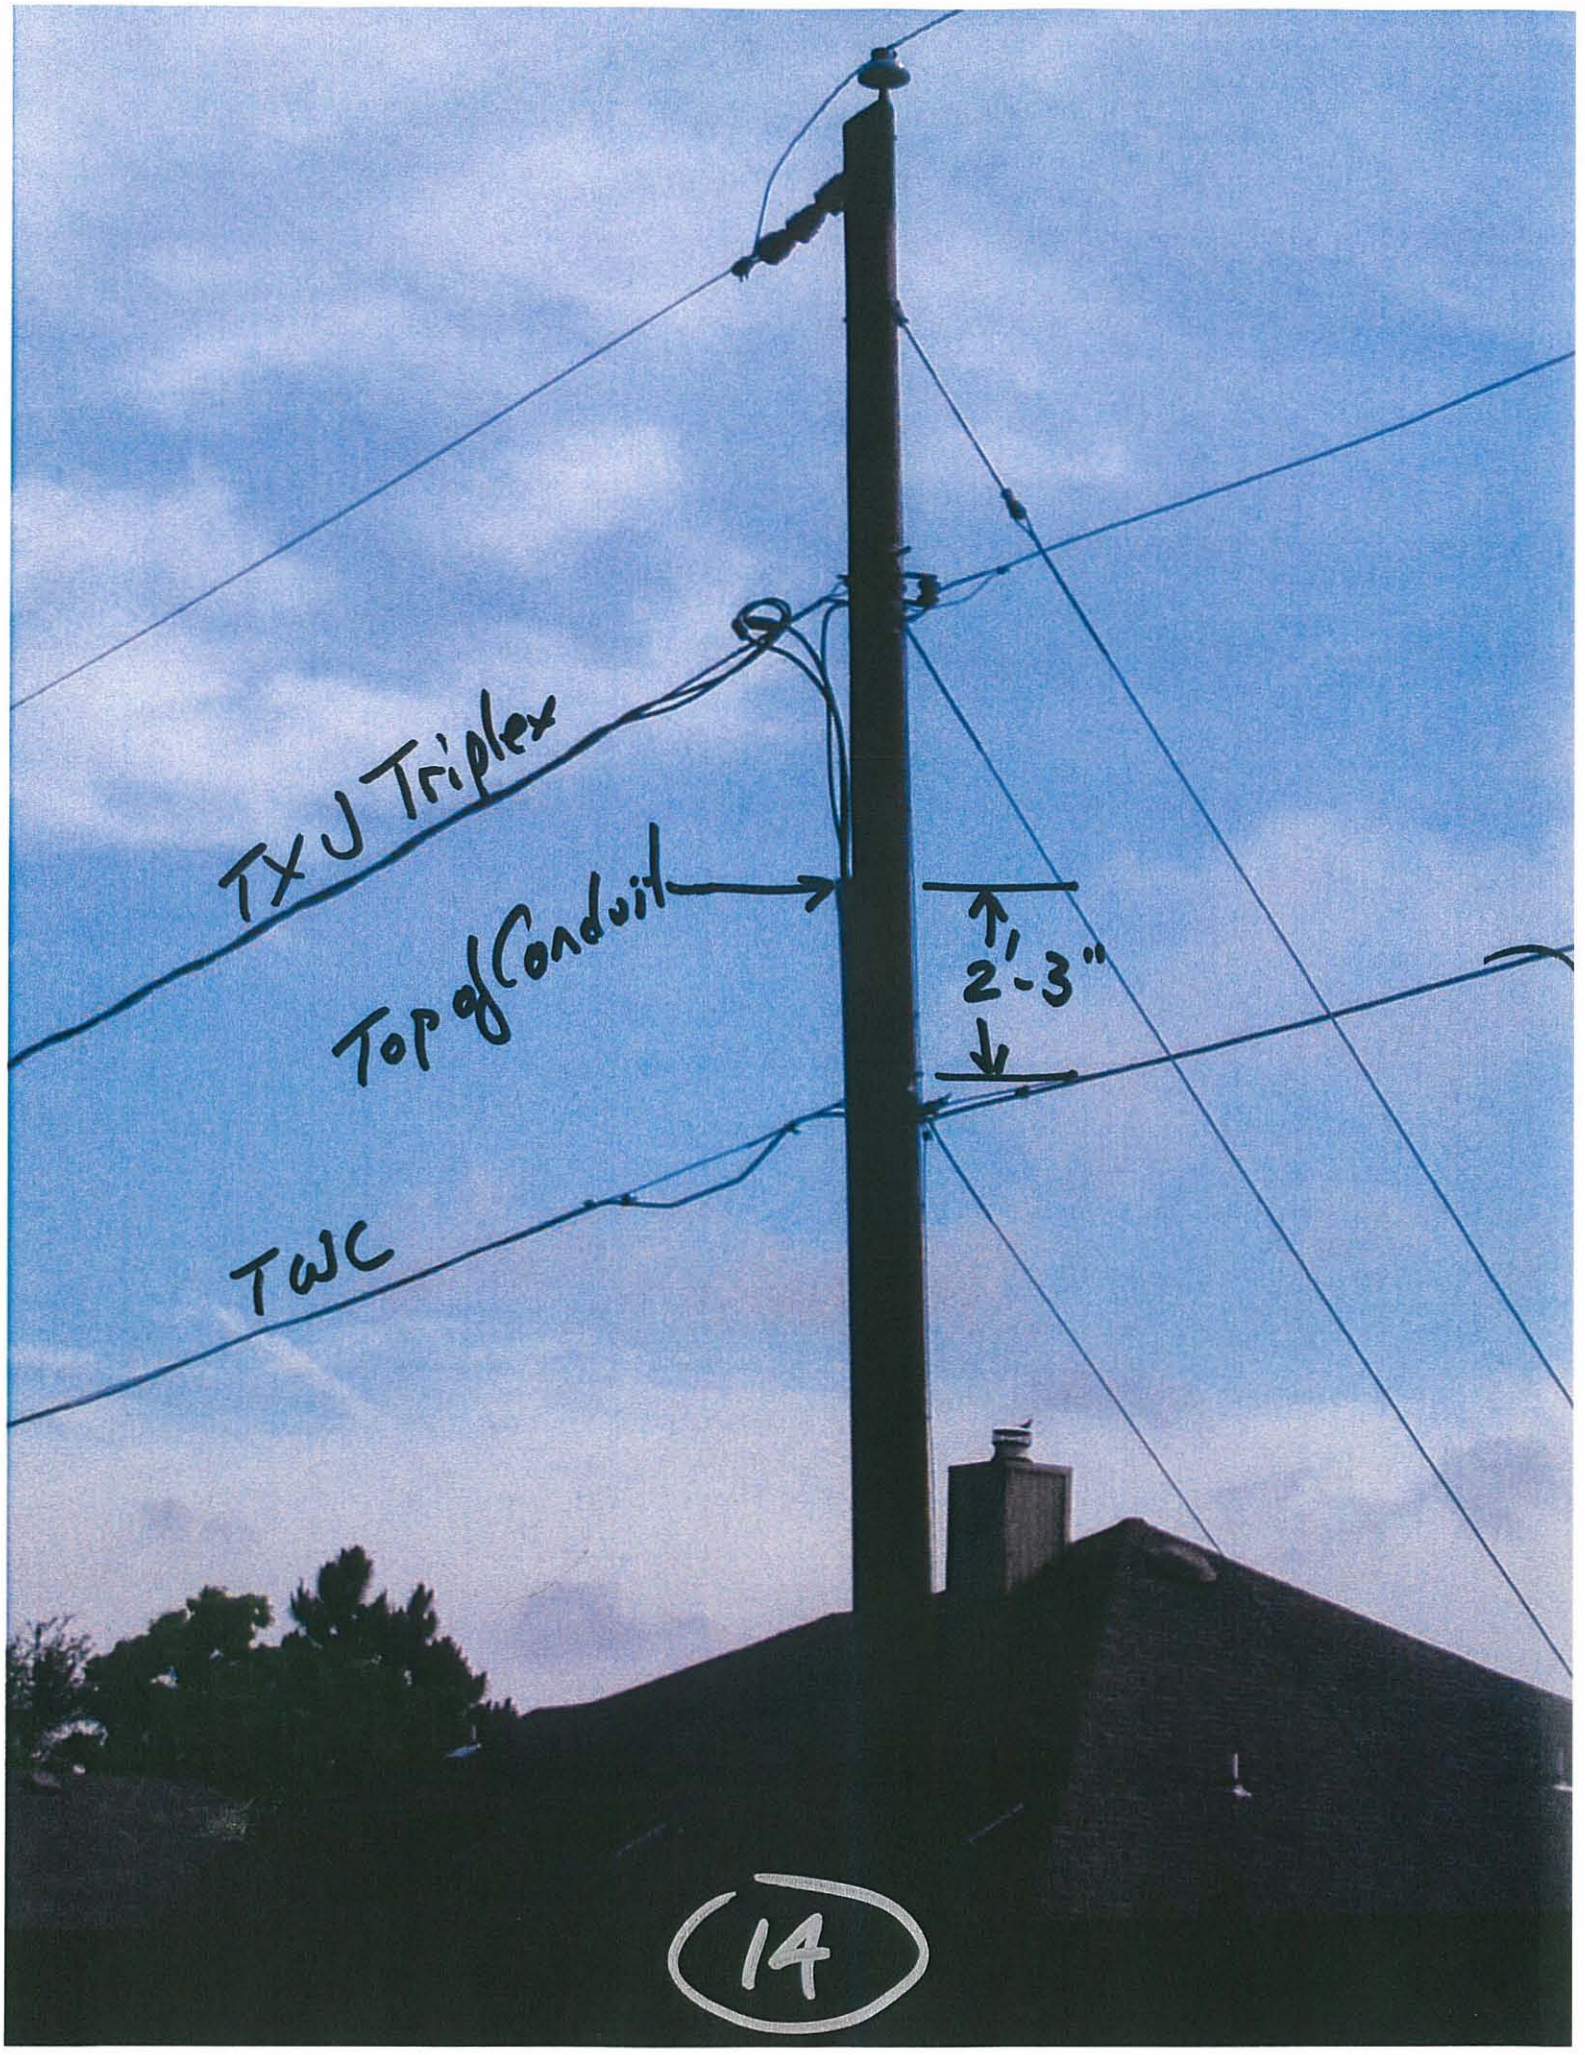
TXU Triplex
Top of Conduit
2'-3"
TWC

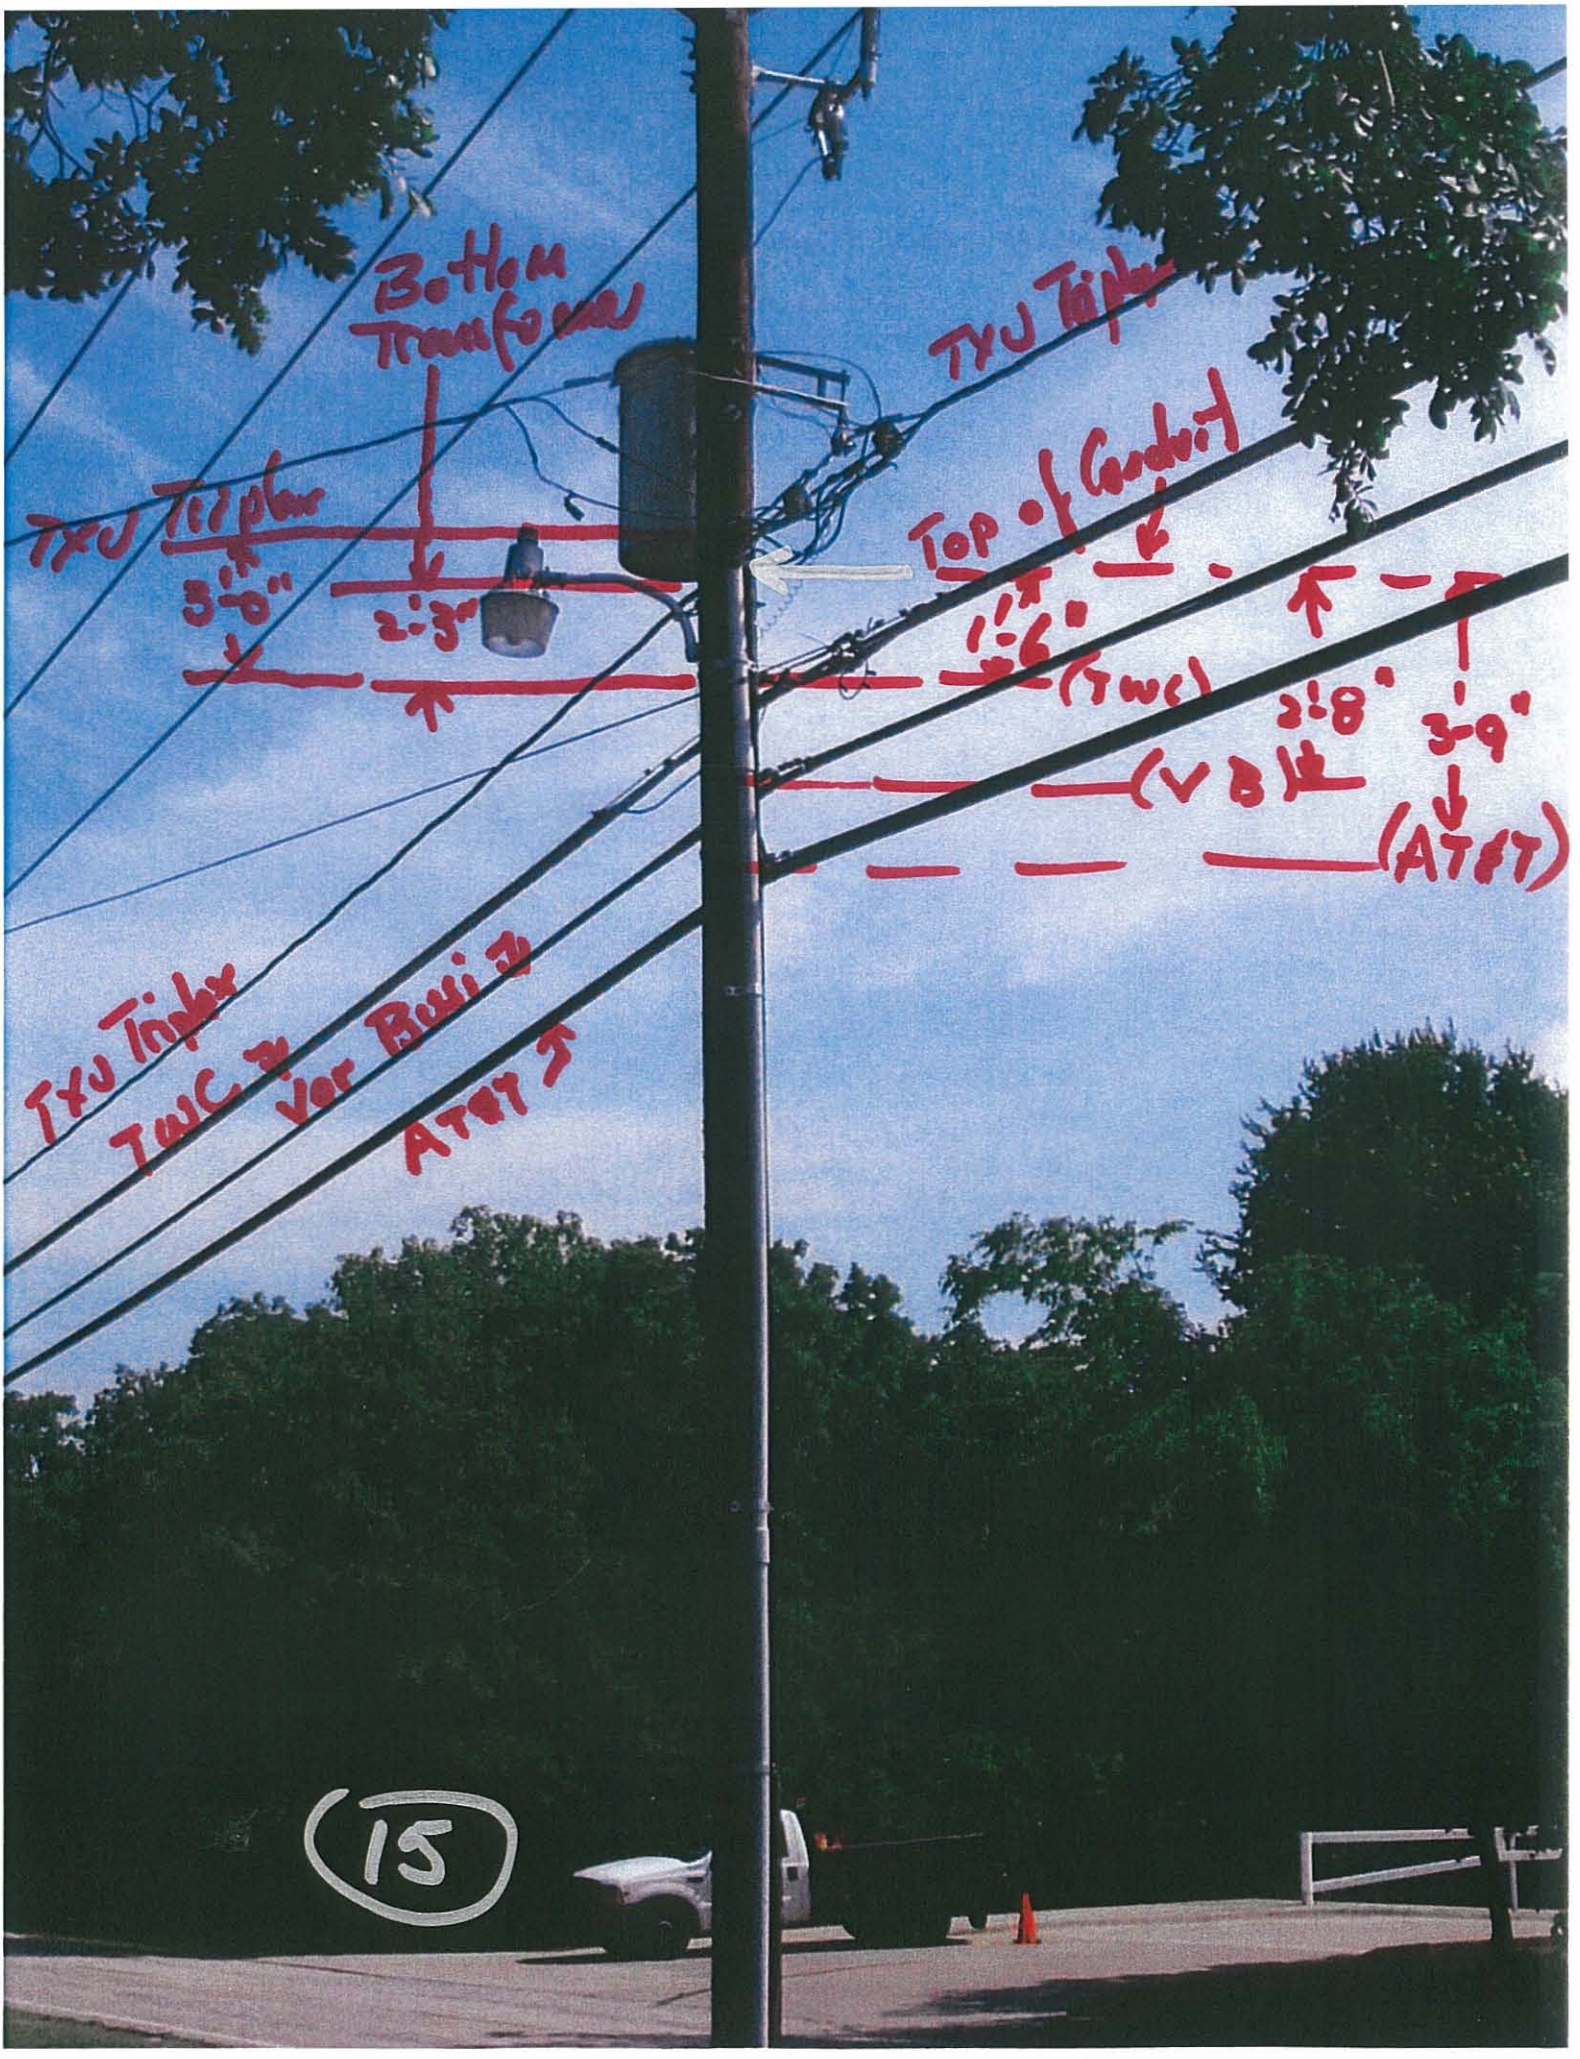
Bottom Transformer
TXU Triplex
TXU Triplex
Top of Conduit
3'-0"
2'-3"
1'-6"
(TWC)
2'-8"
3'-9"
(VB)
(AT&T)
TXU Triplex
TWC
Ver Busi
AT&T
15

TWC
Yes Busi
AT&T
Top of Conduit
Broken Arrester
Grounding Conductor

Bottom Transfmr
To TWC 1'-0"
To VB 2'-4"
Upper Conduit
4"
1'-8"
2'-9"
Lower Conduit
Top of lower Conduit below all communication
TWC
Ver Business
A TET
17

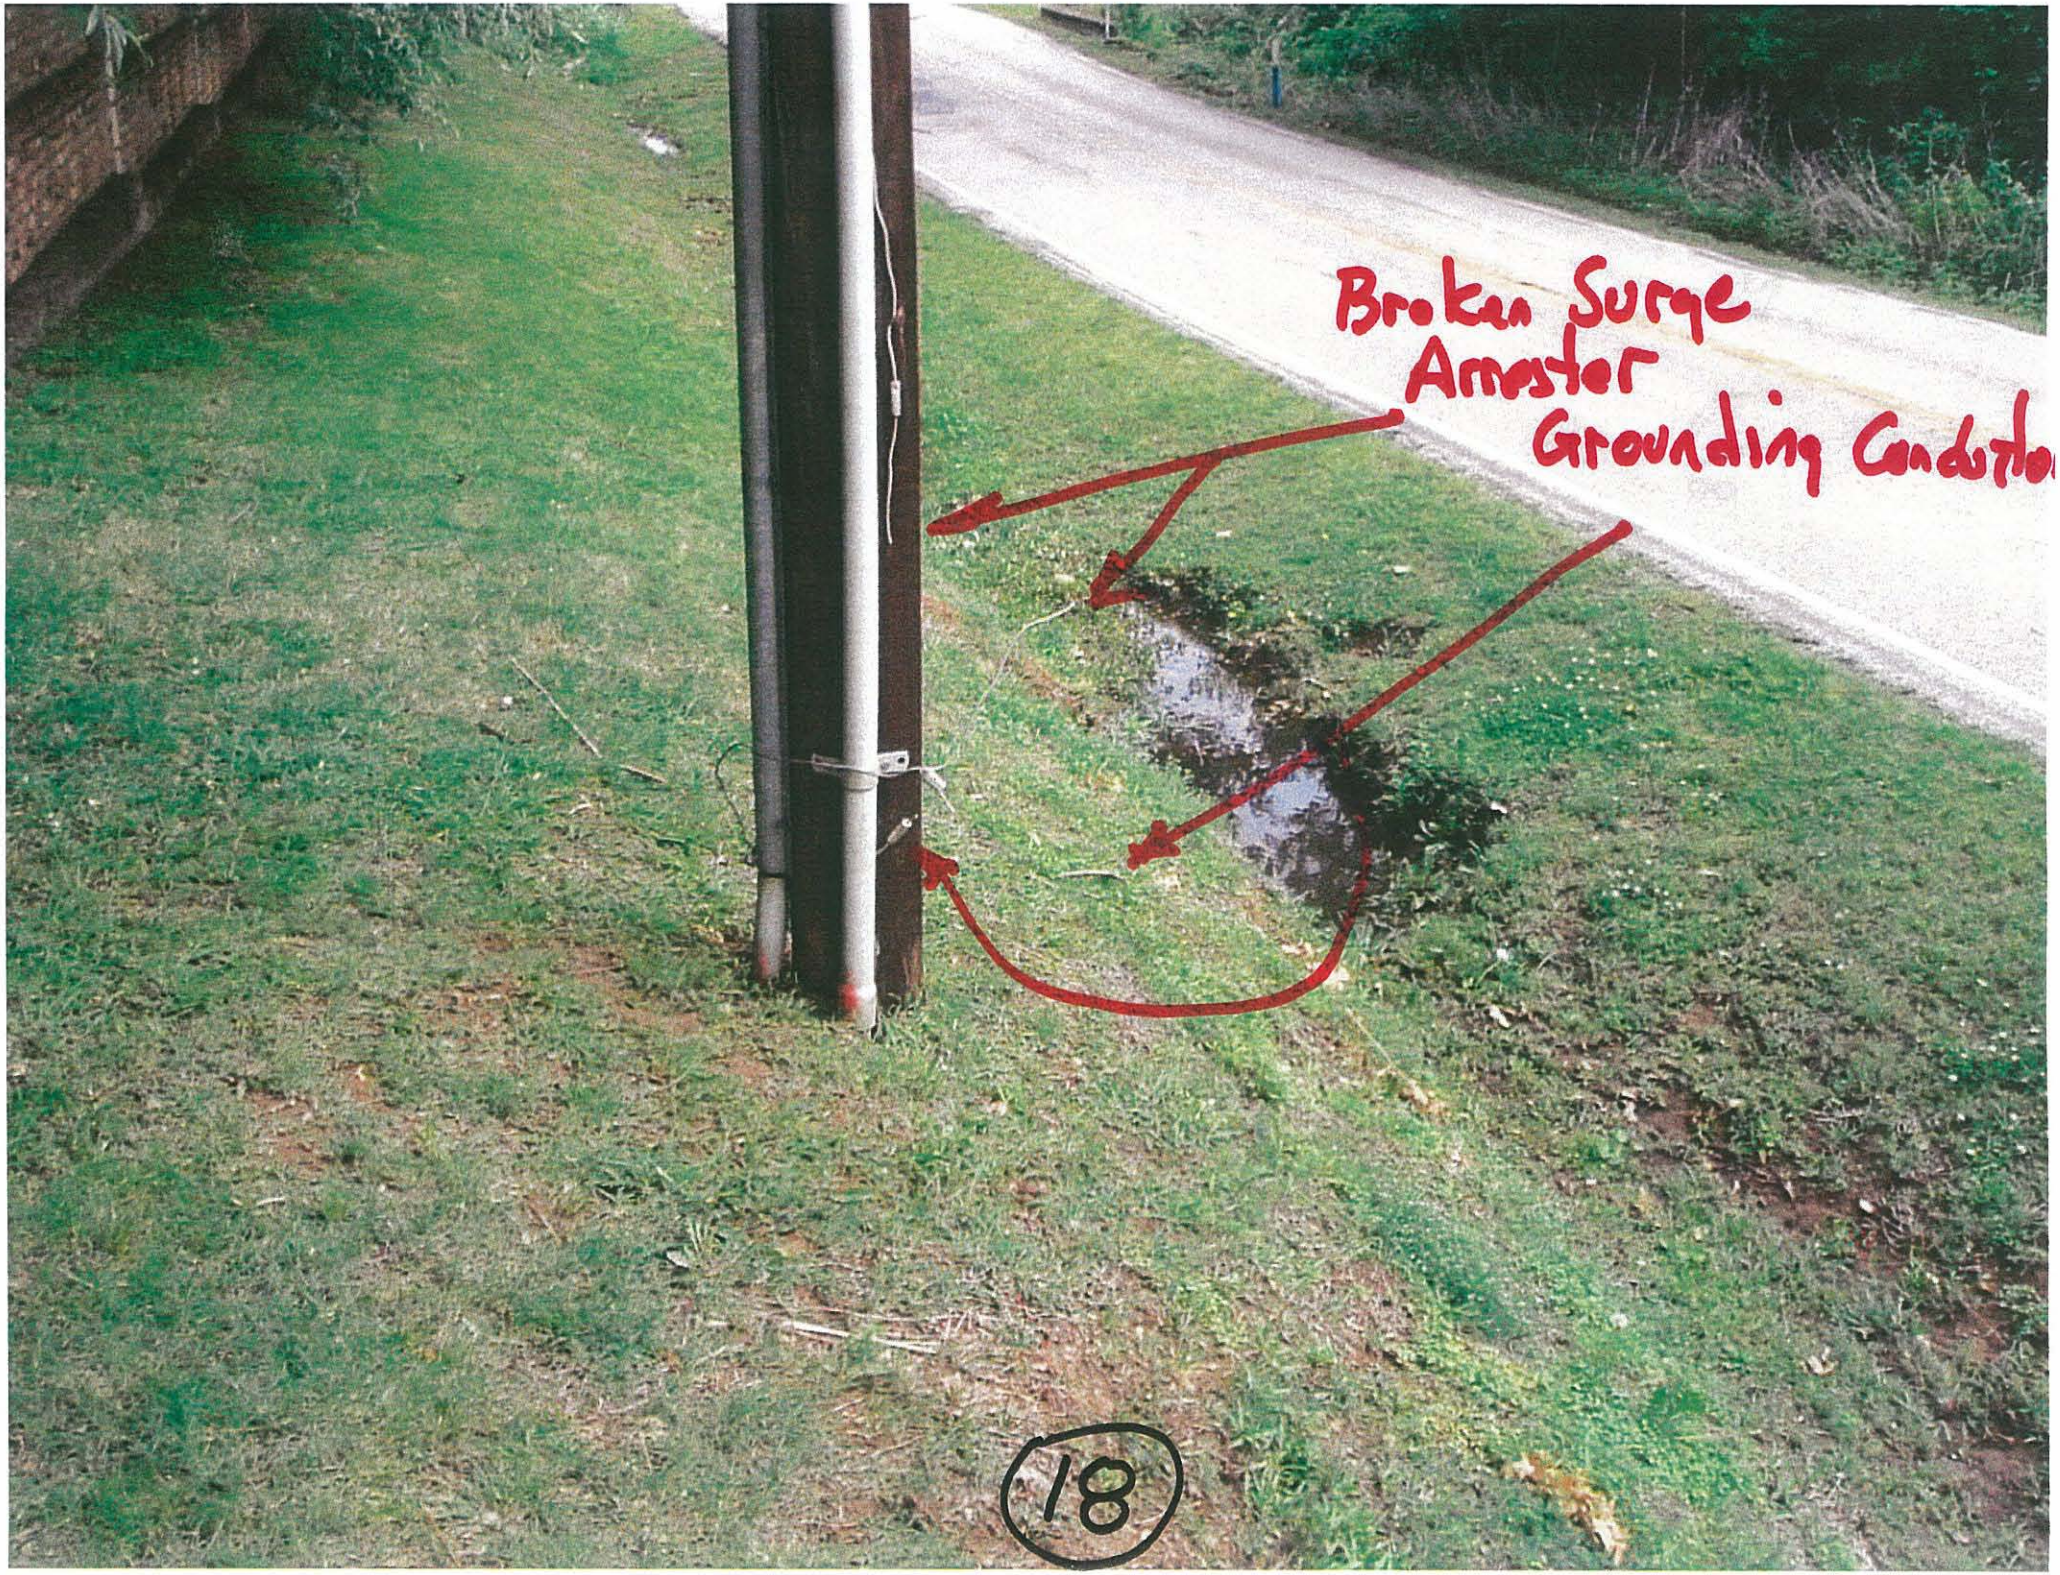
Broken Surge
Arrester
Grounding Conductor
18

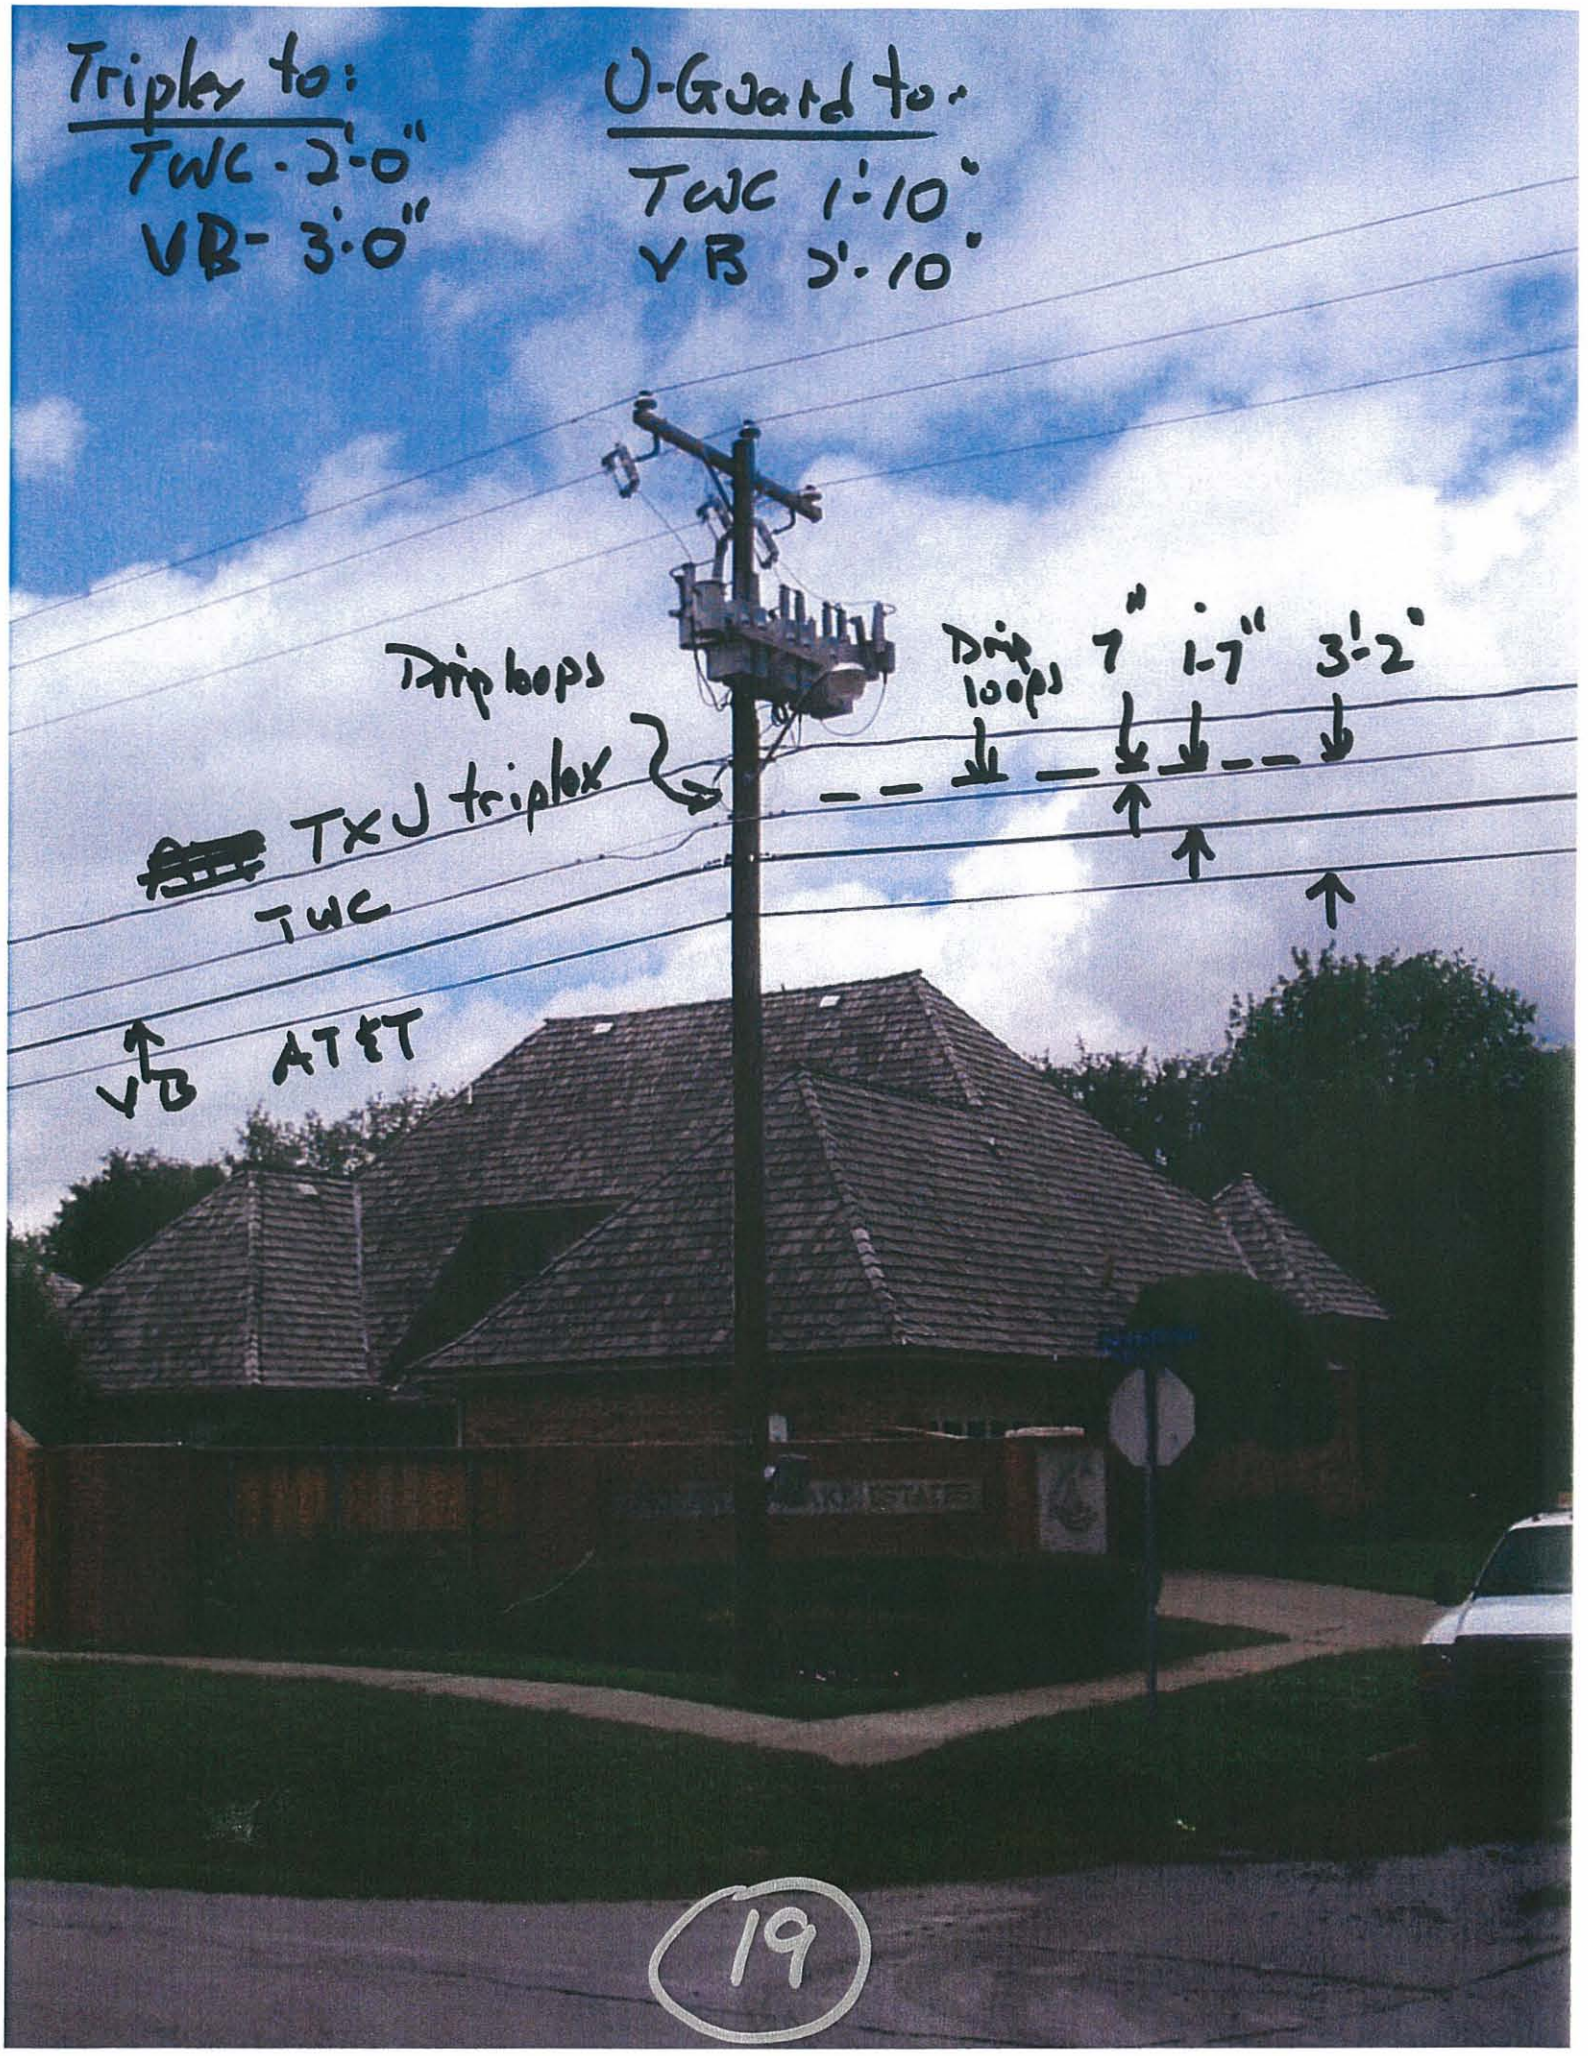
Triplex to:
TWC - 2'-0"
VB - 3'-0"
U-Guard to:
TWC 1'-10"
VB 3'-10"
Drip loops
Drip loops
7"
1'-7"
3'-2"
TXU triplex
TWC
VB
AT&T

TXU triplex
TWC
Jer Business
AT&T
Drip loops to riser
U-guard
20

20'-6"
21

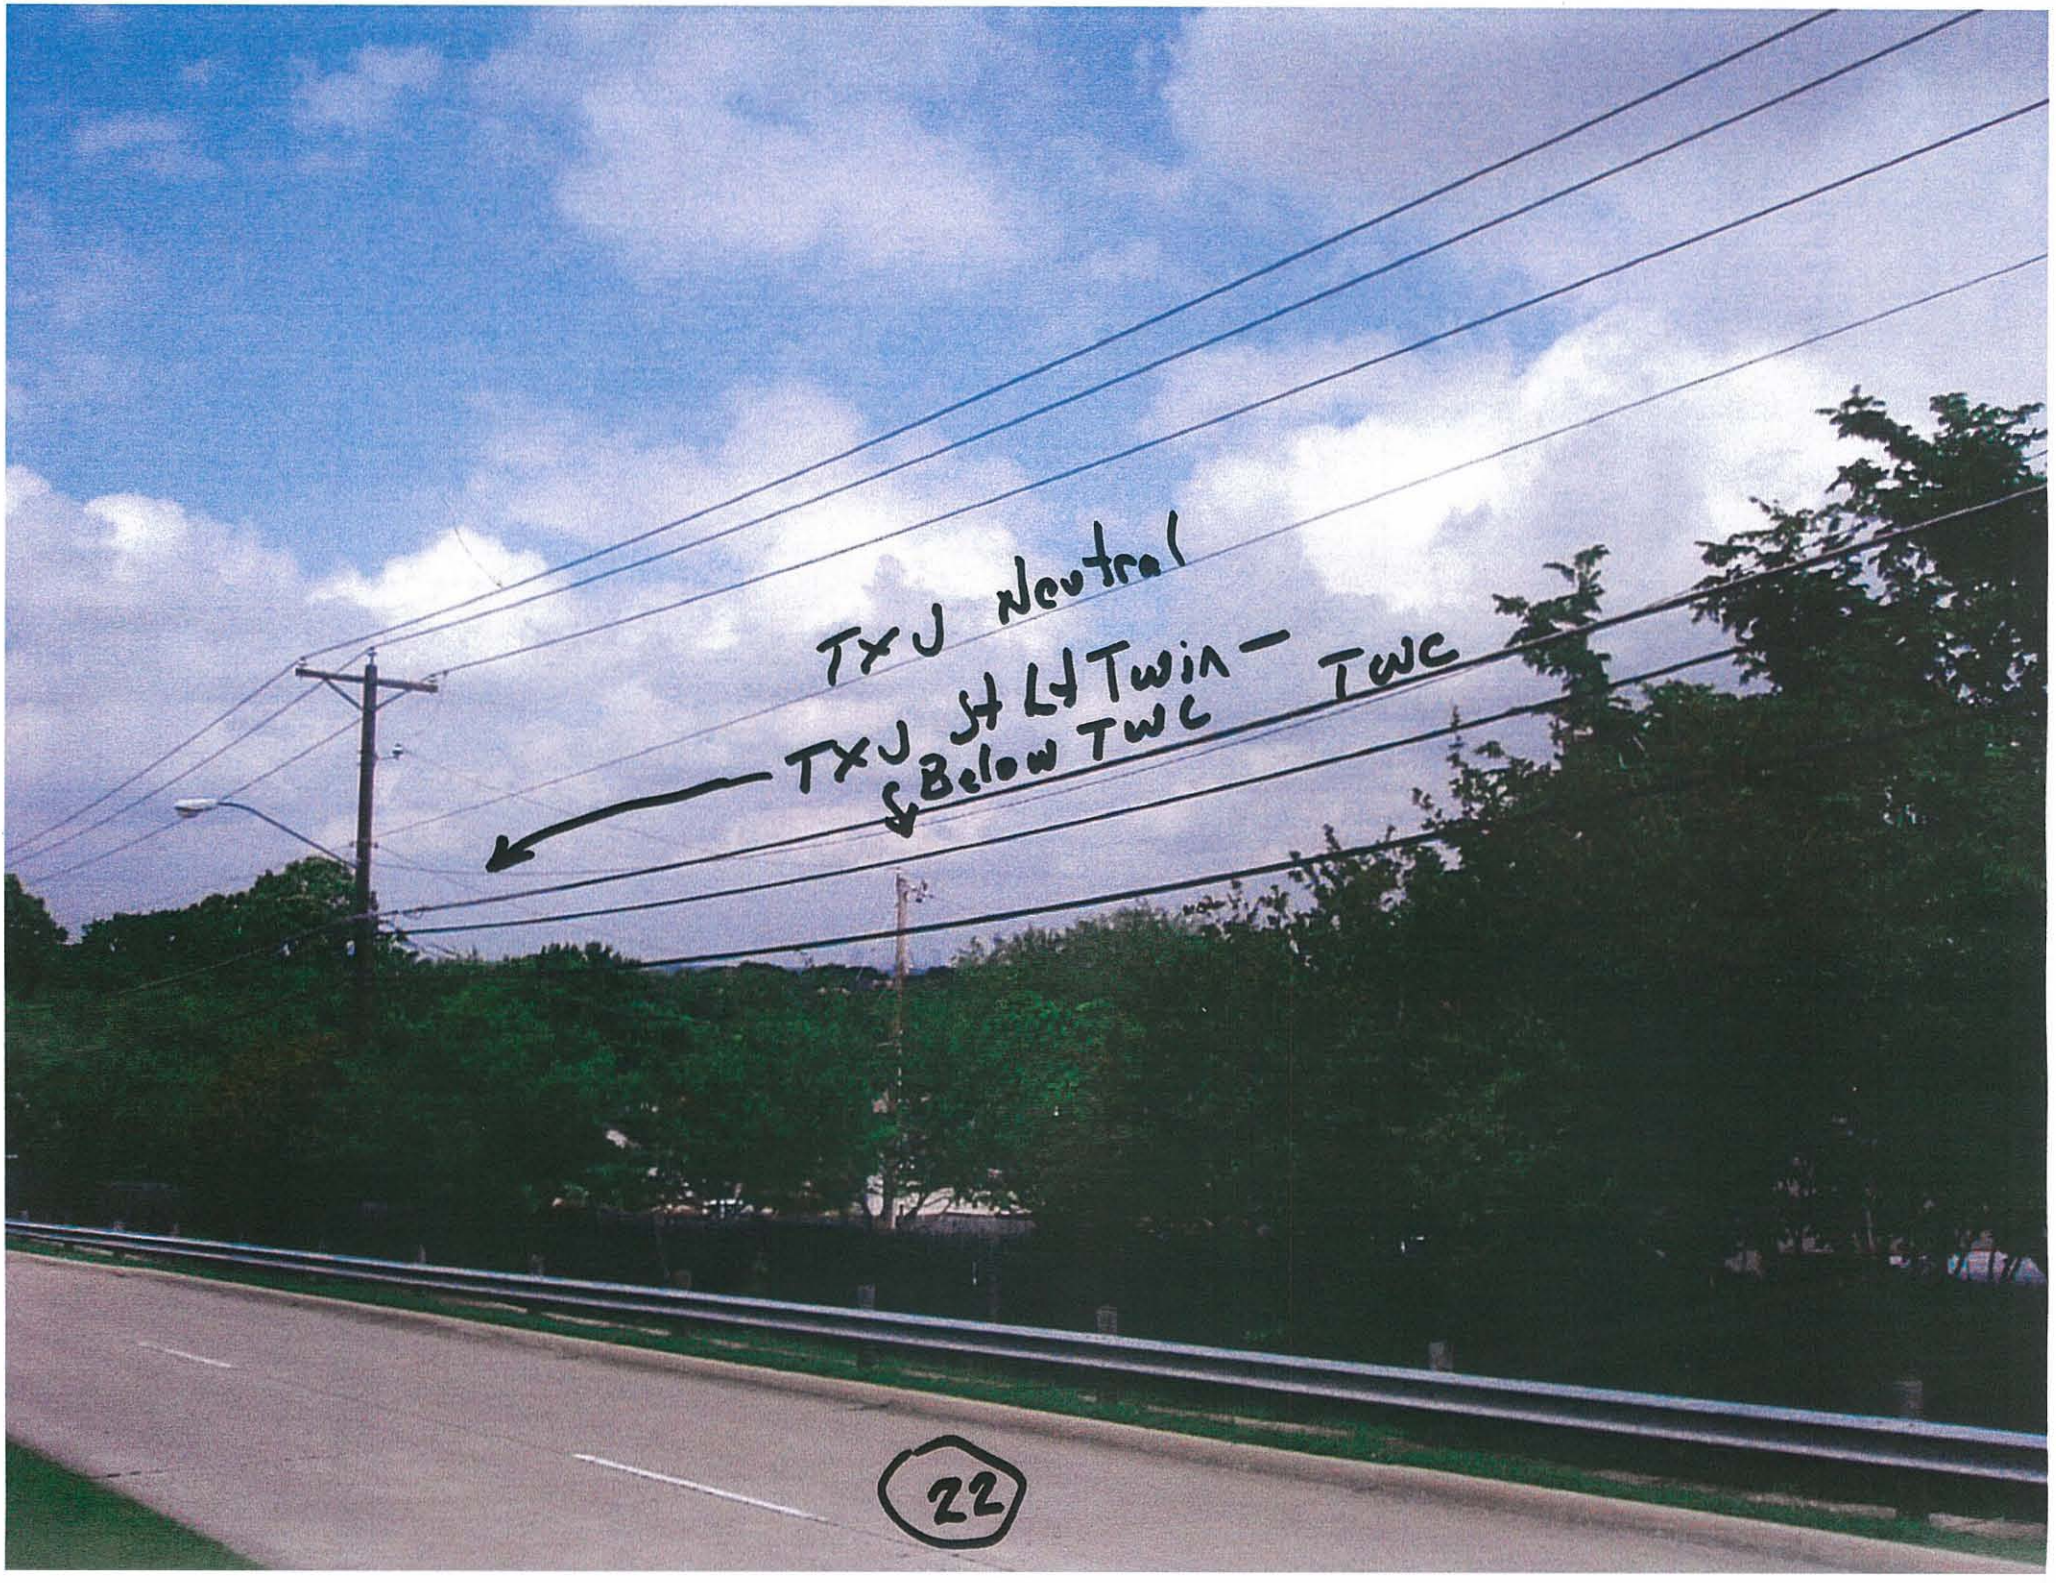
TXU Neutral
TXU St Lt Twin -
Below TWC
TWC
22

TXU Broken St Lt Twin
Dead-end clamp
TXU Neutral
TXU St Lt Twin –
Sagging below TWC
TWC
23

1'-11"
TXU St Lt Twin
TWC
24

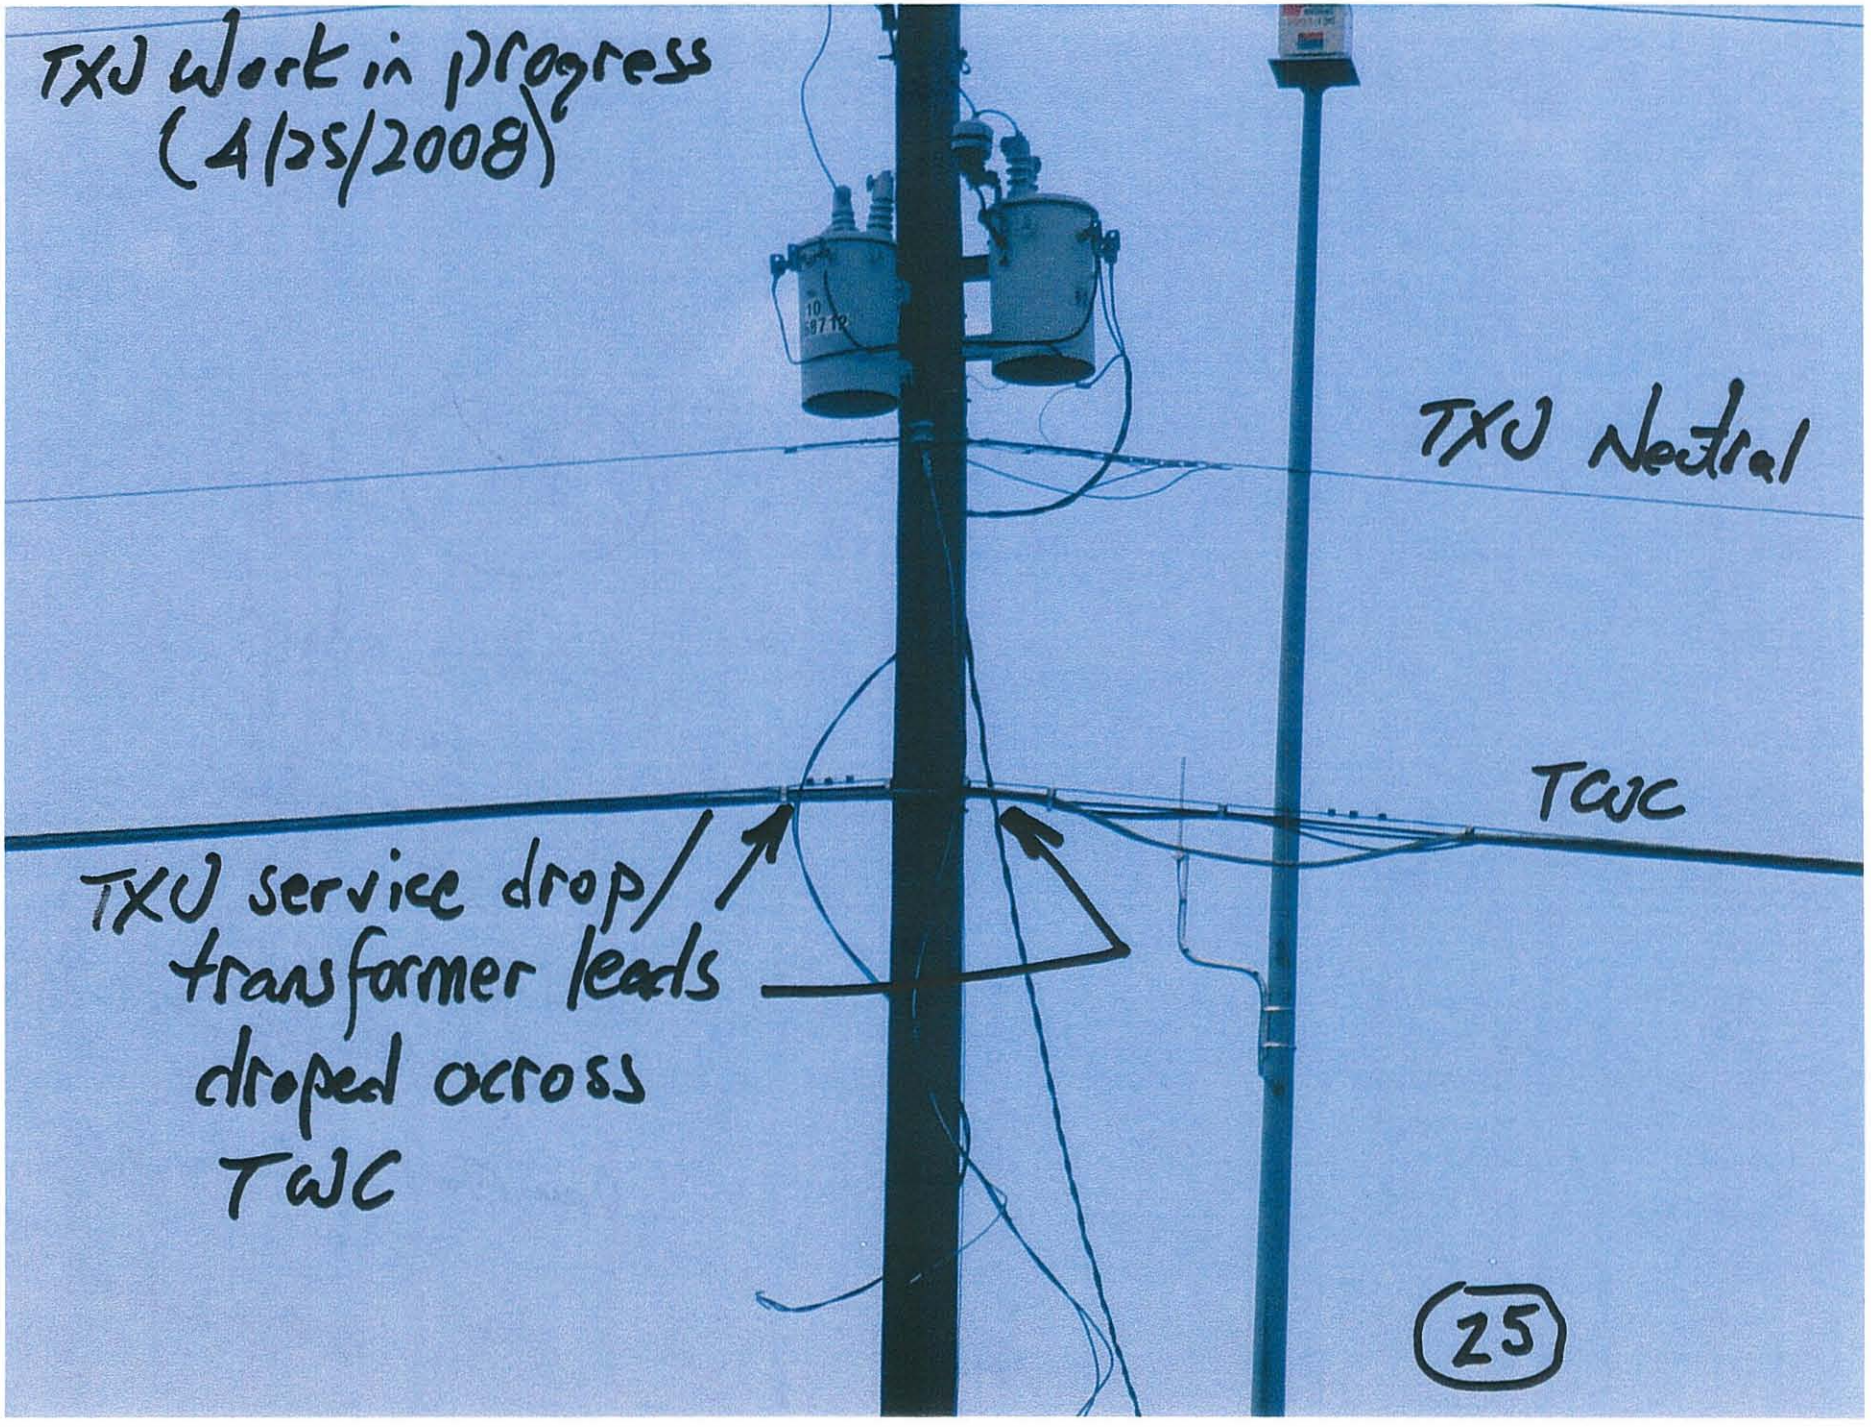
TXU work in progress
(4/25/2008)
TXU Neutral
TCJC
TXU service drop/
transformer leads
droped across
TCJC
25
