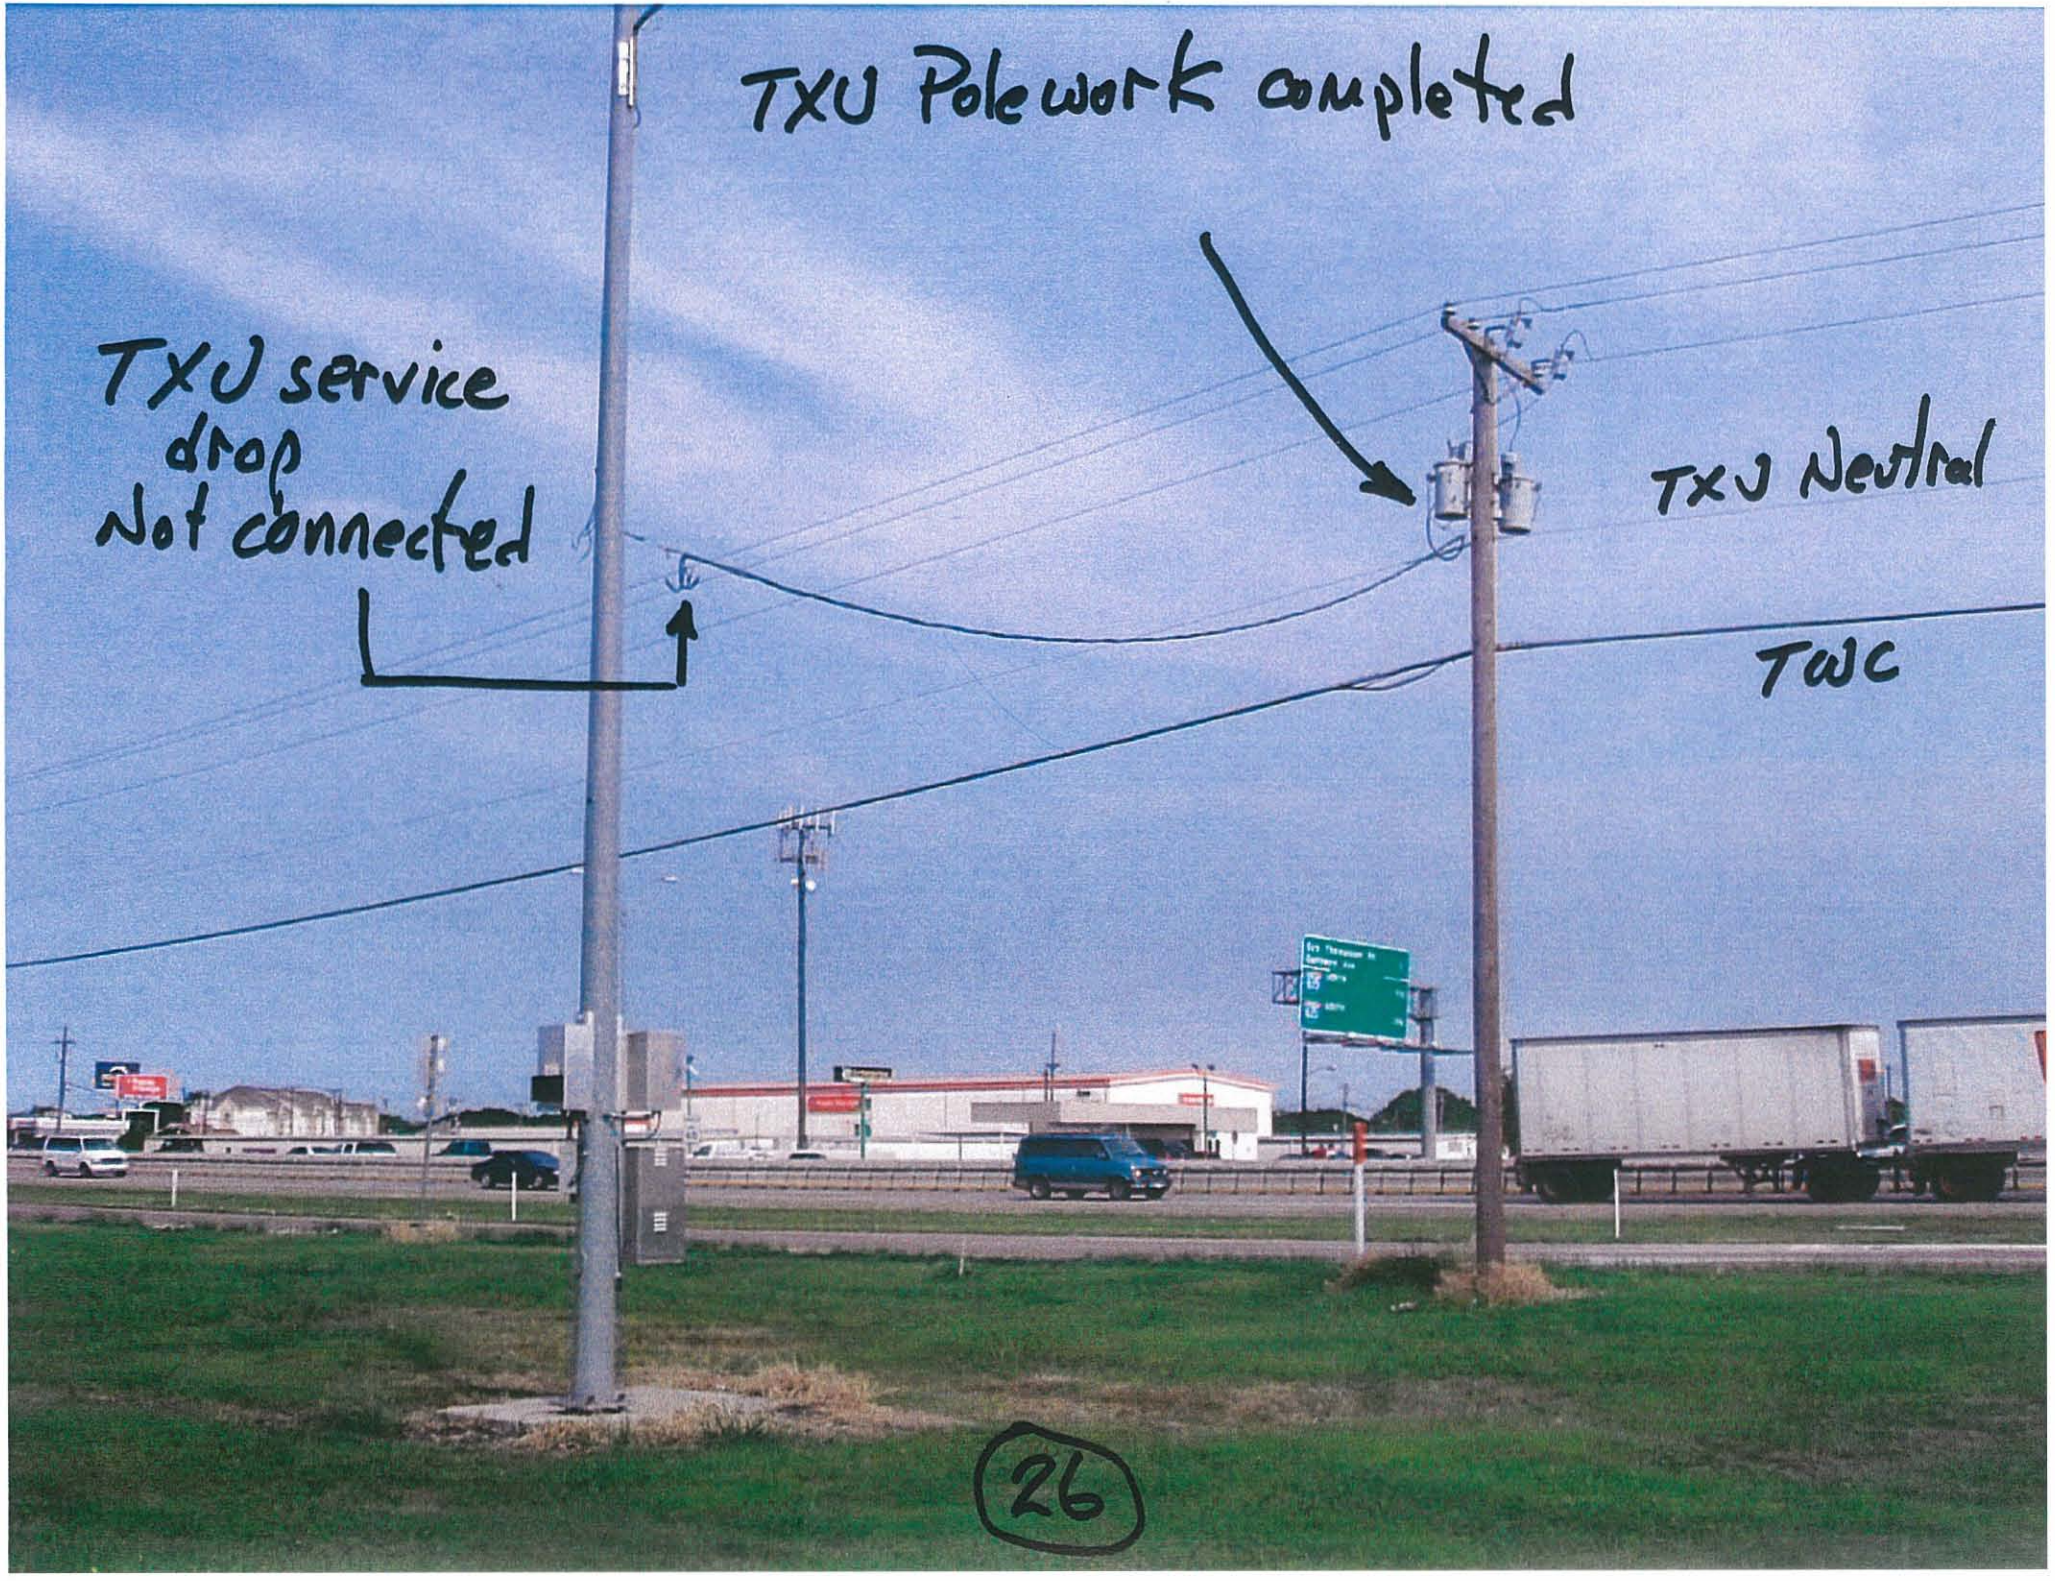
26

TXU Polework completed
TXU service drop Not connected
TXU Neutral
TWC

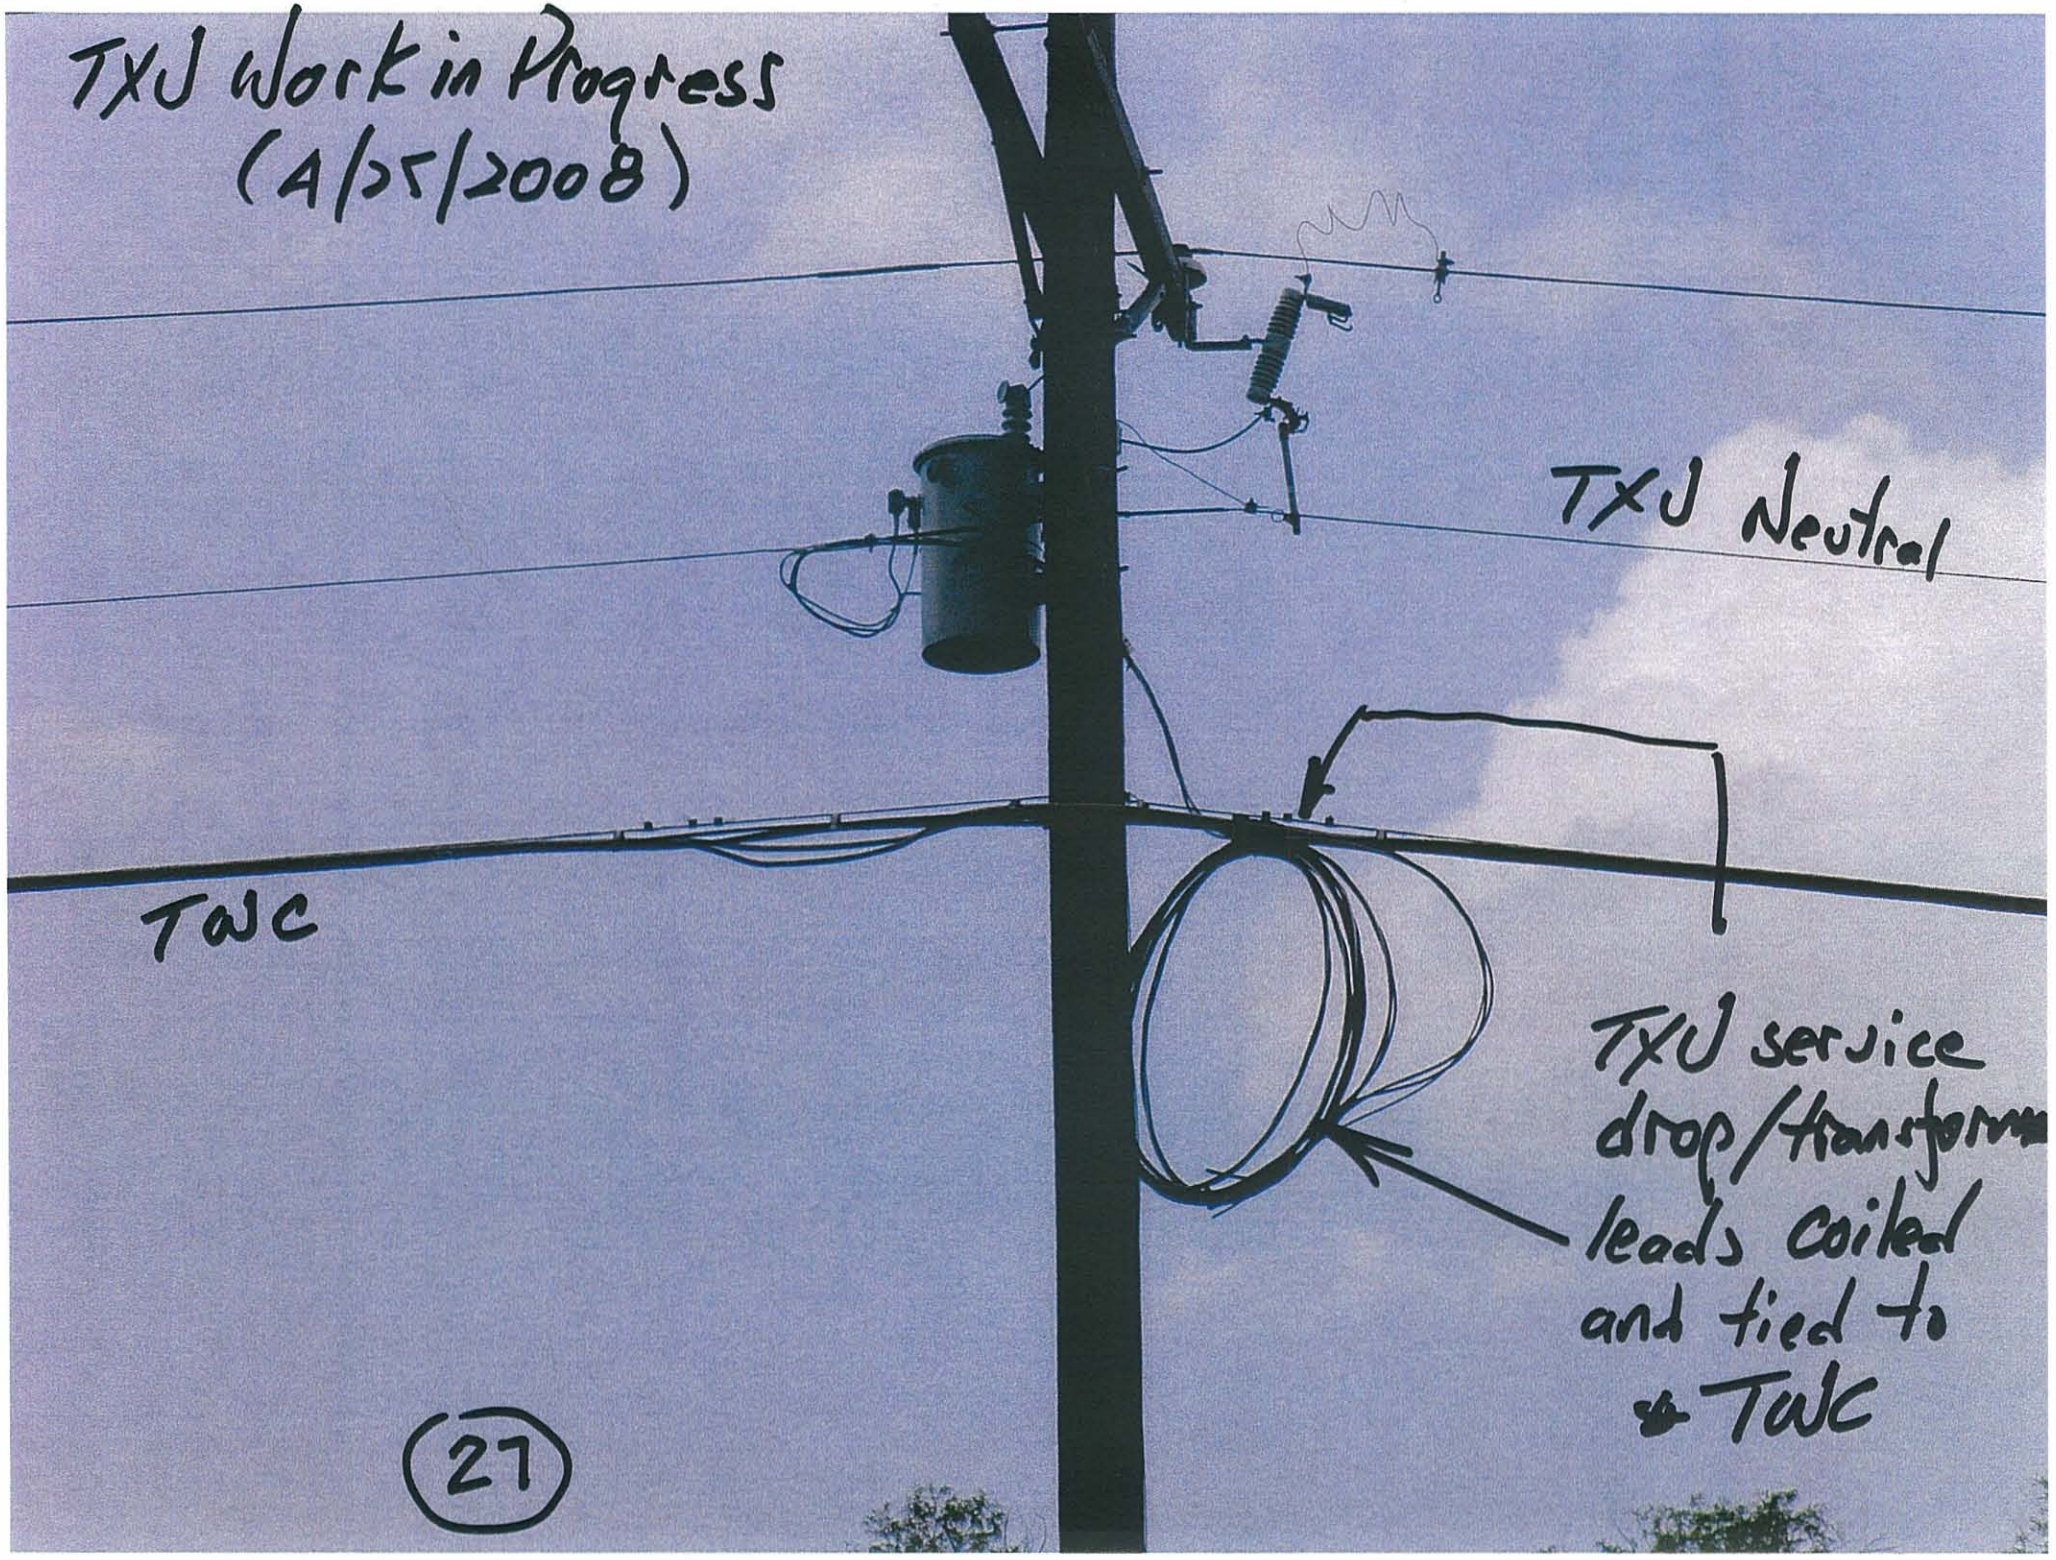
TXU Work in Progress
(4/25/2008)
TXU Neutral
TWC
TXU service drop/transformer leads coiled and tied to TWC
27

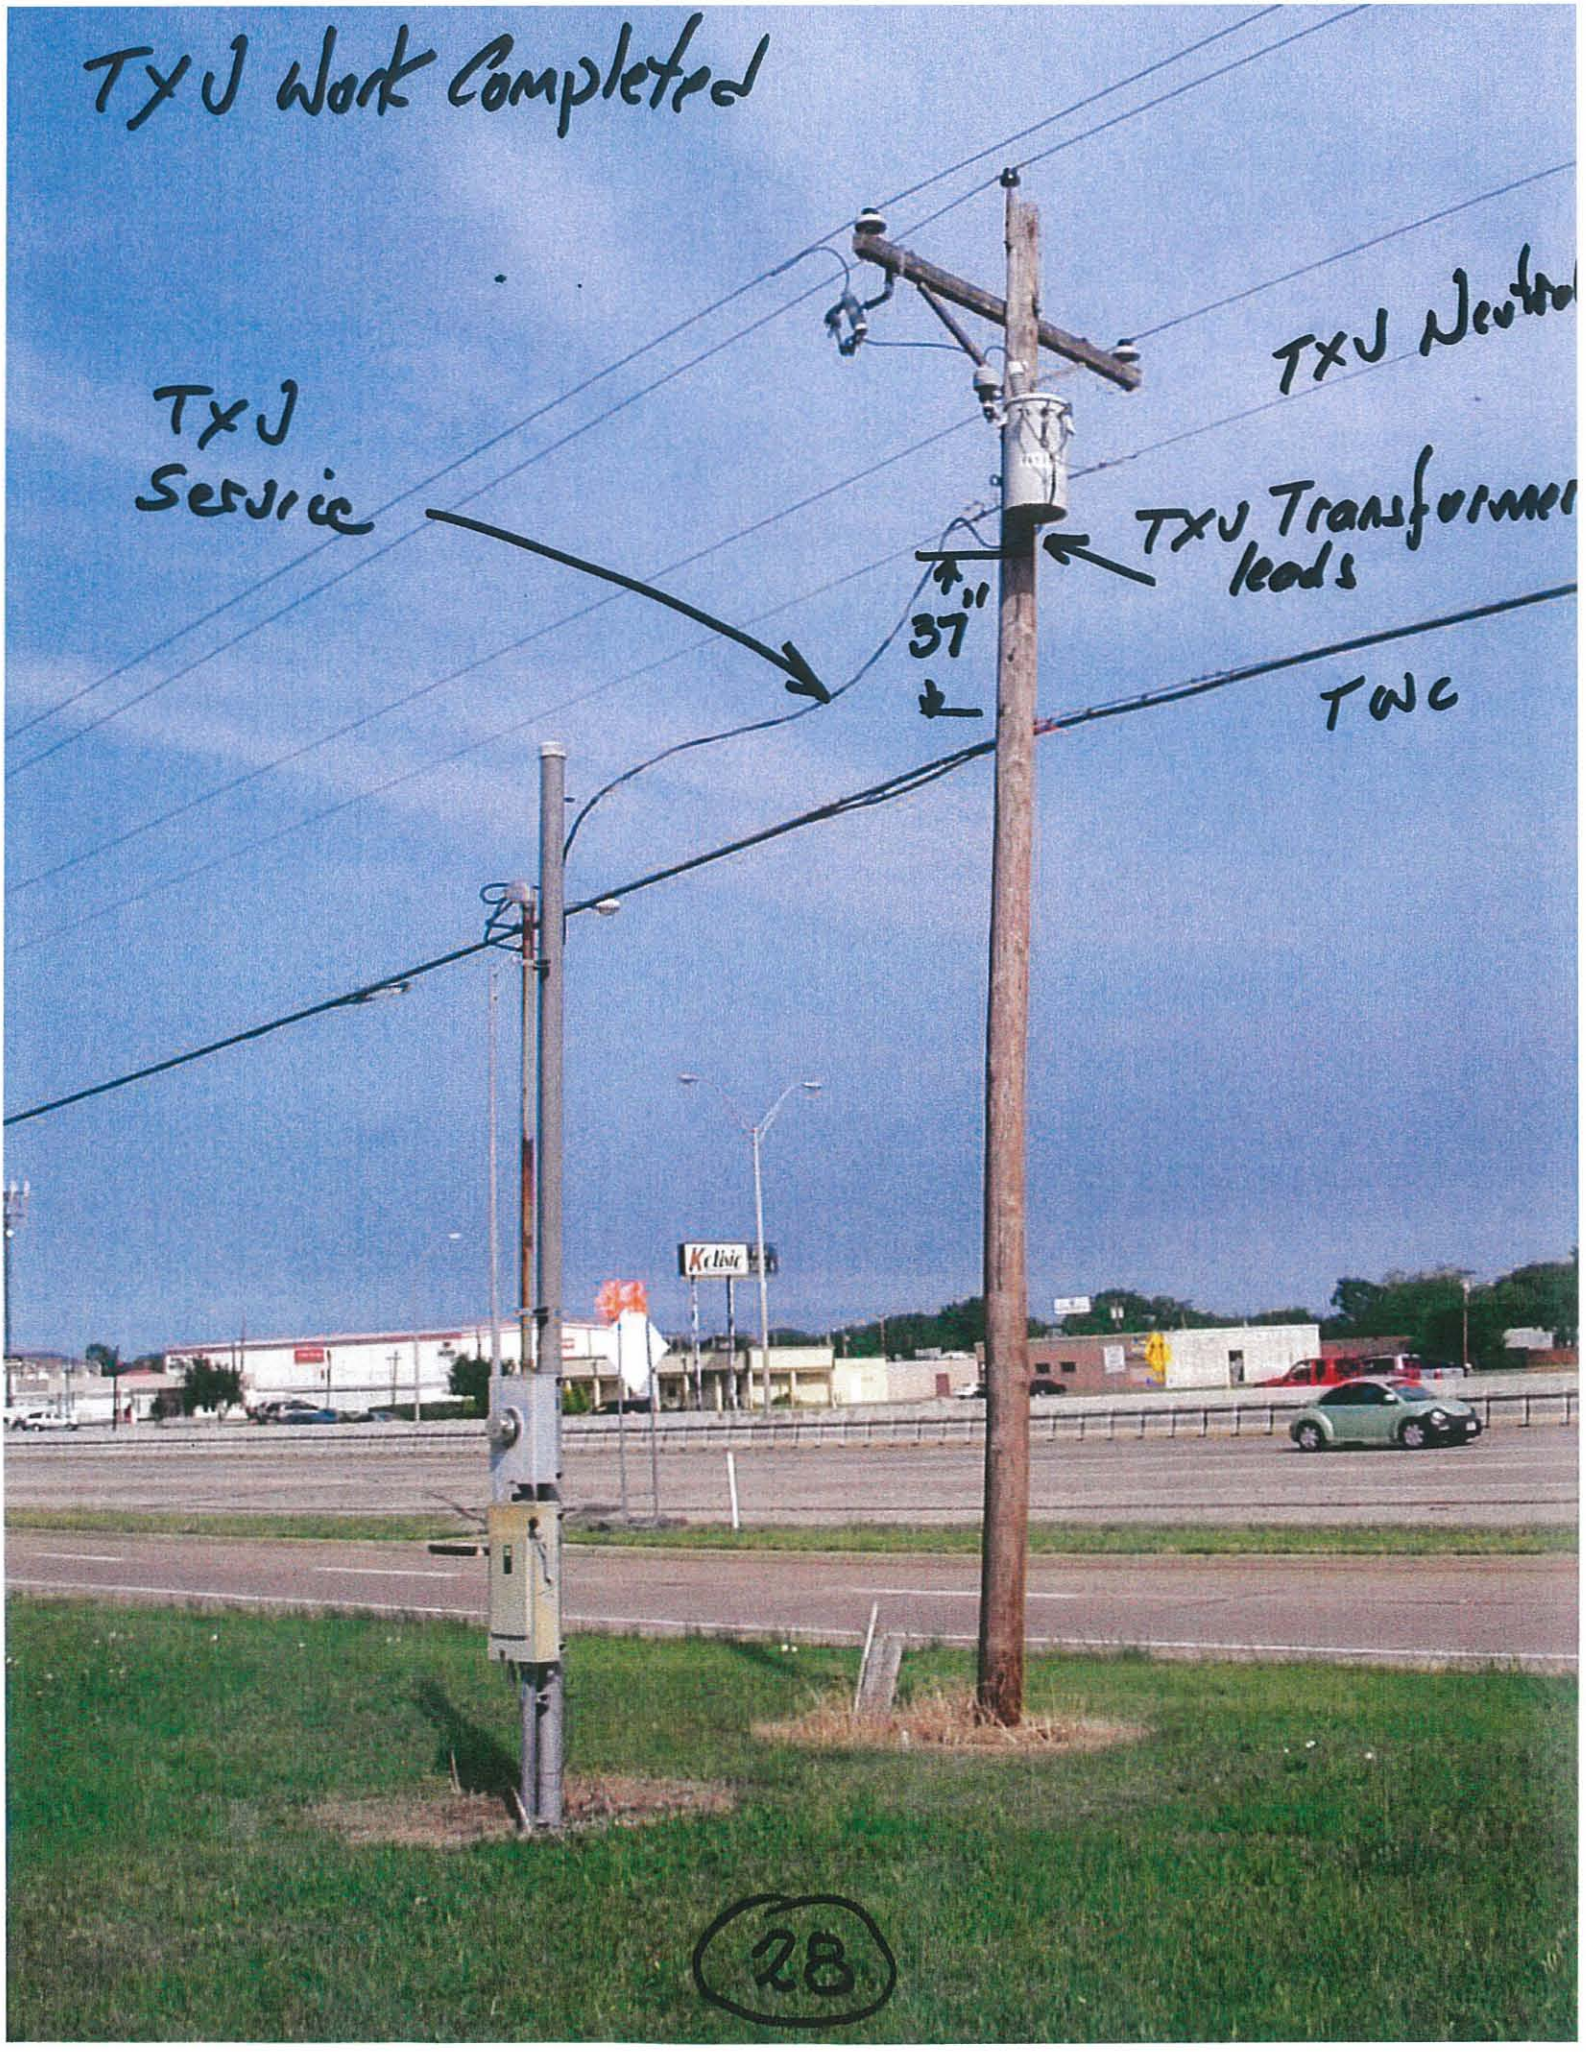
28

TXU Work Completed
TXU Service
TXU Neutral
TXU Transformer leads
37"
TWC
Kelsie

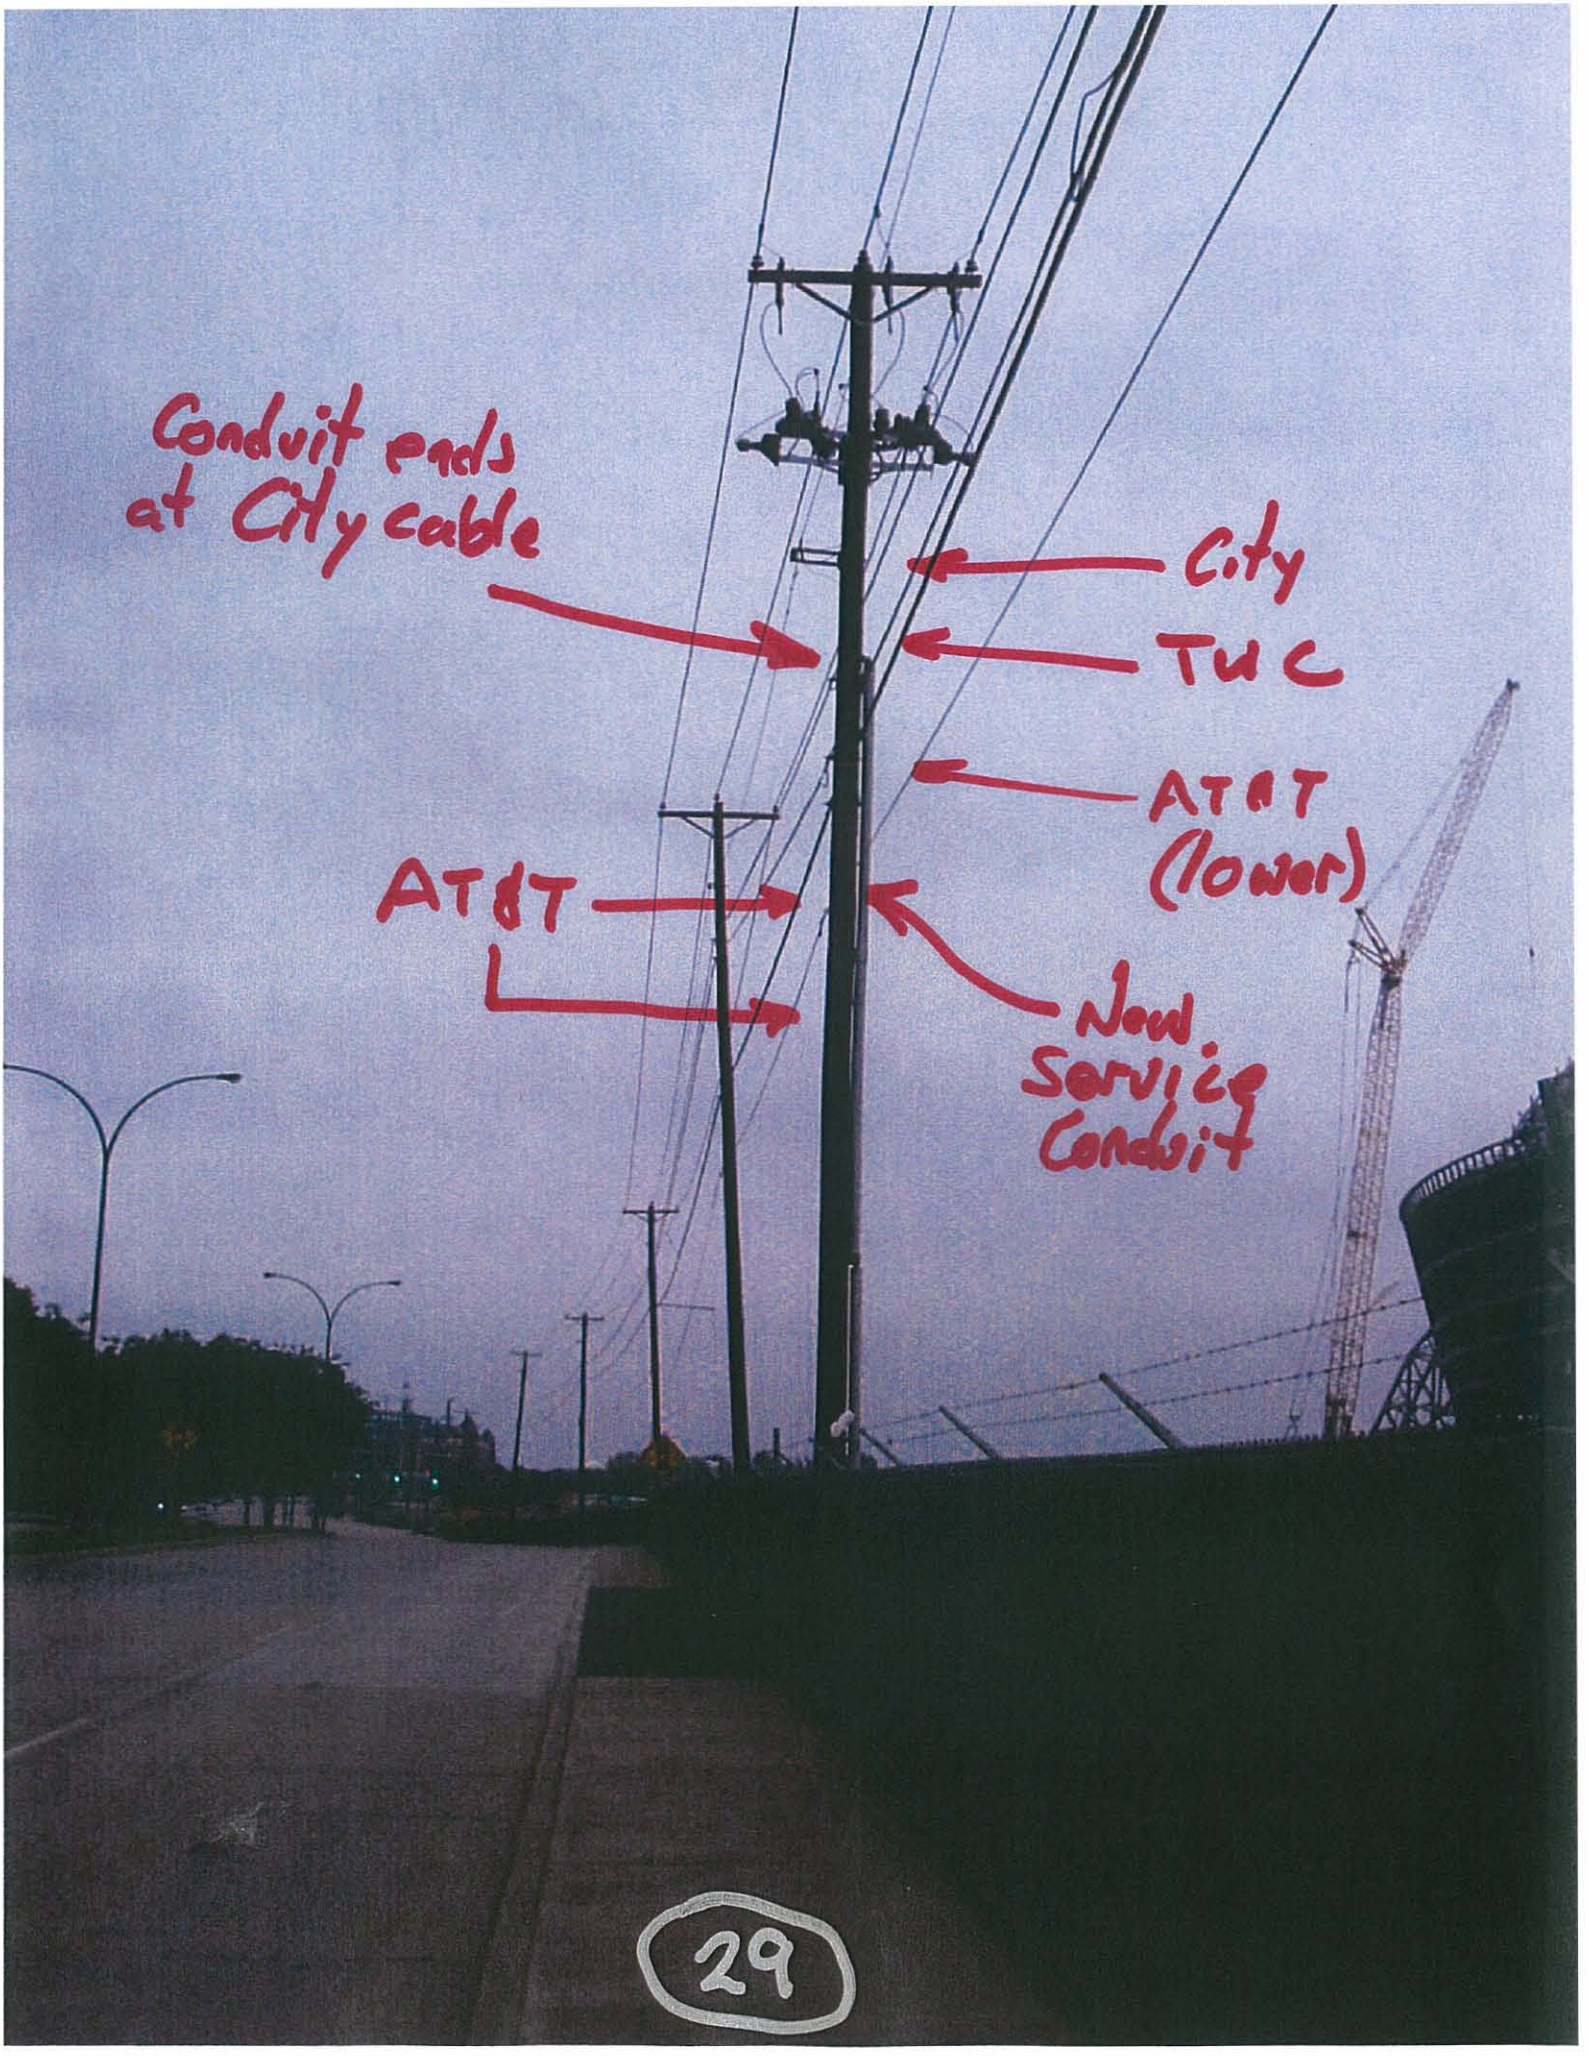
Conduit ends at City cable
City
TUC
AT&T (lower)
AT&T
New Service Conduit
