Overlashing creates real safety and reliability issues

EXHIBIT C

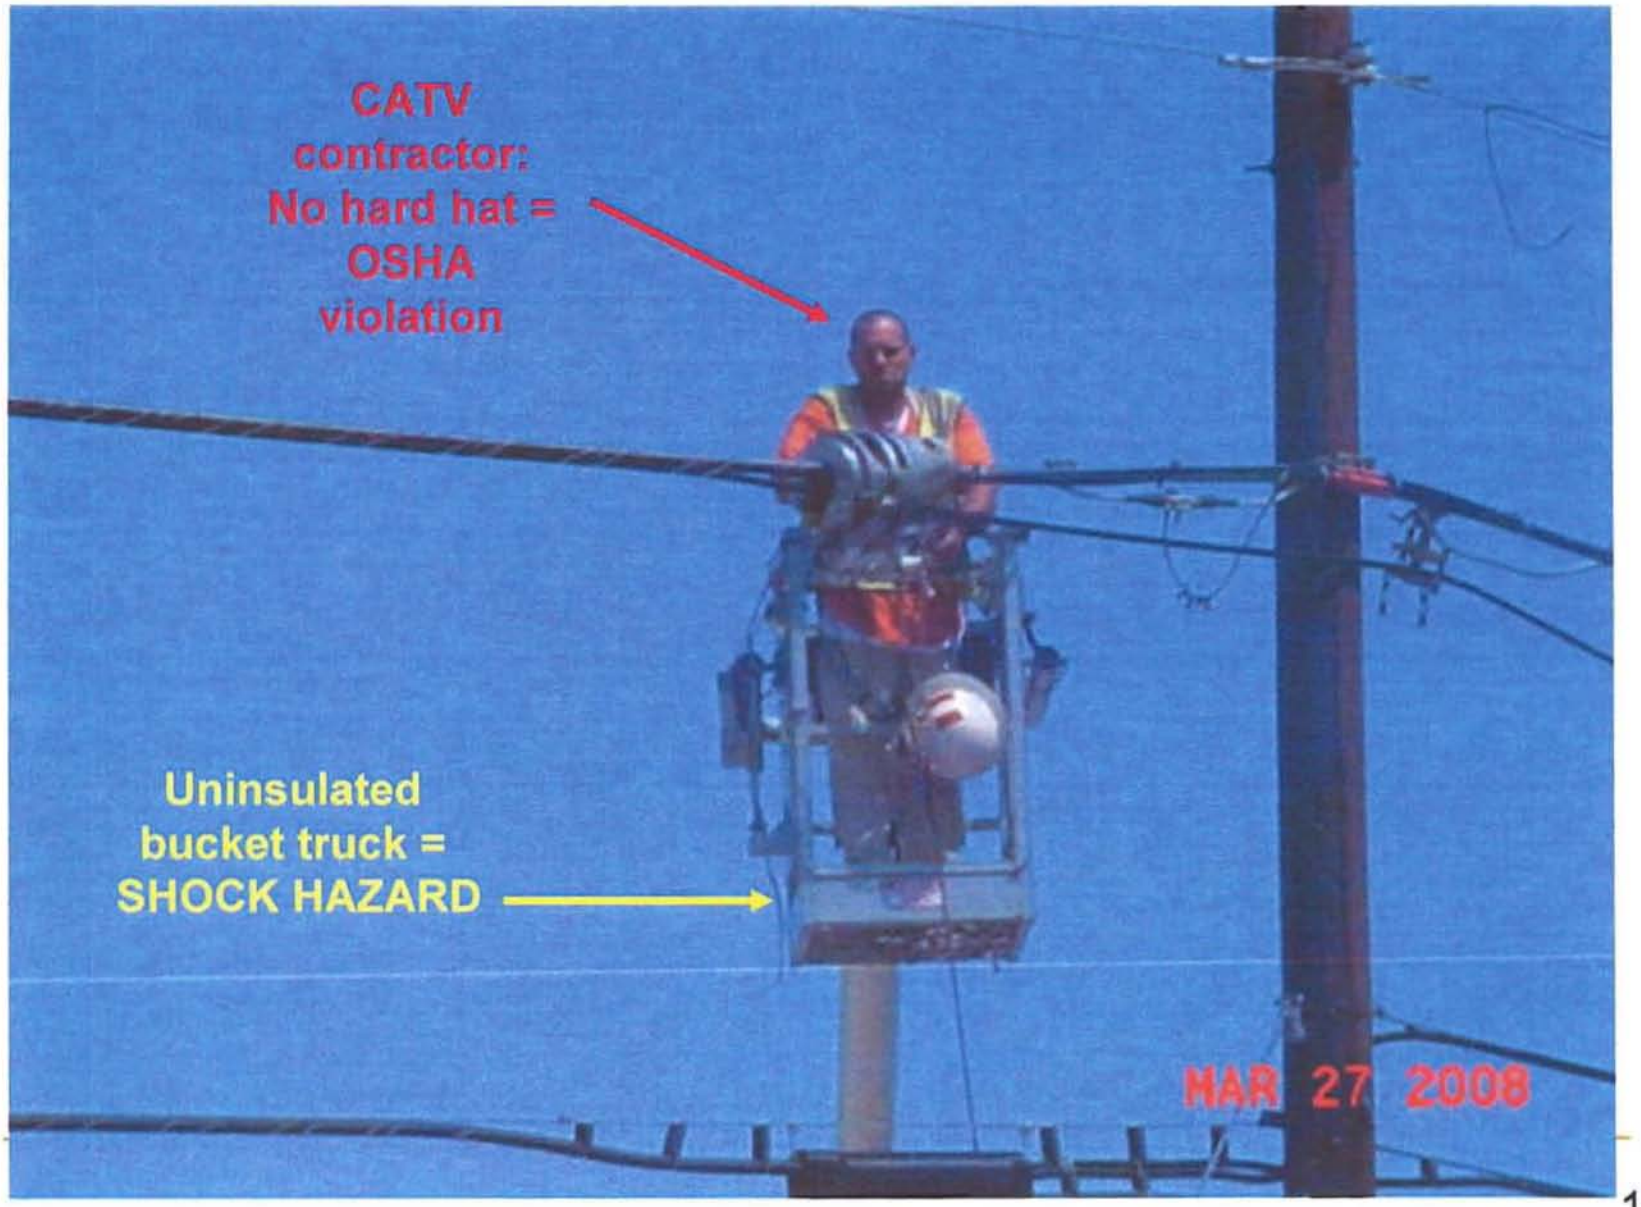
CATV bundle = excessive
strain on pole

CATV
contractor:
No hard hat =
OSHA
violation
Uninsulated
bucket truck =
SHOCK HAZARD
MAR 27 2008

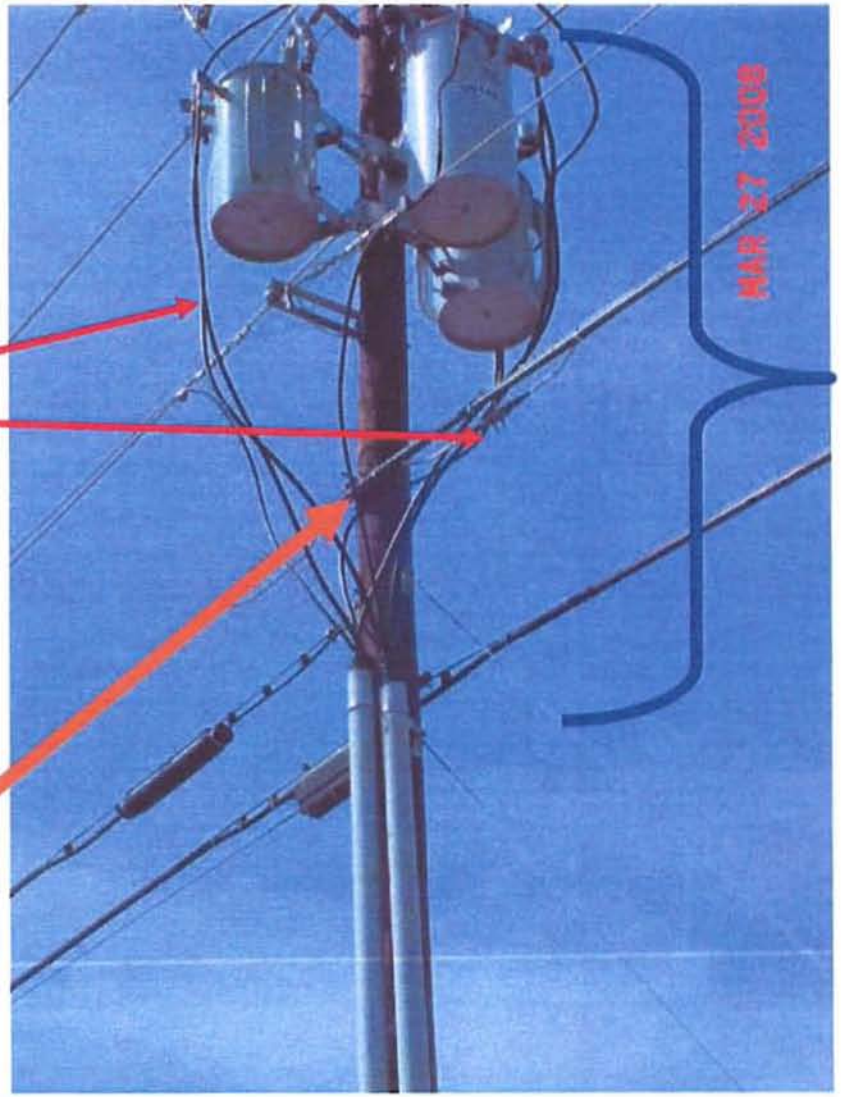
Oncor secondary lines

CATV overlash through power space

CATV contractor
entering power space =
NESC and OSHA
violation
MAR 27 2008

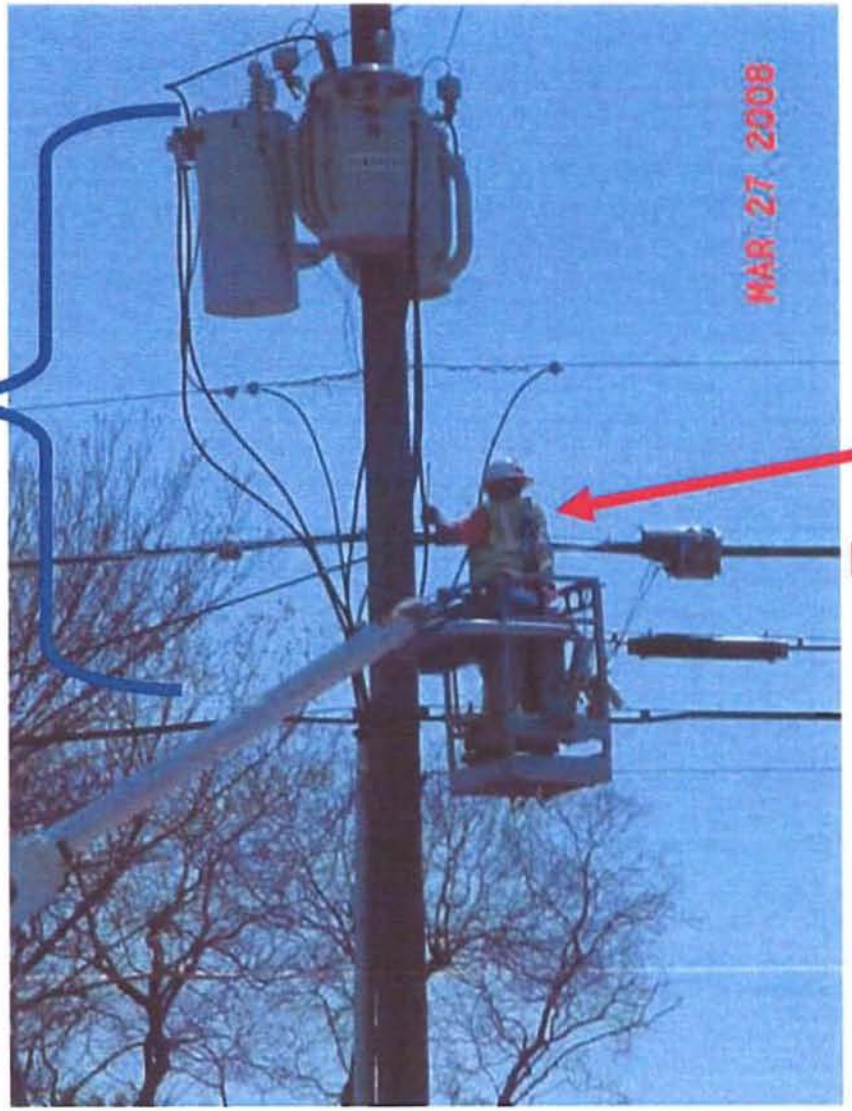
CATV contractor working in power space = NESC violation

(Uninsulated truck, no gloves)

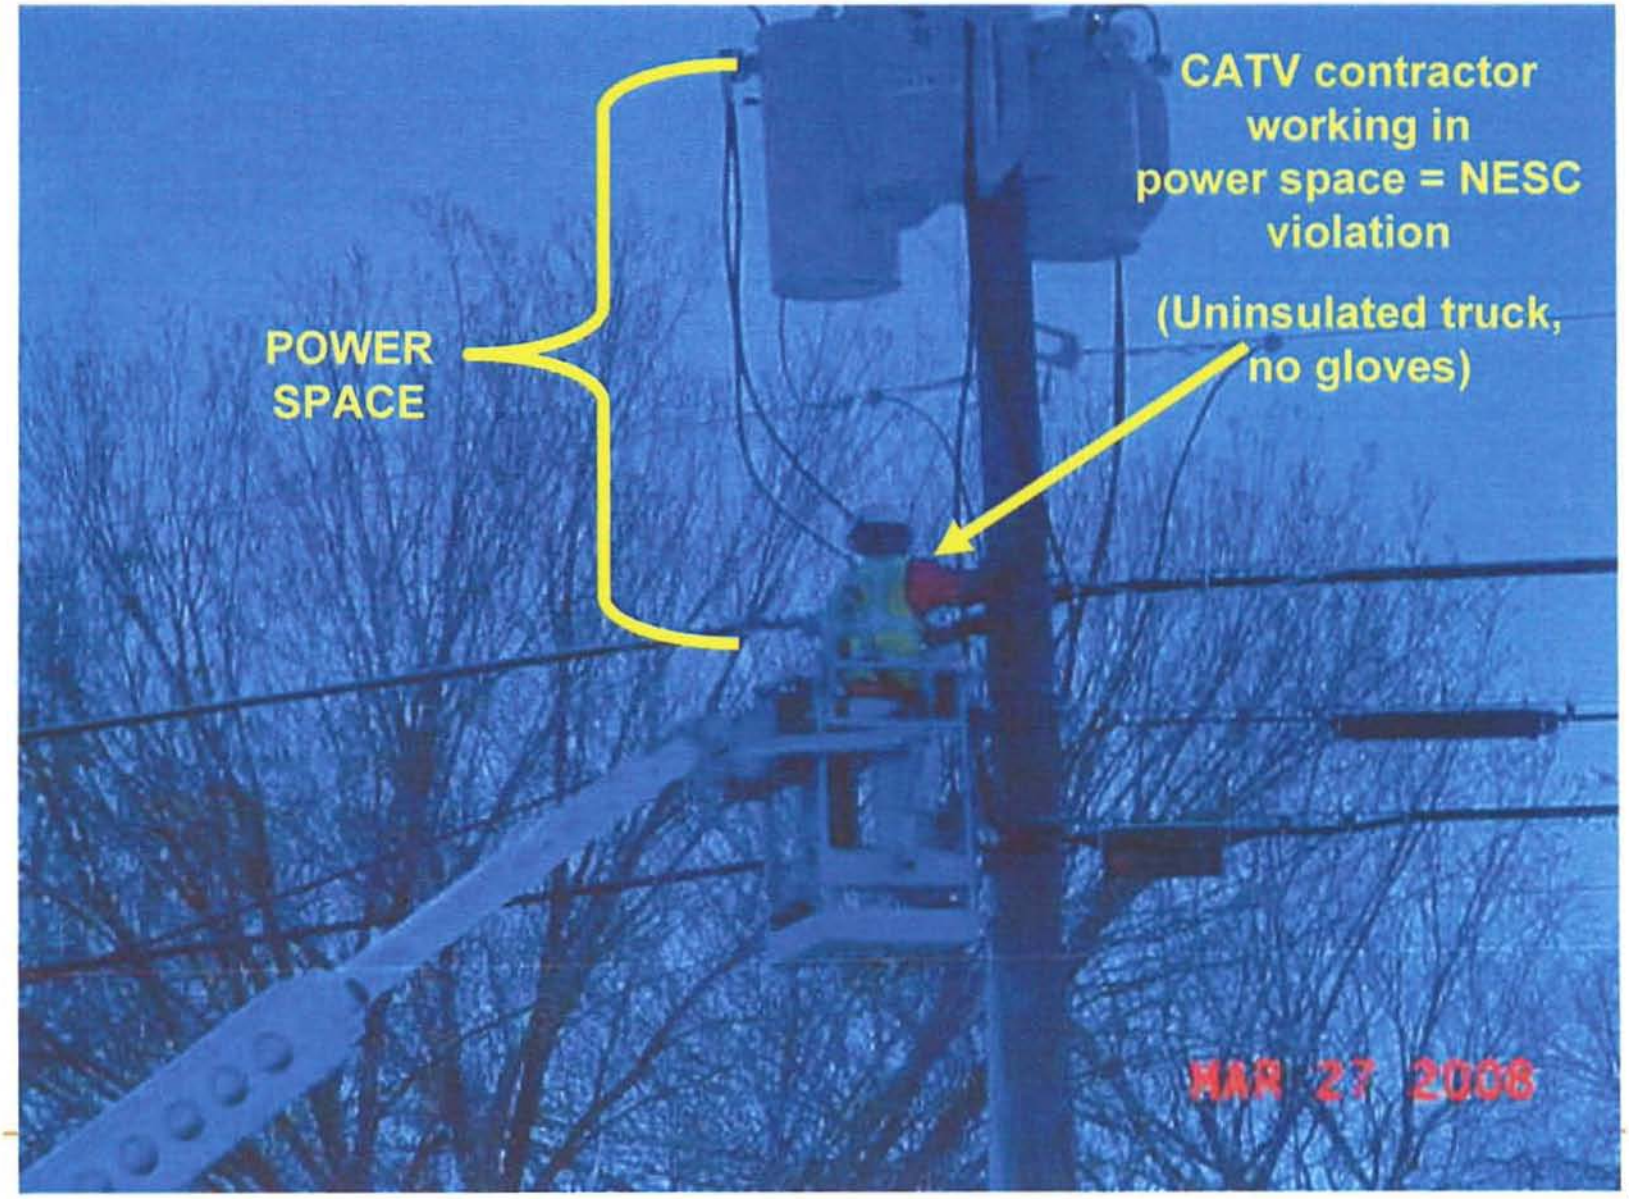
CATV contractor working in power space = NESC violation
(Uninsulated truck, no gloves)
POWER SPACE
MAR 27 2006

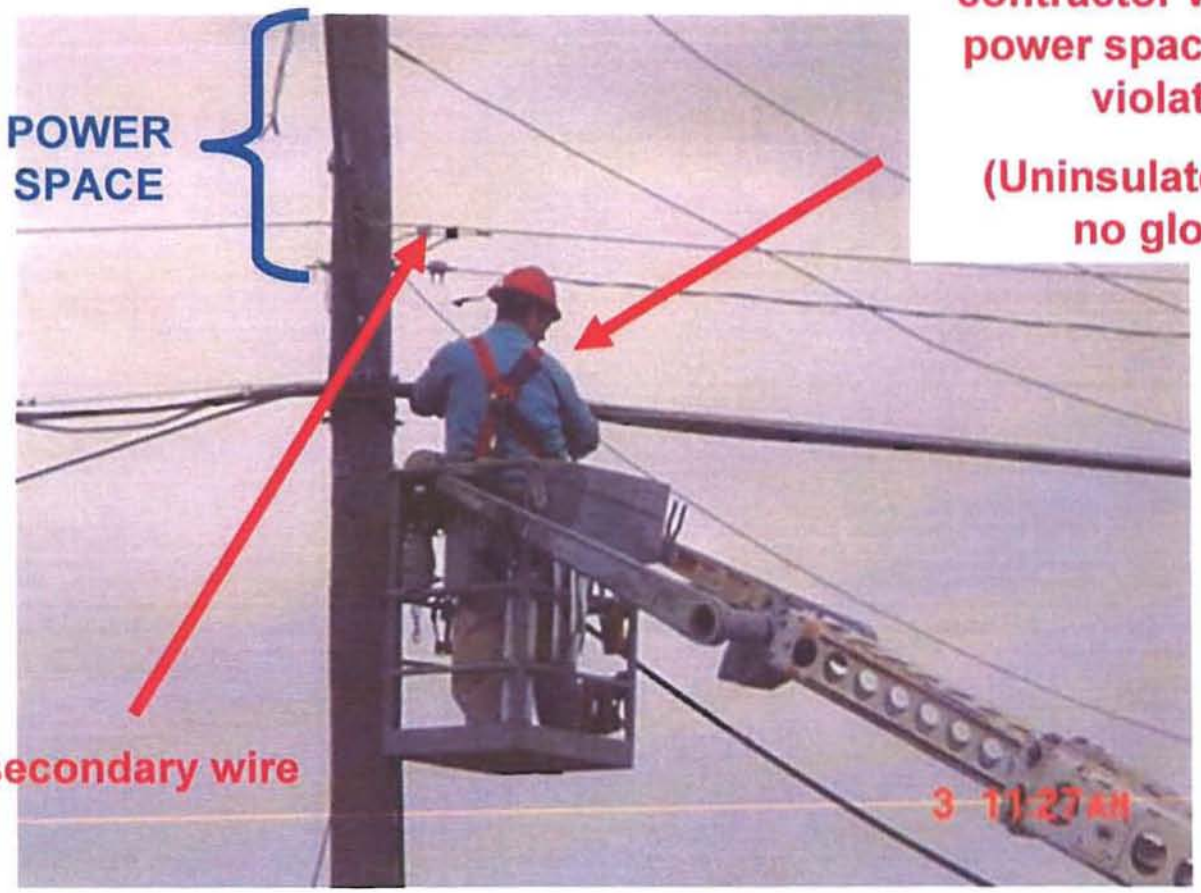
Different CATV contractor working in power space = NESC violation

(Uninsulated truck, no gloves)

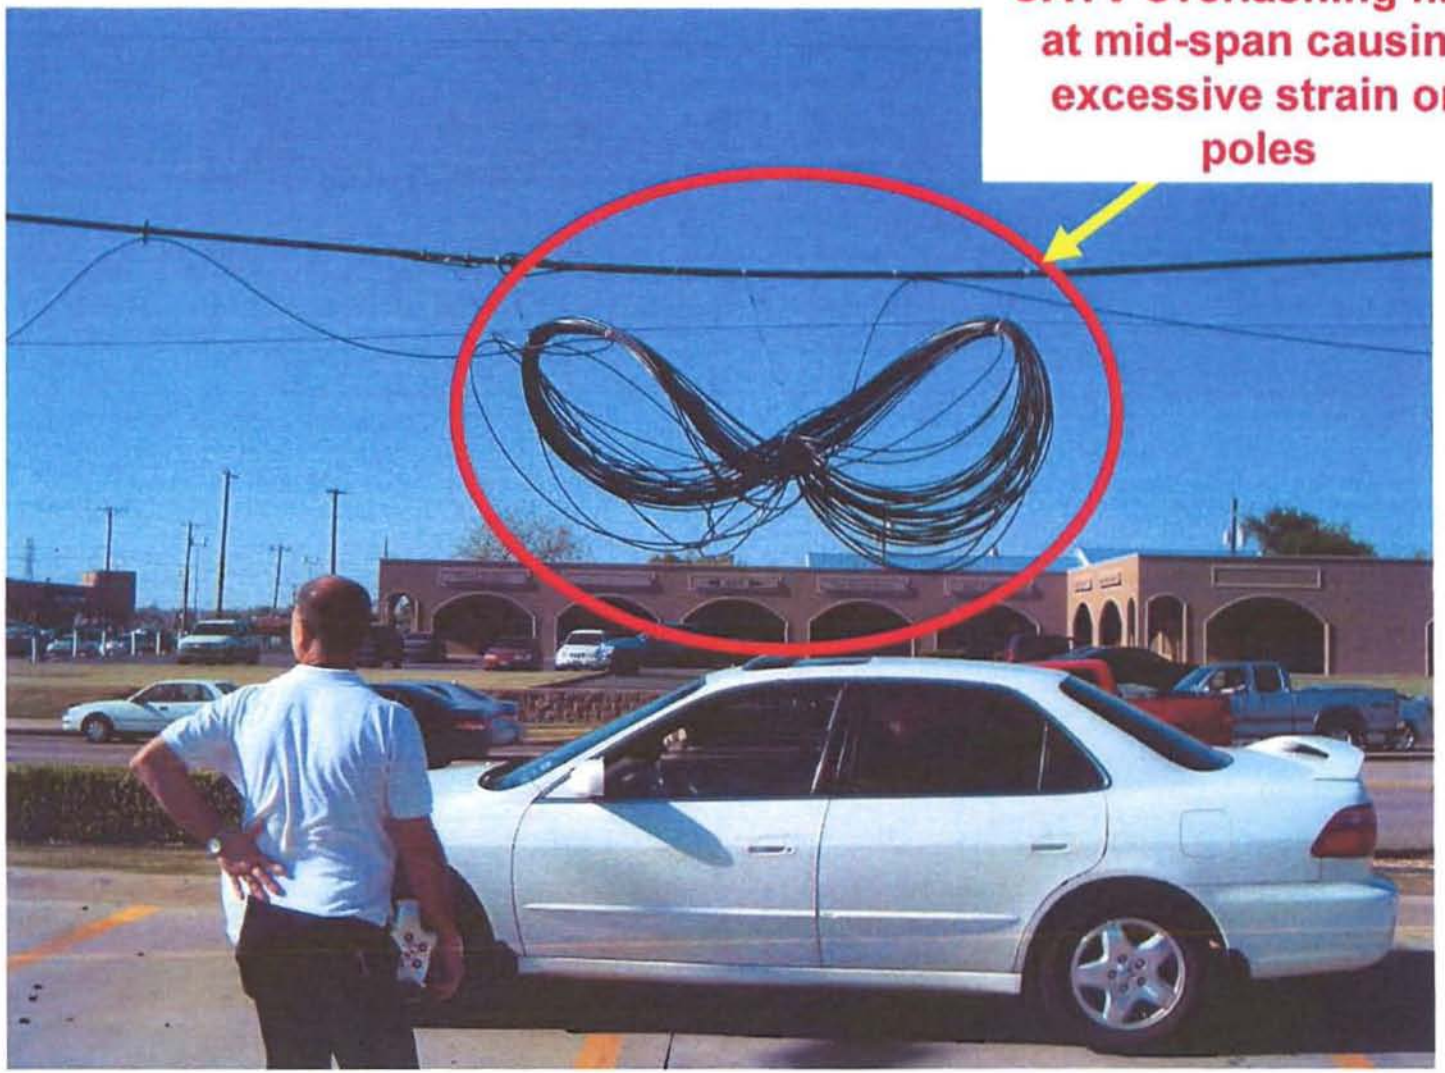
“Temporary” Attachments

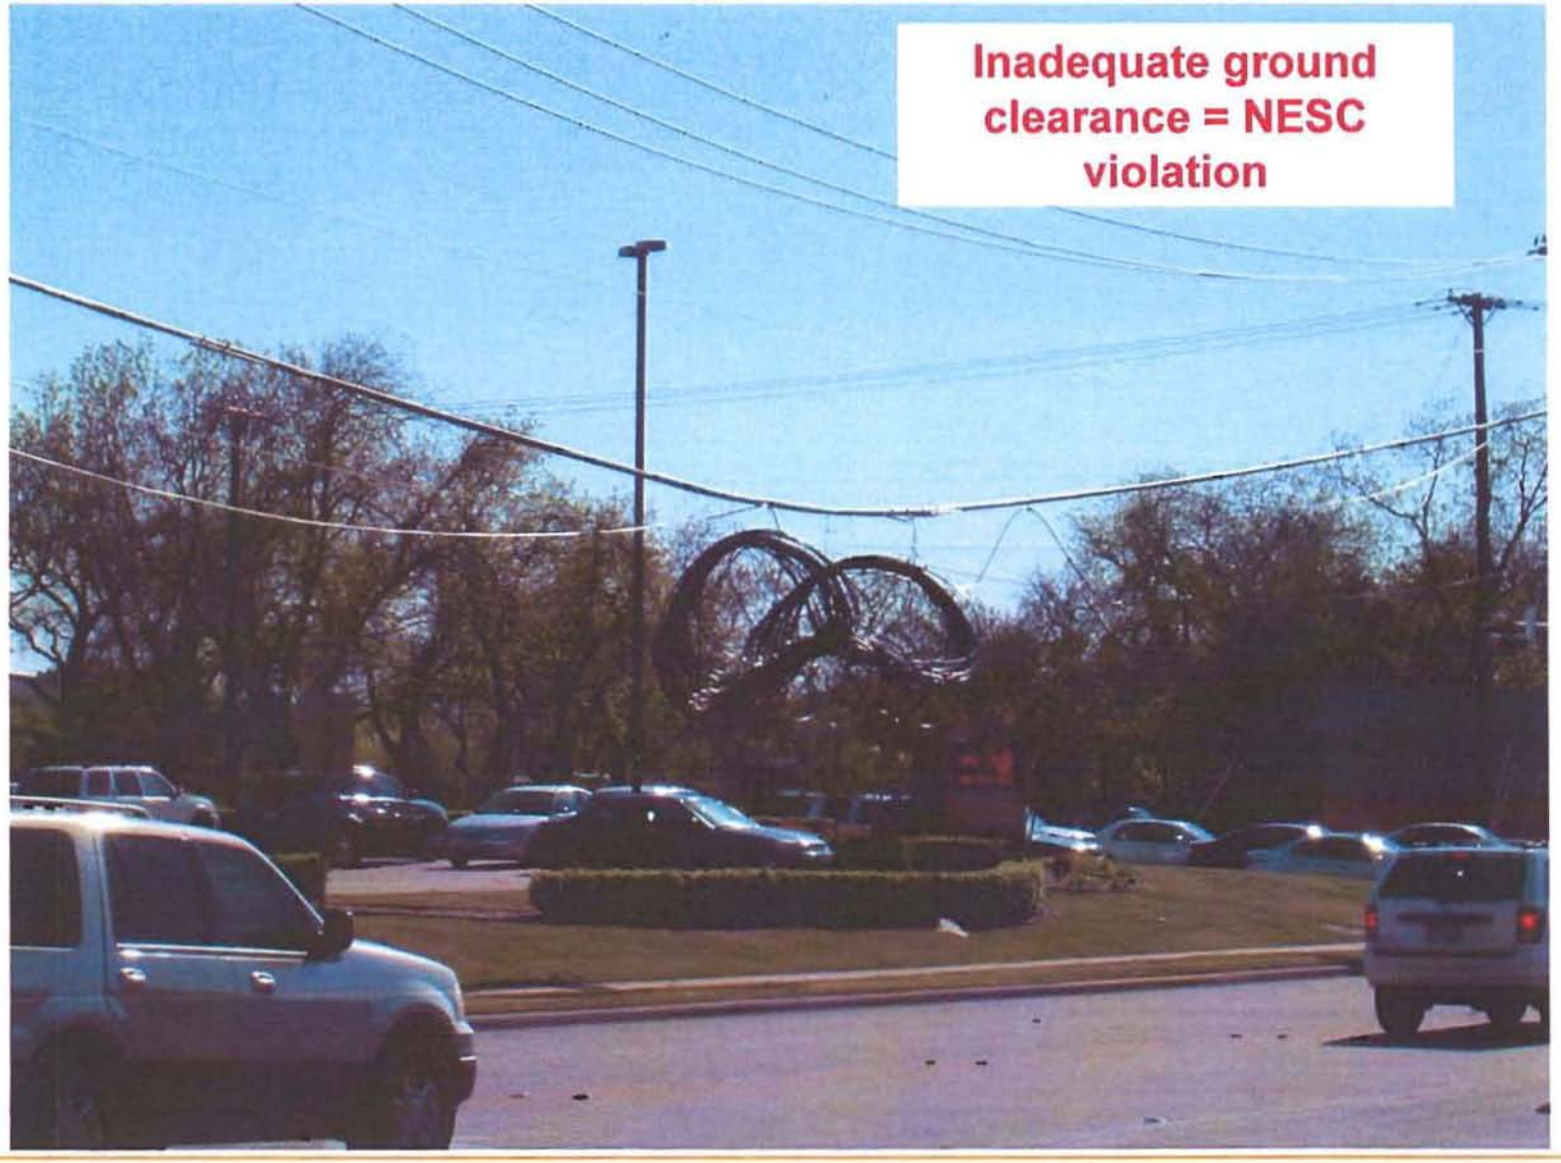
CATV overlashing fiber at mid-span causing excessive strain on poles
