**Before the
Federal Communications Commission
Washington, D.C. 20554**

Accelerating Wireline Broadband)	
Deployment by Removing Barriers)	WC Docket No. 17-84
To Infrastructure Investment)

**REPLY COMMENTS
OF THE
UTILITY COALITION ON OVERLASHING**

**Arizona Public Service
Consumers Energy
Exelon Corporation
FirstEnergy
Hawaiian Electric Companies
Puget Sound Energy
The AES Corporation**

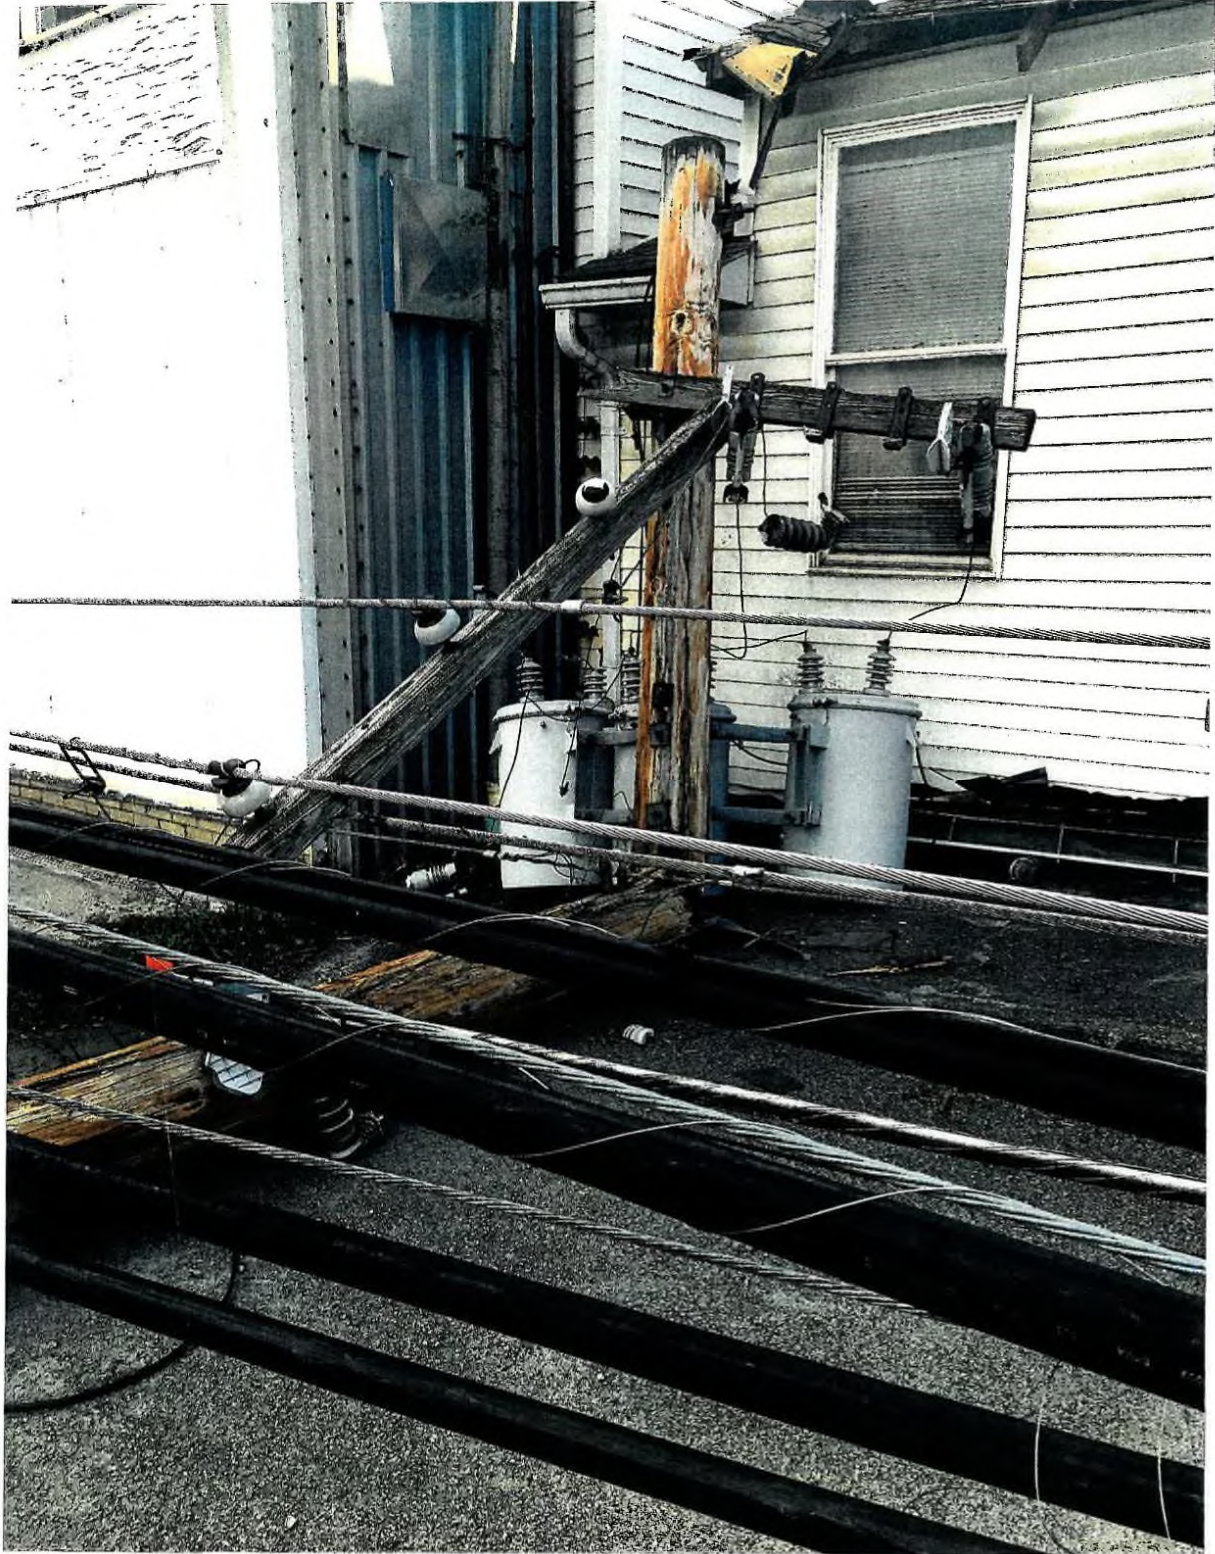
To give the Commission a better understanding of the damage and safety issues that are caused by these low hanging wires, attached hereto at Exhibit C is a detailed report of one of these dozens of accidents from Monongahela Power (a FirstEnergy company), that includes before and after photographs showing the wreckage resulting from these low-hanging communications cables. Here is one of those photographs that shows the cables themselves associated with the accident. These cables have clearly been overlashed:

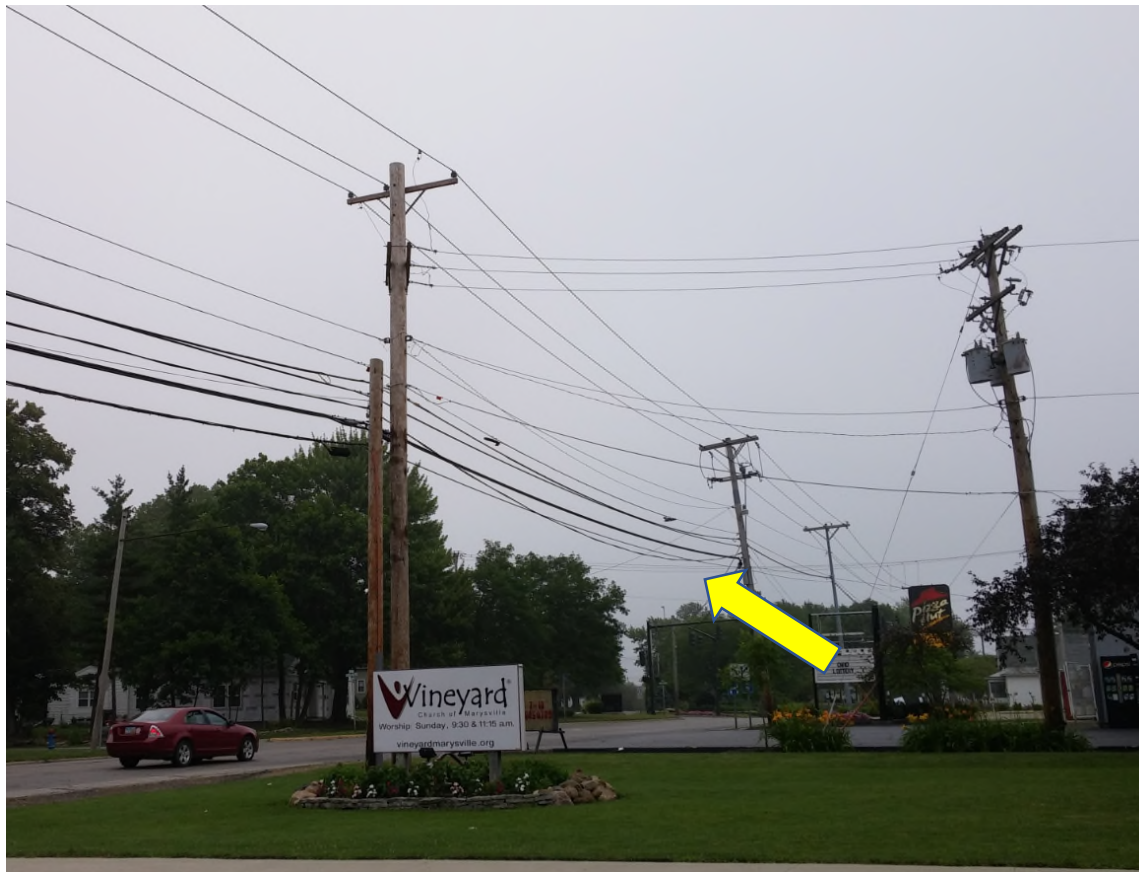
It is not difficult to understand that overlashing can also easily cause a communications wire mid-span to sag too close to other existing communications wires mid-span, causing a violation of NESC mid-span separation requirements between cables. In fact, overlashing can and often does cause existing wires mid-span to sag below the wires that are located below them, eliminating any separation at all. Here is one photograph depicting this problem:

16. Overlashing can easily cause a communications wire mid-span to sag too close to other existing communications wires mid-span, causing a violation of NESC mid-span separation requirements between cables. Overlashing can and often does cause existing wires mid-span to sag below the wires that are located below them, eliminating any separation at all.
